Third Five-Year Review of Remedial Actions

Hunters Point Naval Shipyard San Francisco, California

November 8, 2013

Prepared for:
Department of the Navy
Base Realignment and Closure
Program Management Office West
San Diego, California

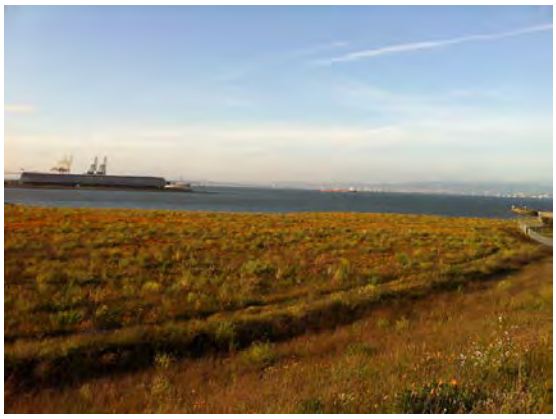
Quarterly inspections were conducted in October 2011, January 2012, April 2012, and July 2012 during the first year of long-term monitoring and maintenance (ERRG 2012c). Inspections found all remedy components in good condition (photograph at right shows established vegetation on the cover in April 2012). A land survey of the two settlement monuments on the soil cover conducted in July 2012 found no settlement had occurred. Minor issues encountered included occasional vandalism of the fencing, a few shallow animal burrows, and minor areas where vegetation needed to be reseeded.

Animal burrows were checked for inhabitants, confirmed to be unoccupied, and filled in using a spade. The disturbed area was then reseeded.

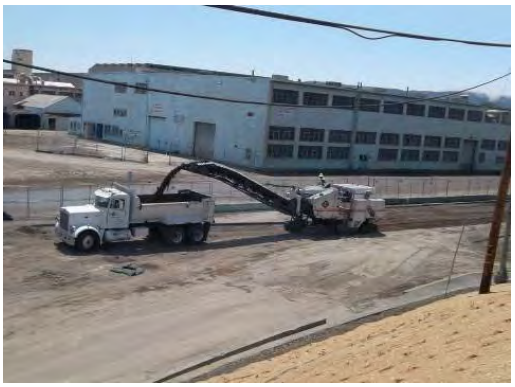
- Installation of soil covers, cover stabilization, and vegetation planting
- Asphalt cover (roadway) restoration and replacement (photograph at right)
- Fence installation
- Final survey
- Final inspection
- Demobilization

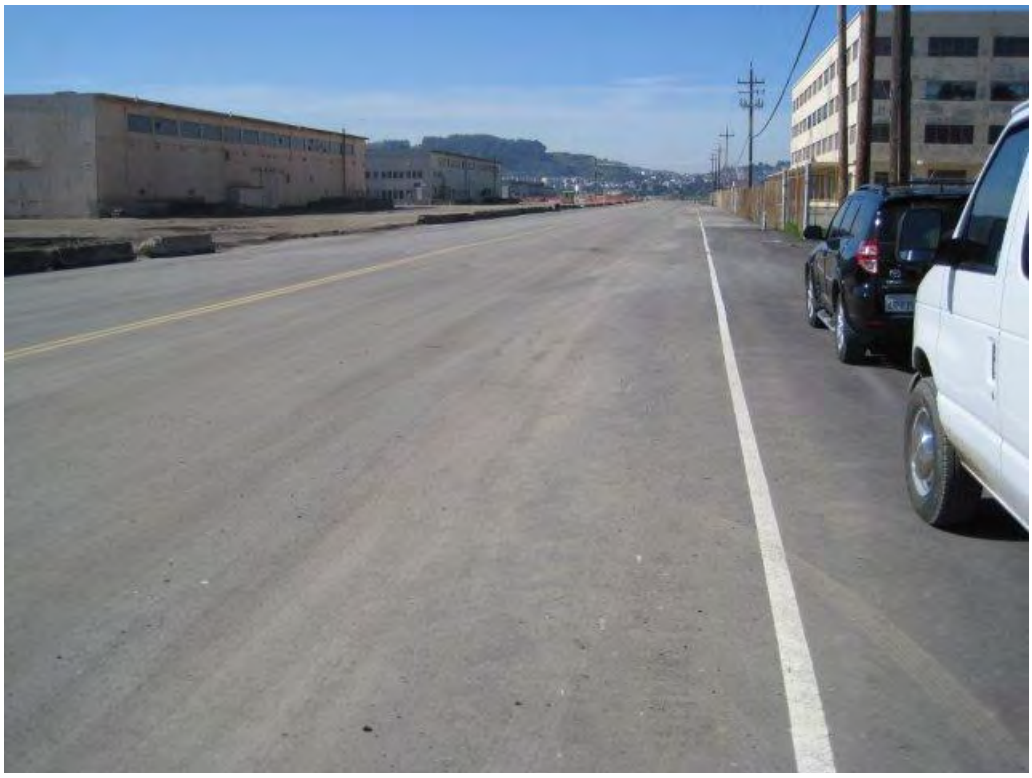
Photograph 42. Roadway at Parcel UC-1 (Spear Avenue) looking southwest.

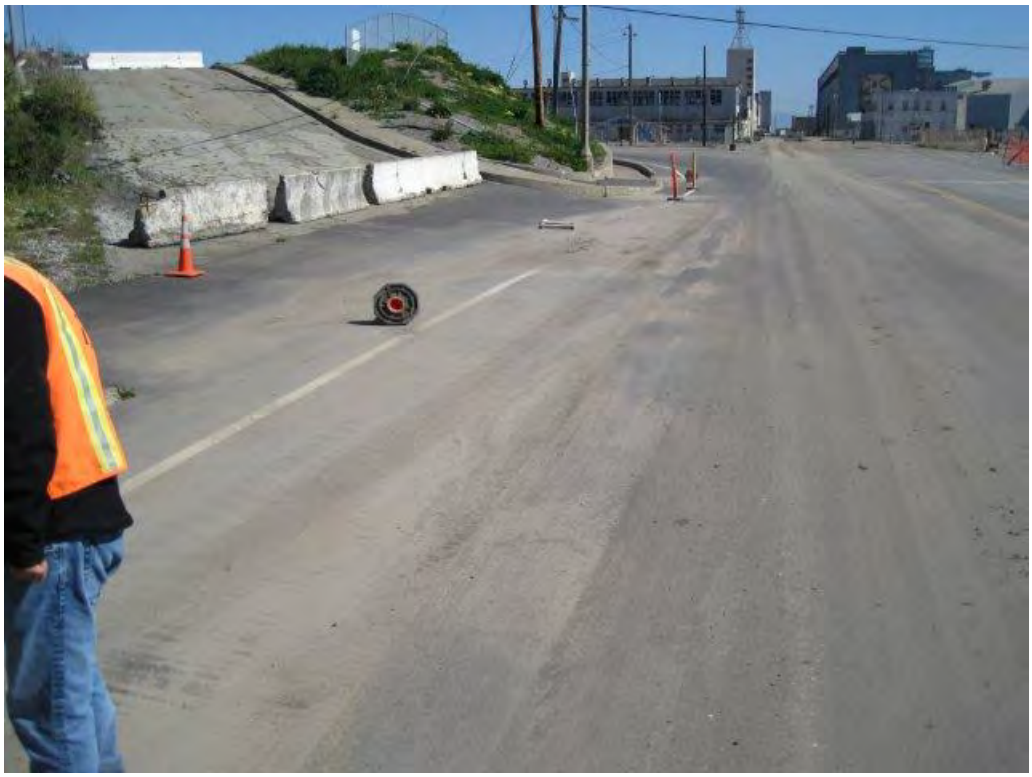
Photograph 43. Roadway at Parcel UC-1 (Spear Avenue) looking northeast. Lighter color on left is silt deposited from previous storm water ponding on the north side of the roadway.

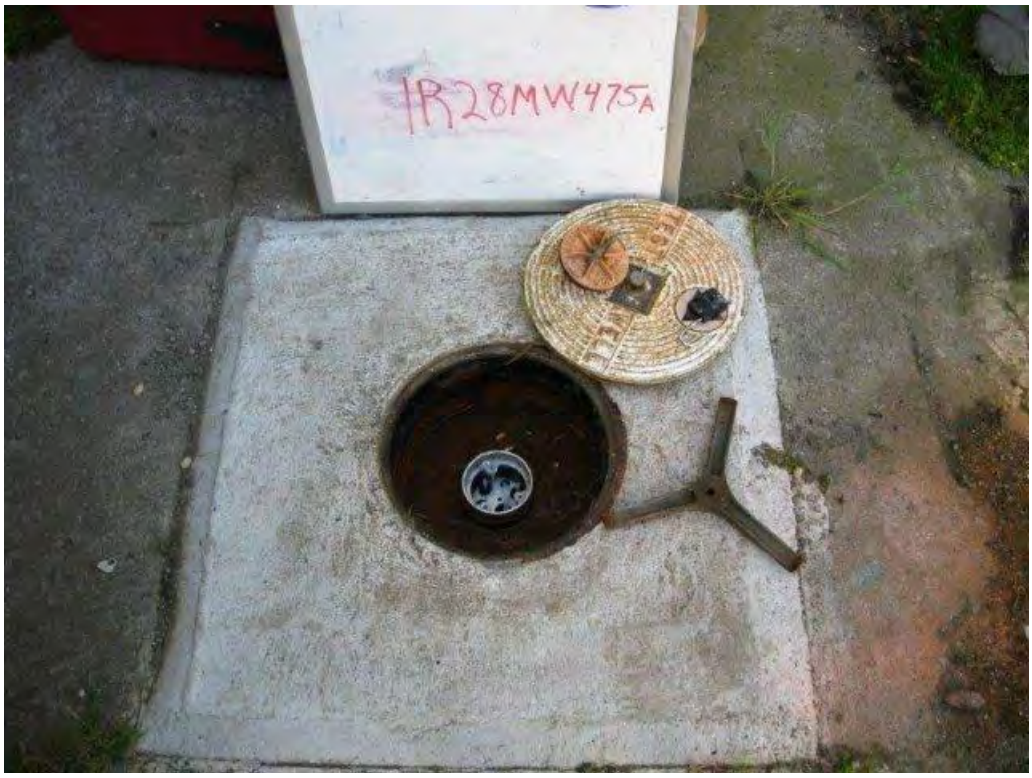
Photograph 64. Well IR28MW475A at Parcel C.
