INITIAL INVESTIGATION INSPECTION

Report #N26952 Site Name (b) (6) RESIDENCE

County KING Site Location 10118 DES MOINES MEMORIAL WY. S.
Tax Parcel #: _____ Lat _____ Long _____

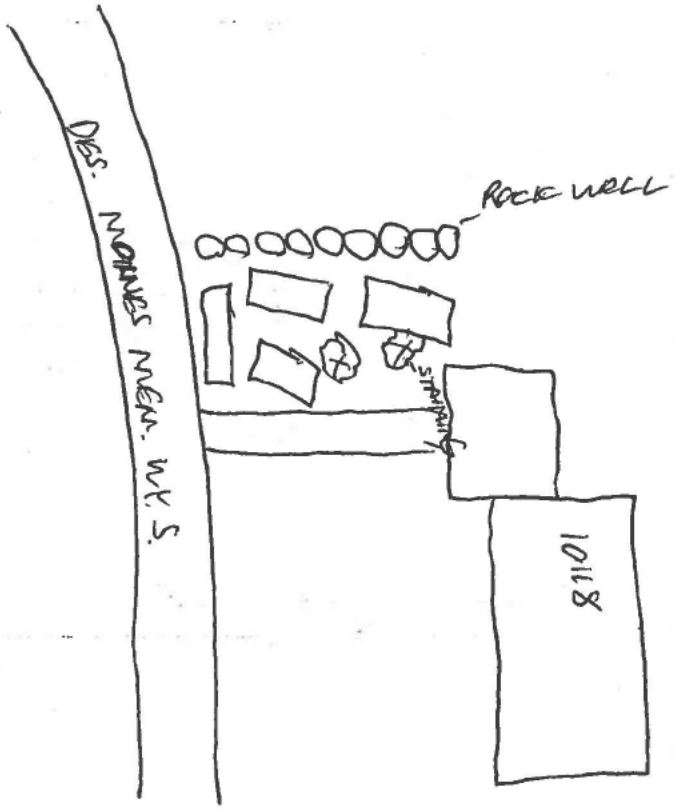
Site Diagram

Observations: LARGE HOUSE WITH OWNER AND RENTERS LIVING THERE. SIX CARS ON PROPERTY IN VARIOUS STATES OF DISREPAIR. SEVERAL AREAS OF SOIL STAINED WITH MOTOR OIL AND TRANSMISSION FLUID. COULD NOT SEE FULL EXTENT OF SOIL CONTAMINATION DUE TO SOLID WASTE COVERING STAINED AREAS. SEVERAL AUTOMOTIVE BATTERIES ALSO IN AREA.
