U&O INSPECTION REPORT

USE: Derelict Pontoons LEGAL: Sec 14; Twp 24 N; Rng 1E

ADDRESS: Thompson Drive, Bremerton, WA;

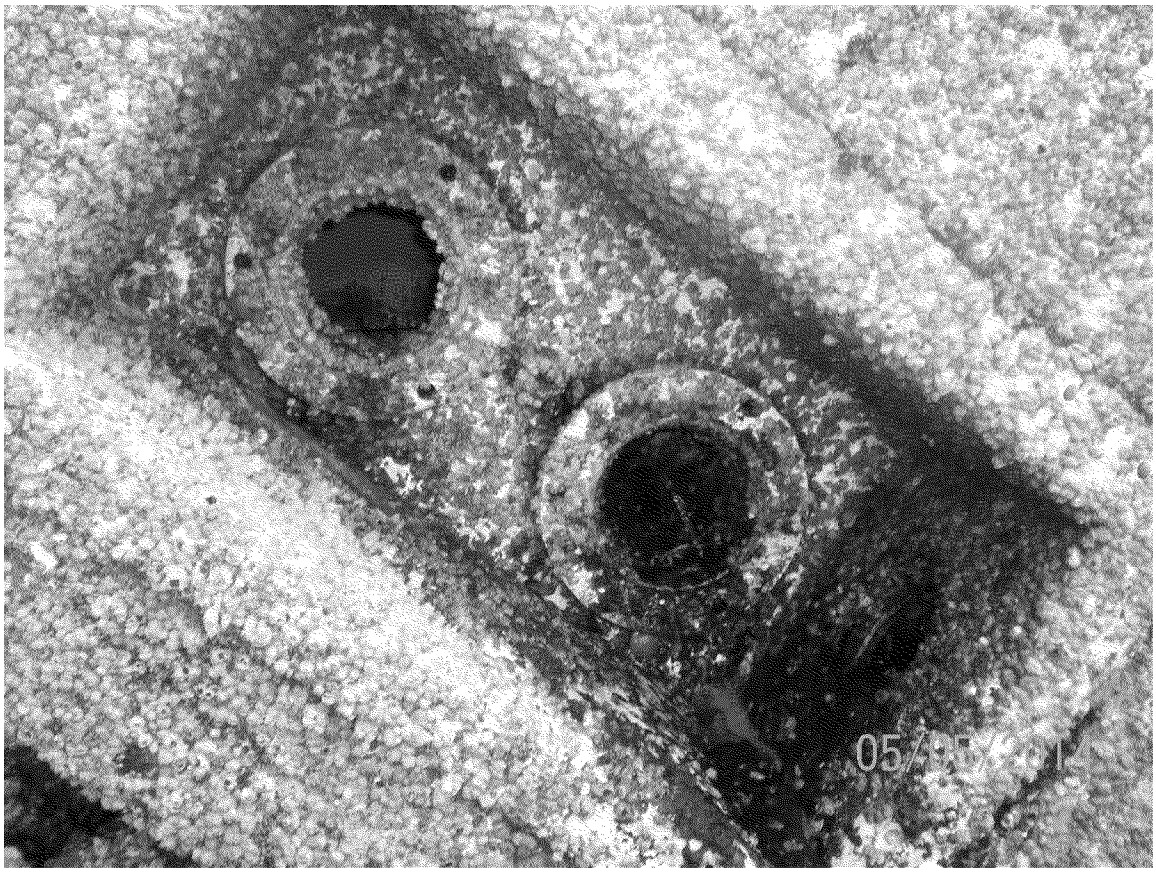
Foreground, ballast tank with white paint. Background ballast tank with red paint.

Water observed coming out of the ballast tank with red paint.

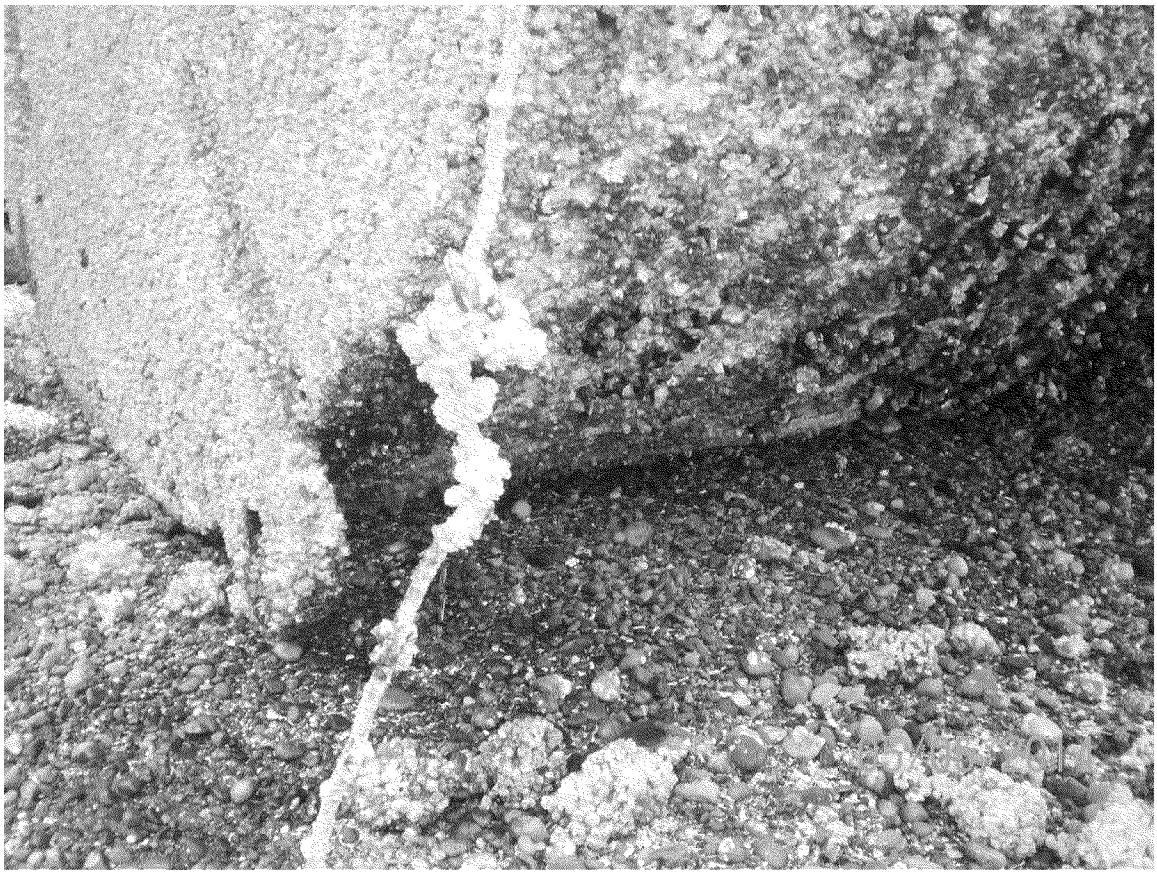
Water dripping out of the ballast tank with white paint.

Ballast tank can be seen resting on the beach surface.
