RE: 4701 VINE ST

As part of the VB/I-70 Superfund Site investigation, we recently took soil samples at your property to find out if there is too much lead or arsenic in your yard. ***The results show that your property does not require a cleanup.*** The levels of both lead and arsenic are below our cleanup levels. The soil sampling results for your property are as follows:

4701 Vine Street

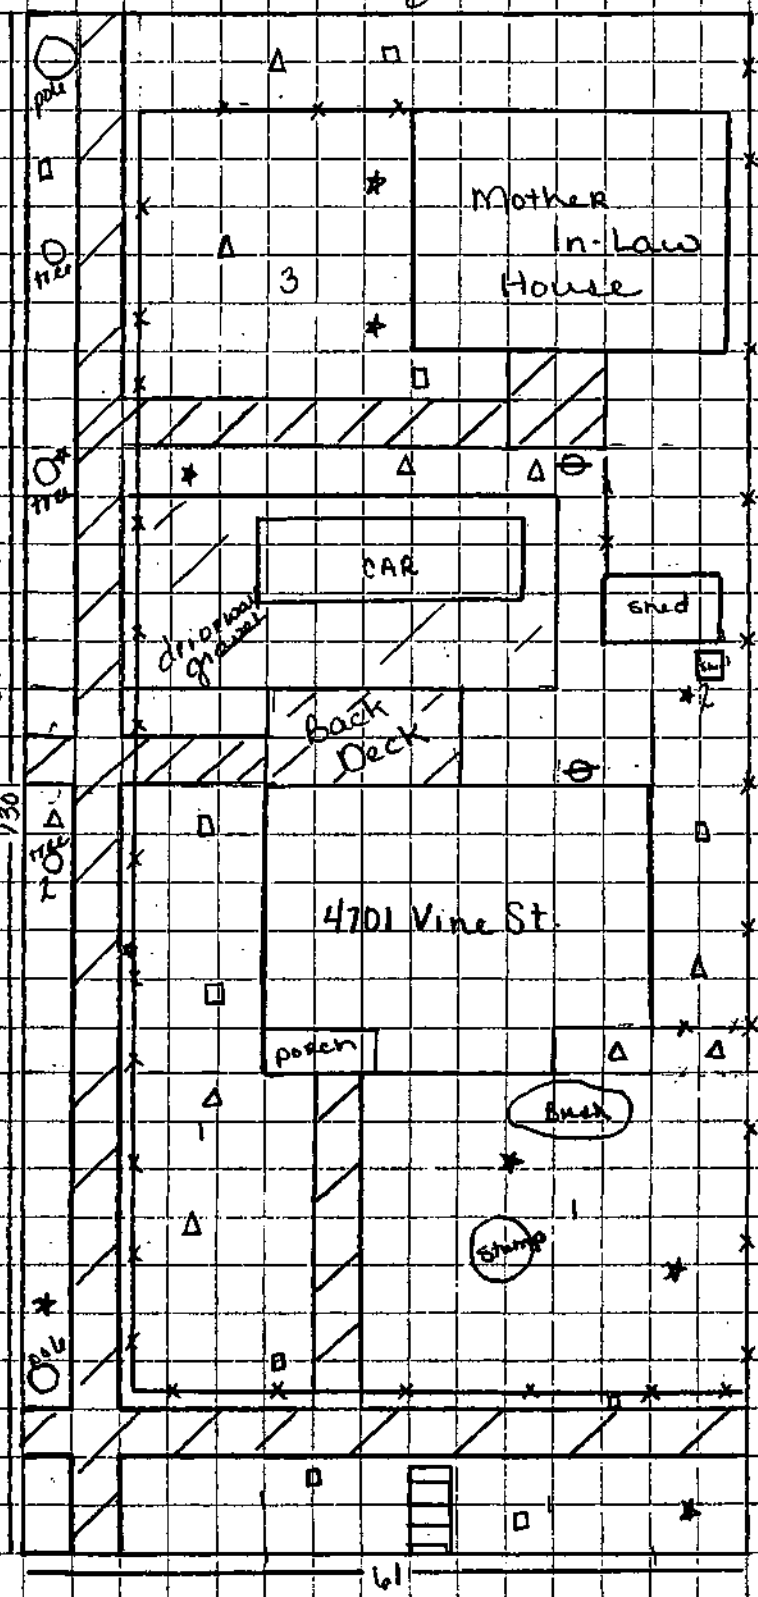
Section	# of Grids	Sample Points
01	121	12
02	103	11
03	68	7

VB-4701-V1-01 □ Green 1037
VB-4701-V1-02 Δ Yellow 1035
VB-4701-V1-03 × Red 1032
