SDMS Document ID
1035163

Property Access Checklist

Property ID # 3469 / 4660 Race Street

SITE NAME: VASQUEZ BOULEVARD AND I-70

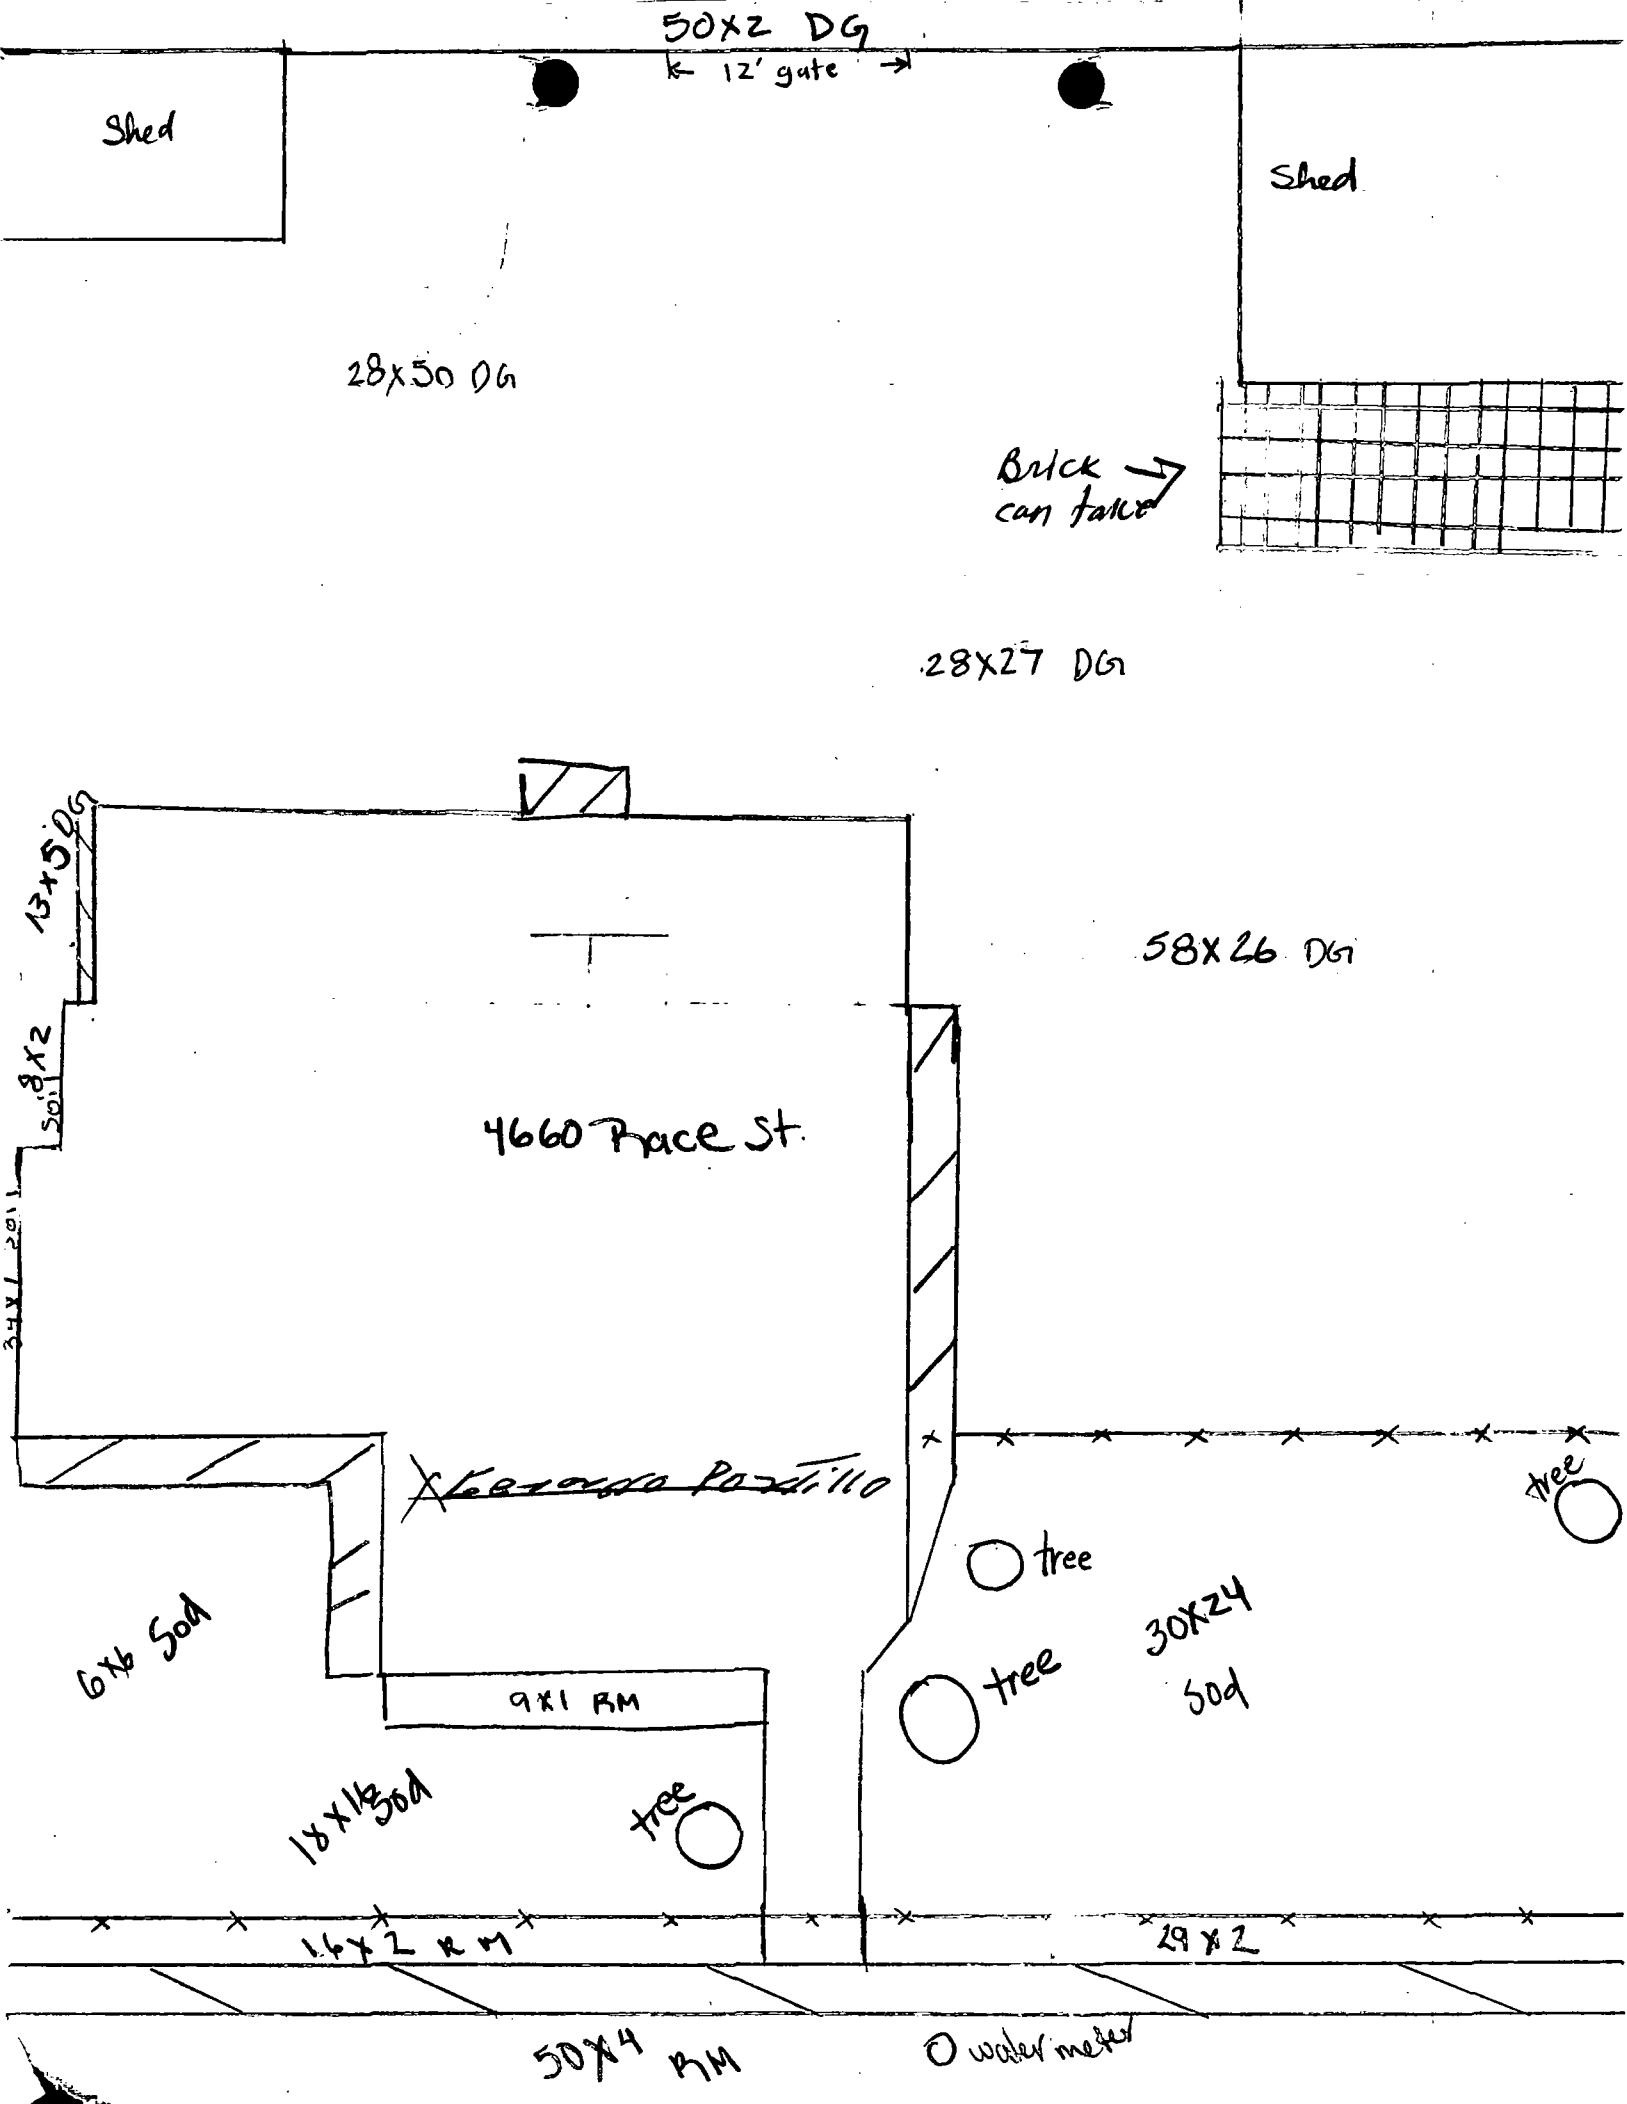
50x2 DG
12' gate
Shed
Shed
28x50 DG
Brick can take
28x27 DG
13x5 DG
8x2
58x26 DG
4660 Pace St.
Veranda Pavilio
tree
tree
tree
tree
6x6 Sod
30x24 Sod
9x1 RM
18x1½ Sod
14x2 RM
29x2
50x4 RM
water meter

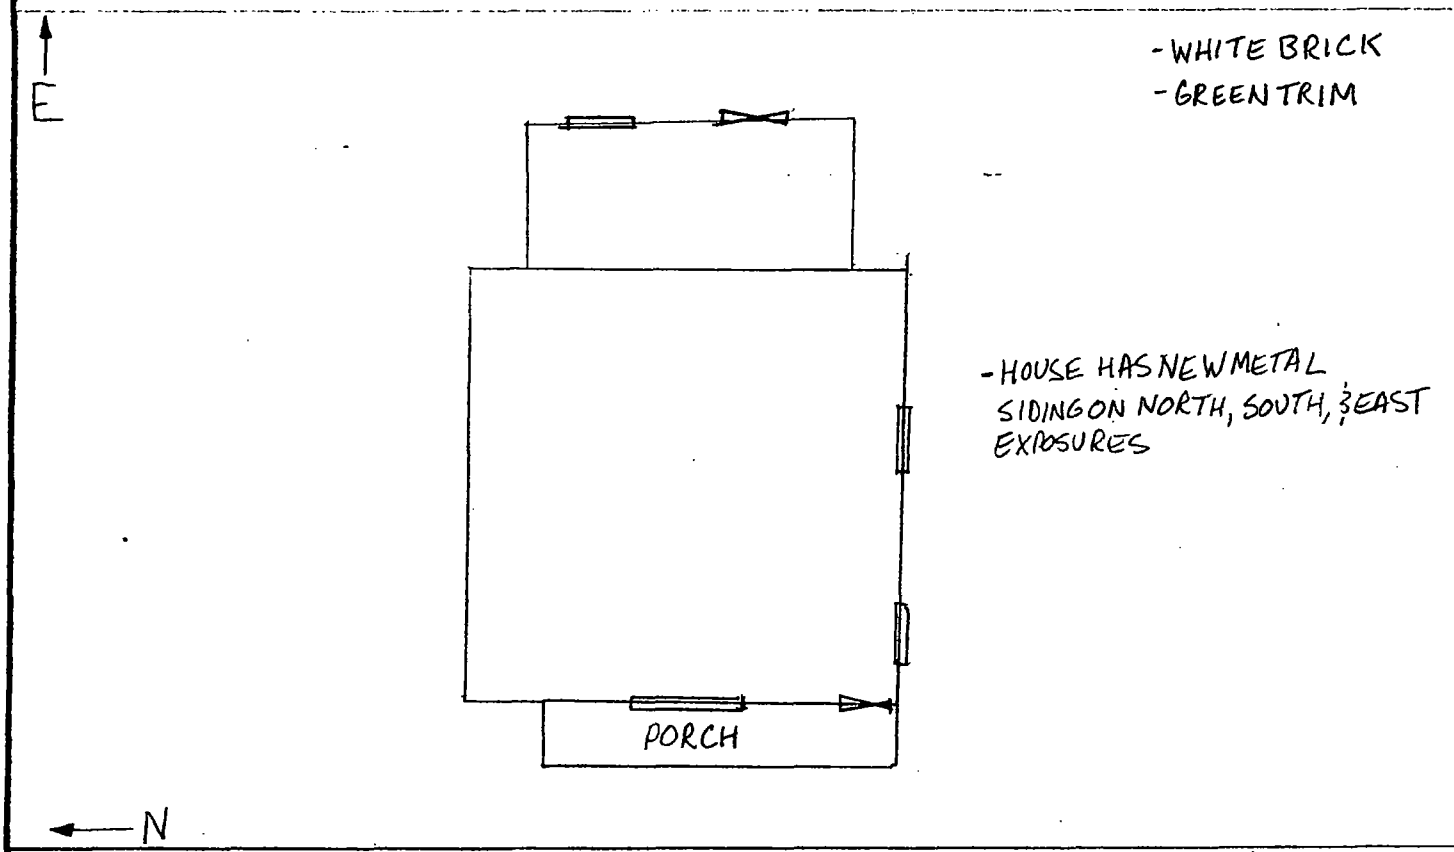
Plot Plan:

Exterior Walls				Doors/Trim			
	Material	Area	Peel/Chip	XRF (Lead)	Material	Area	Peel/Chip	XRF (Lead)
North								
South					WOOD TRIM	—	—	—
East								
West					WOOD	—	—	11.4
Total					Total

Window Trim/Fascia/Soffit				Patios/Decks/Porches			
	Material	Area	Peel/Chip	XRF (Lead)	Material	Area	Peel/Chip	XRF (Lead)
North								
South	WOOD	—	—	8.3				
East	WOOD	—	—	19.3	WOOD COLUMN	—	—	22.2
West					WOOD	—	—	11.1
Total					Total

Time	Site	Component	Substrate	Side	Condition	Color	Floor	Room	Results	Depth Ind	PbC	PbC Error
8/13/2005 13:49	3469	WALL	BRICK	WEST	CRACKED	WHITE	FIRST	PORCH	Negative	10	-0.13	0.41
8/13/2005 13:51	3469	FLOOR	CONCRETE	WEST	CRACKED	WHITE	FIRST	PORCH	Negative	7.85	0.03	0.05
8/13/2005 13:52	3469	TRIM	WOOD	WEST	CRACKED	TAN	FIRST	PORCH	Positive	5.92	11.4	1.5
8/13/2005 13:52	3469	CEILING	WOOD	WEST	CRACKED	TAN	FIRST	PORCH	Positive	4.6	11.1	1.4
8/13/2005 13:54	3469	EXT. SIDING	METAL	WEST	INTACT	GREEN	FIRST	OUTSIDE	Negative	1	0	0.02
8/13/2005 13:55	3469	WINDOW FRAME	WOOD	SOUTH	CRACKED	GREEN	FIRST	OUTSIDE	Positive	10	8.3	1.2
8/13/2005 13:57	3469	DOOR FRAME	WOOD	EAST	CRACKED	WHITE	FIRST	OUTSIDE	Negative	2.52	0.01	0.02
8/13/2005 13:59	3469	SOFFIT	WOOD	SOUTH	CRACKED	BLUE	FIRST	OUTSIDE	Negative	2.52	0.02	0.03
8/13/2005 14:17	3469	COLUMN	WOOD	EAST	CRACKED	WHITE	FIRST	PORCH	Positive	10	22.2	2.1
8/13/2005 14:21	3469	WINDOW FRAME	WOOD	EAST	INTACT	WHITE	FIRST	PORCH	Positive	7.52	19.3	1.8
