RCRA FACILITY ASSESSMENT REPORT

Asheville Dyeing and Finishing Co./Anvil Knitwear
NCD070619663

July 29, 2004

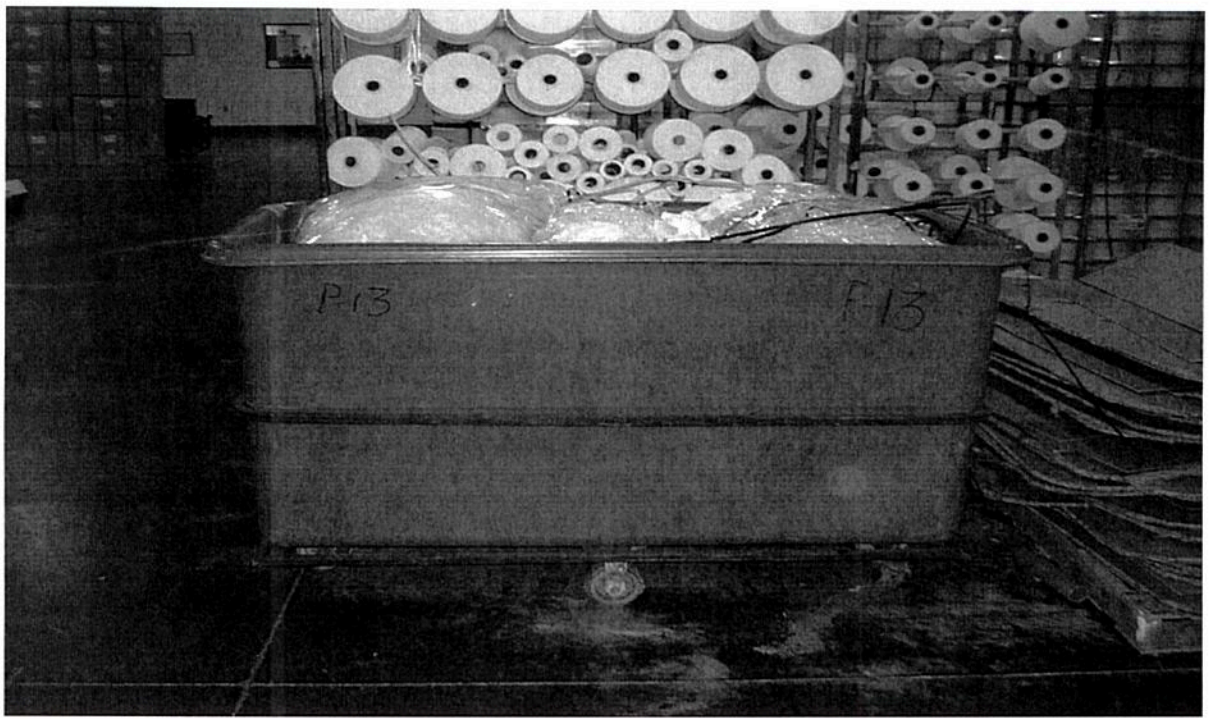
There are many plastic trash receptacles utilized within the manufacturing areas of the facility inside the main building. The receptacles receive the municipal solid waste that is generated by the manufacturing process and the employees. The Knitting Room contains fifteen 55-gallon mobile trash receptacles. The Dye House contains six 55-gallon trash receptacles and four large mobile trash receptacles that are approximately 6 feet by 4 feet. The Finishing Area contains twenty-six 55-gallon trash receptacles. All of the trash receptacles appeared to be in good condition (Reference No. 4; Reference No. 30).

Photo Number: 9
Direction: Facing east
Description: Large blue trash receptacle located in the Yarn Receiving area.(SWMU 1)

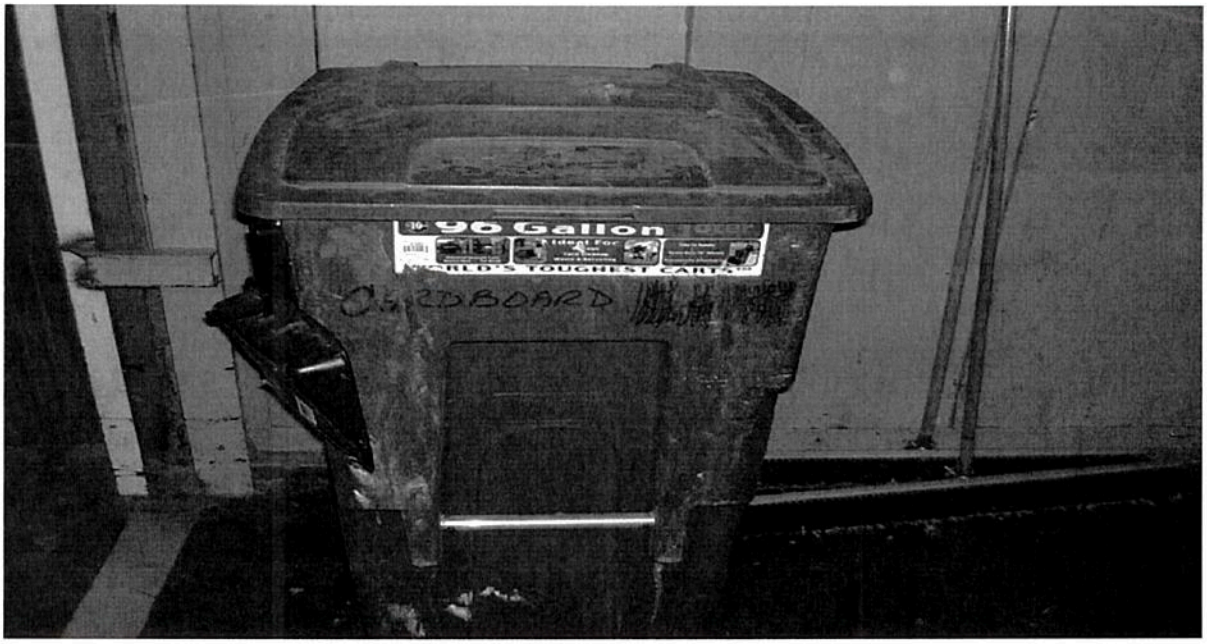
Photo Number: 10
Direction: Facing north
Description: 55 gallon trash receptacle (SWMU 1)

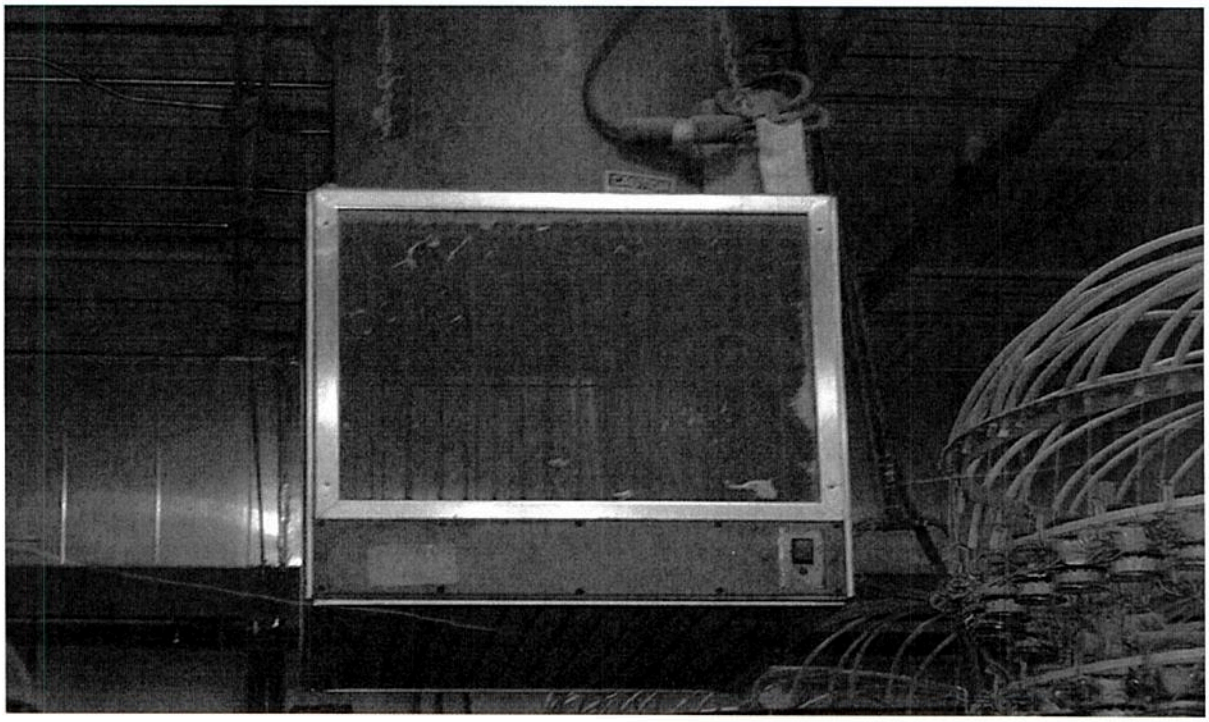
Photo Number: 11
Direction: Facing northt
Description: Air collector in Knitting Room (SWMU 2)

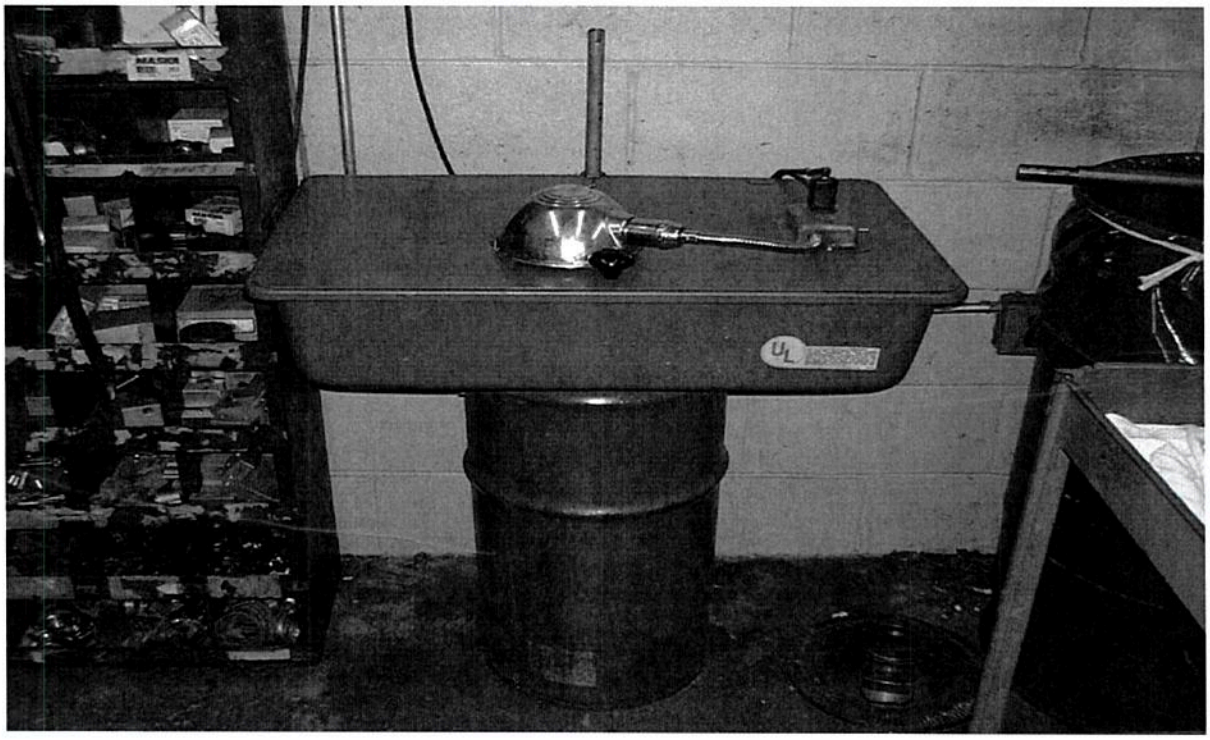
There are four parts washing units that are located at the site. Two parts washers are located in the Knitting Parts Room. There is a small parts washer located on the eastern wall and a large parts washer (approx. 55 gallons) located on the western wall. The other two parts washers are located in the Maintenance Shop. A small parts washer is located on the north wall and a small parts washer is located on the south wall. All four parts washers appeared to be in good condition (Reference No. 4; Reference No. 30).

Photo Number: 15
Direction: Facing north
Description: Small parts washer inside Knitting Parts Room (SWMU 5)

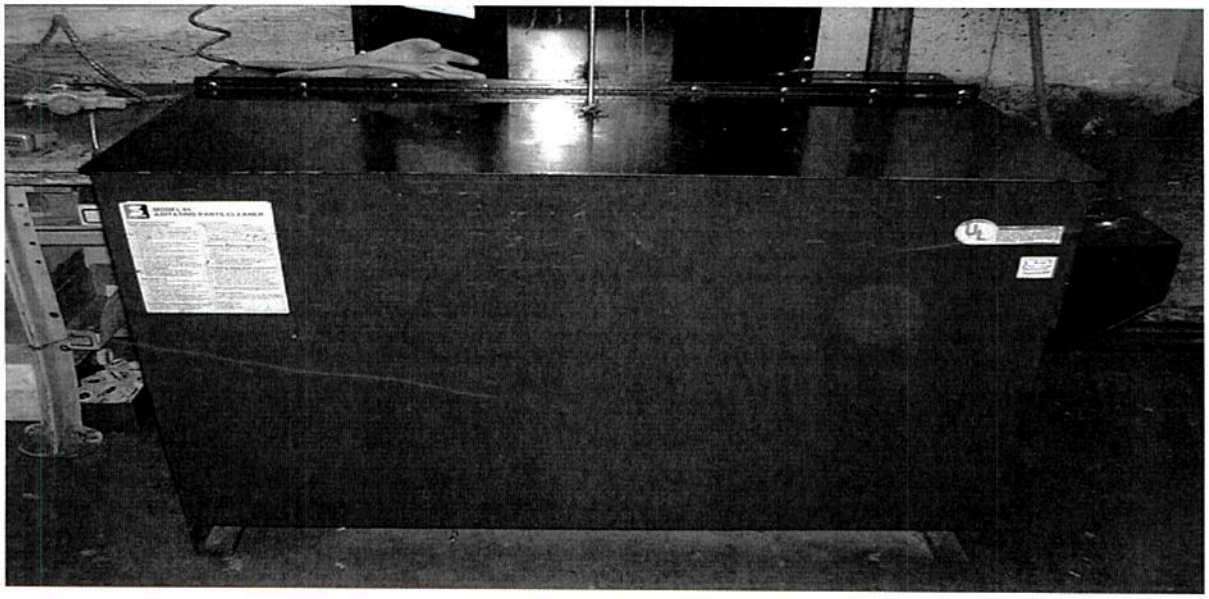
Photo Number: 16
Direction: Facing south
Description: Large parts washer inside Knitting Parts Room (SWMU 5)

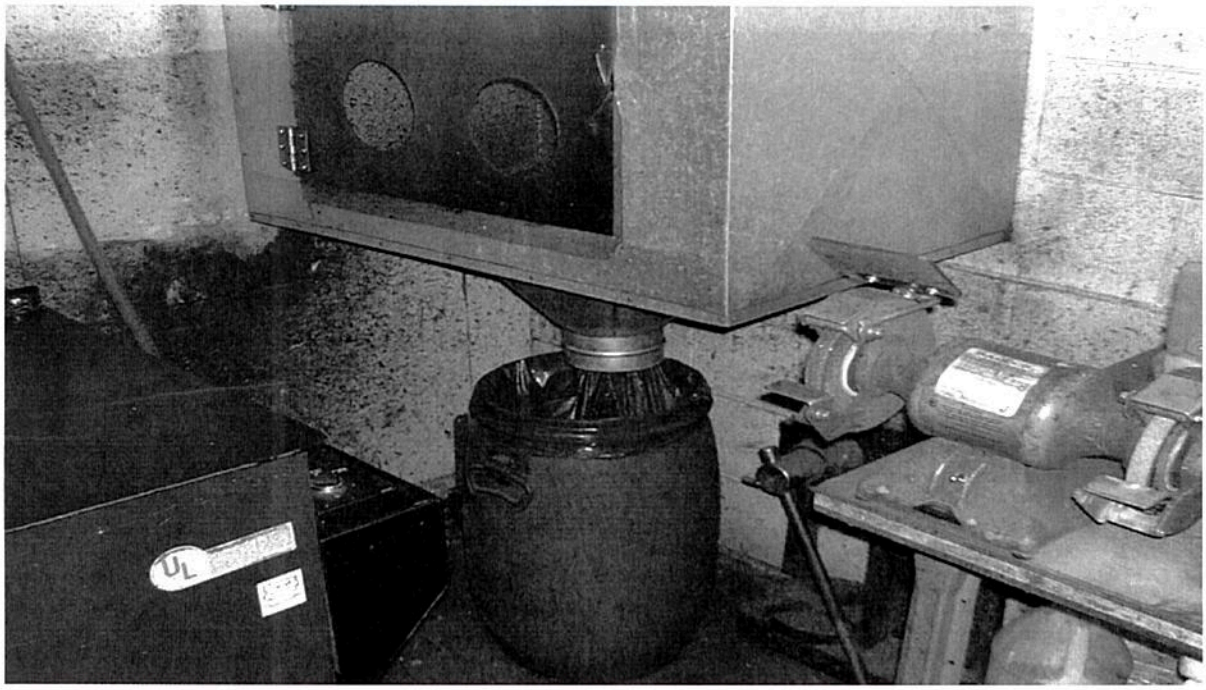
Photo Number: 17 **Photographer:** Jeremy Hogard
Direction: Facing southwest **Date:** 6/2/2004
Description: Compressed Air Cleaning Box and Collection Bin (SWMU 6)

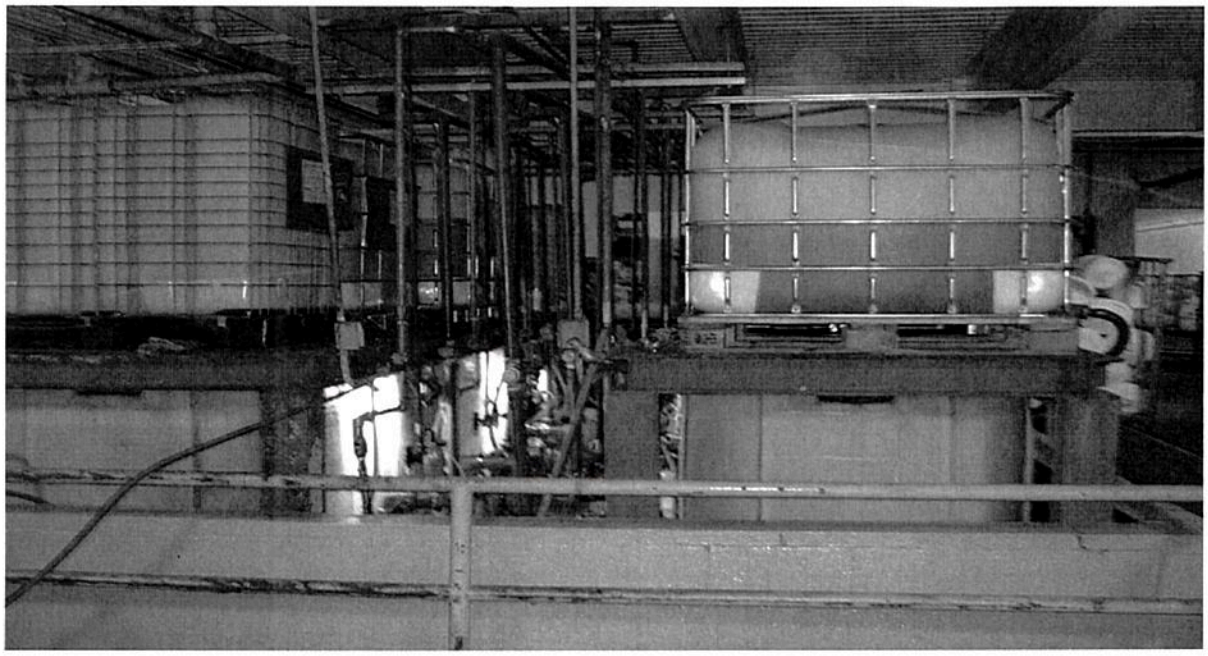
The secondary containment for the facility's tote farm is located in the facility's Dye Receiving Area and consists of a concrete floor with a concrete cinder block dike. The tote farm has approximately eighteen (18) 250-gallon capacity totes containing a variety of chemicals used in the mixing the fabric dyes. The dimensions of the secondary containment were approximately 25 feet by 10 feet. The height of the secondary containment structure is approximately 24 inches. The secondary containment structure was sealed and painted and appeared to be in good condition with no visible leaks or past leaks. A floor drain was located in the center of the secondary containment structure. Facility representatives stated that the floor drain was connected to the facility's waste water treatment system (SWMU 12) by the facility's piping infrastructure (Reference No. 4).

Photo Number: 18 **Photographer:** Jeremy Hogard
Direction: Facing east **Date:** 6/2/2004
Description: Chemical Tote Farm and Secondary Containment (SWMU 7)

[1] Based on the age of the piping infrastructure and the unknown nature of the pipe's integrity, additional investigation of the unit's integrity should be performed to determine whether a release has occurred. In the event the integrity is compromised or breached, confirmatory sampling of the soil to the depth of groundwater in the vicinity of the drains, pipes and catchment basins may be necessary to determine whether releases of hazardous constituents have occurred. Otherwise, documentation of the unit's integrity can be provided to support a no further action designation.

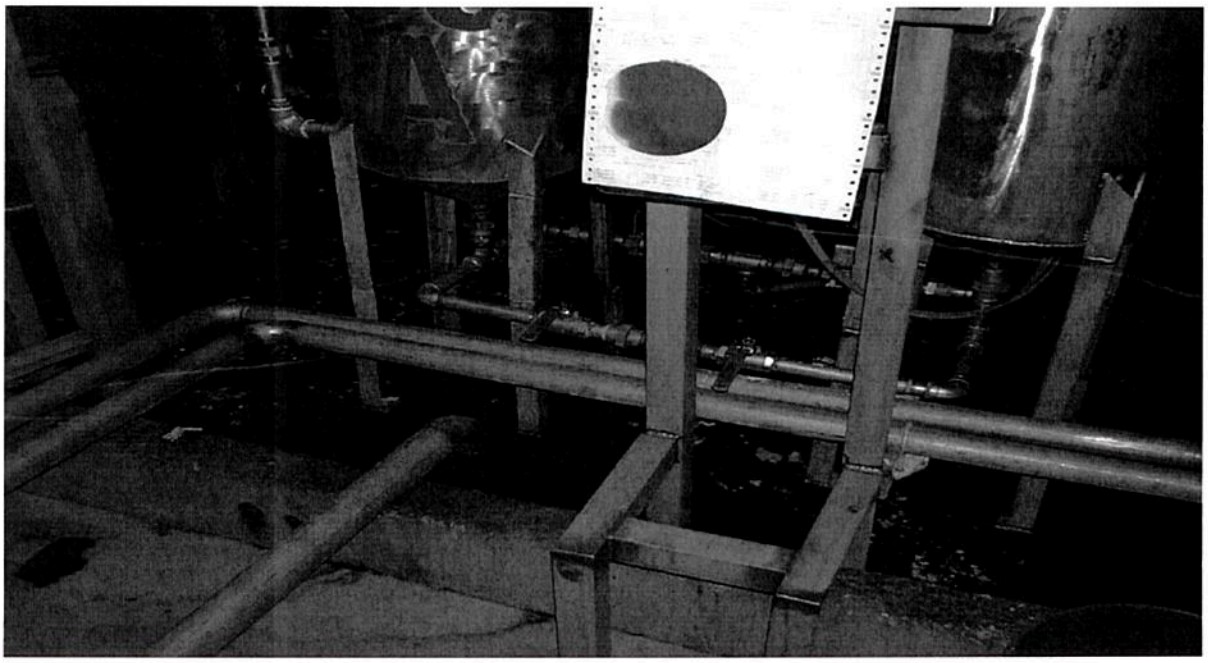
This secondary containment system is located in the facility's Dye Mixing Room on the second floor of the facility building. The system provides secondary containment for approximately half of the dye mixing vessels located within this room. The secondary containment system is constructed of concrete and has a six-inch berm. At the time of the VSI, no cracks or scarring was observed in the concrete floor or berm. The unit is approximately 120 feet by 6 feet and is sloped toward the south. Located at the south end of the secondary containment is a drain which is reportedly connected to the facility's waste water treatment system (SWMU 12) by the facility's piping infrastructure (Reference No. 4).

Photo Number: 22
Direction: Facing west
Description: Secondary Containment in Dye Mixing Room (SWMU 8)

[1] Based on the age of the piping infrastructure, and the unknown nature of the pipe's integrity, additional investigation of the unit's integrity should be performed to determine whether a release has occurred. In the event the integrity is compromised or breached, confirmatory sampling of the soil to the depth of groundwater in the vicinity of the drains, pipes and catchment basins may be necessary to determine if releases of hazardous constituents have occurred. Otherwise, documentation of the unit's integrity can be provided to support a no further action designation.

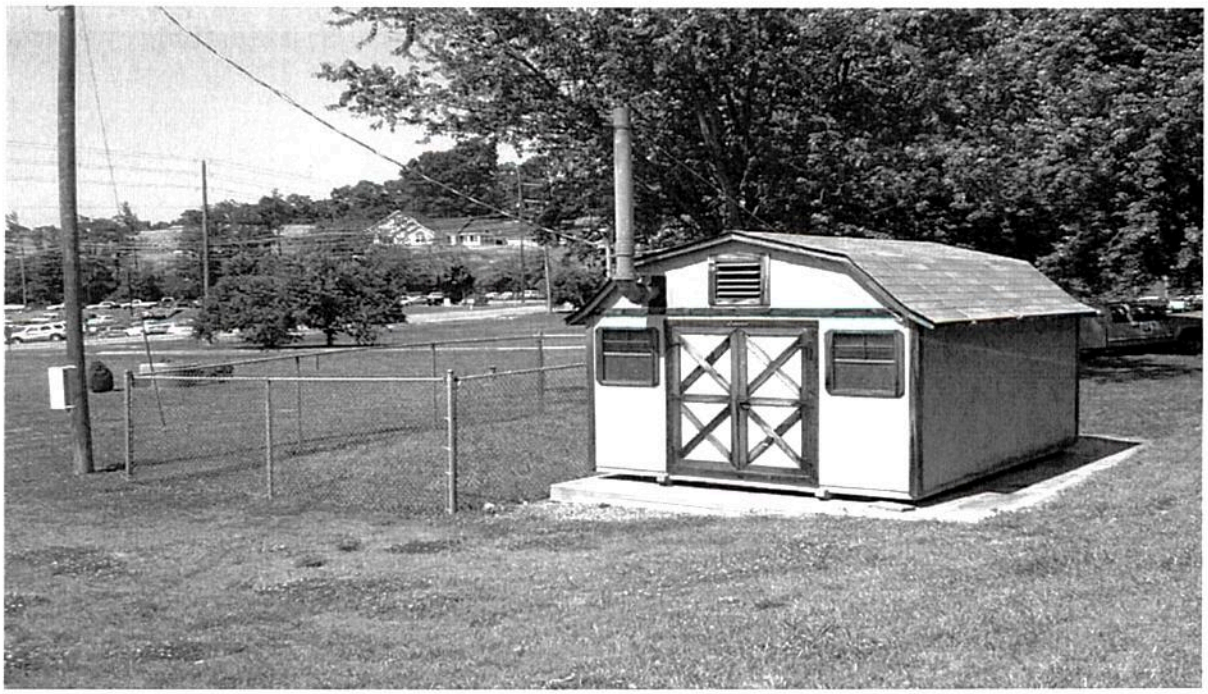
Photo Number: 26
Direction: Facing southeast
Description: View of former waste PCE tank area and air sparging shed (SWMU 11).

[1] The no further action recommendation for this SWMU is contingent upon continued groundwater remediation and monitoring per the closure plan and as required by the NCDENR.

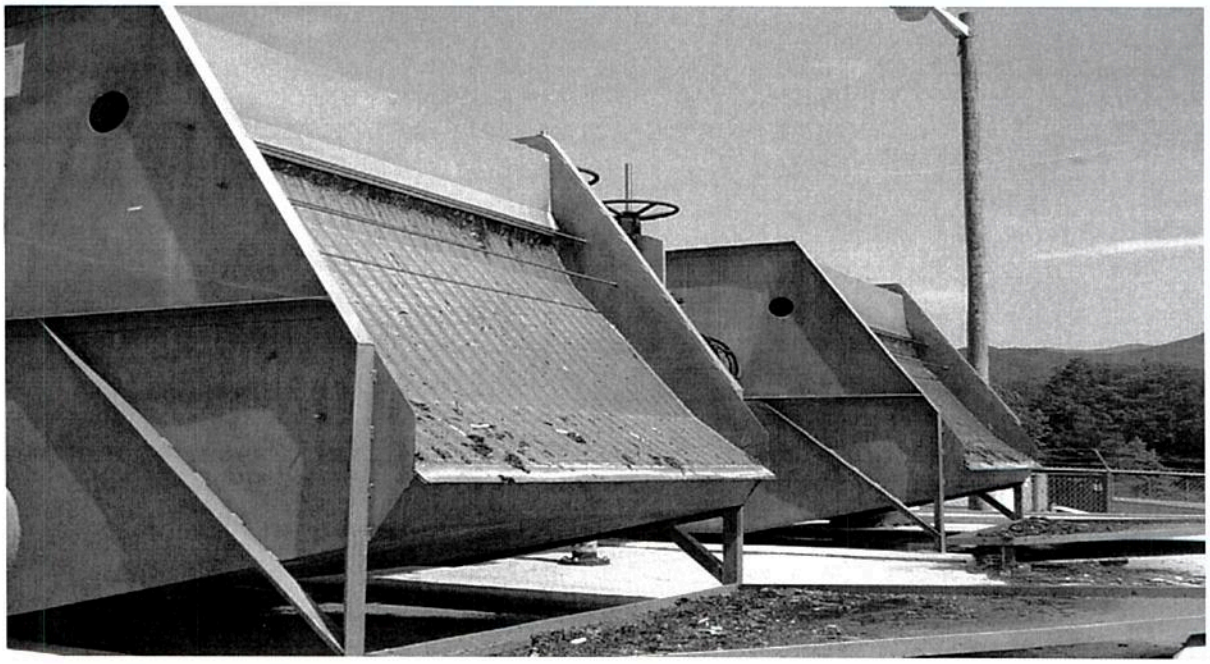
Photo Number: 27
Direction: Facing north
Photographer: Jeremy Hogard
Date: 6/2/2004
Description: View of two Grit Chambers for the facility Waste Water Collection/ Treatment System (SWMU 12)

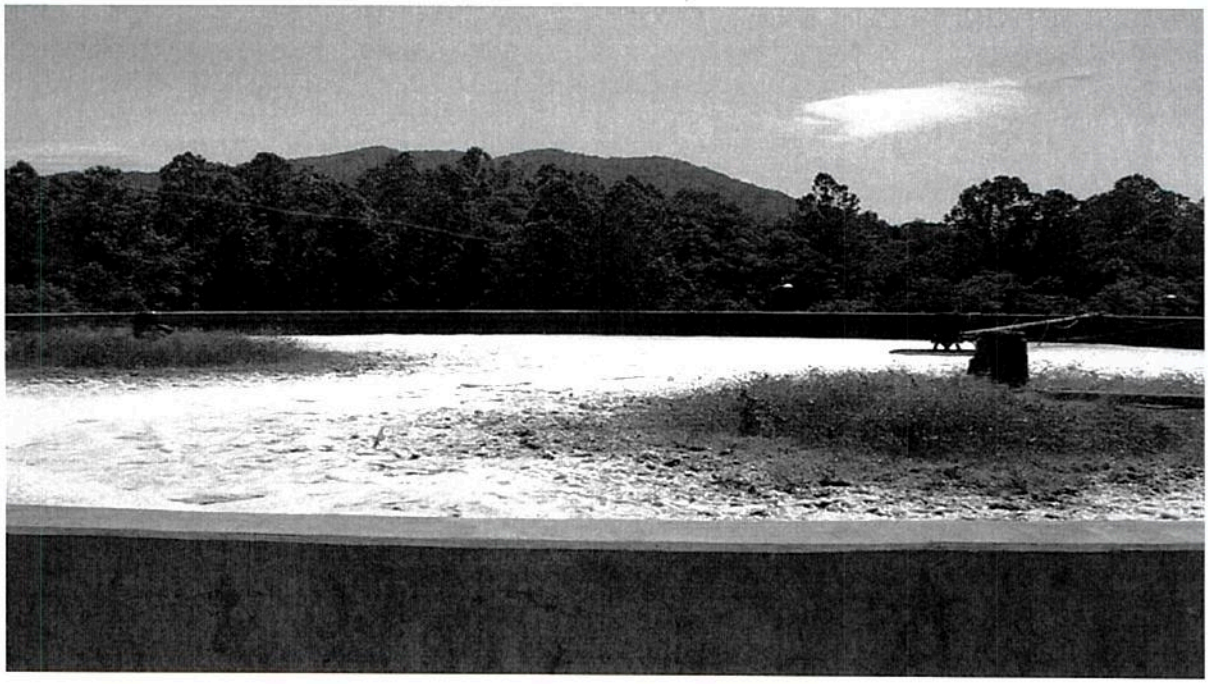
Photo Number: 28
Direction: Facing east
Photographer: Jeremy Hogard
Date: 6/2/2004
Description: View of concrete surface water impoundment (SWMU 12)

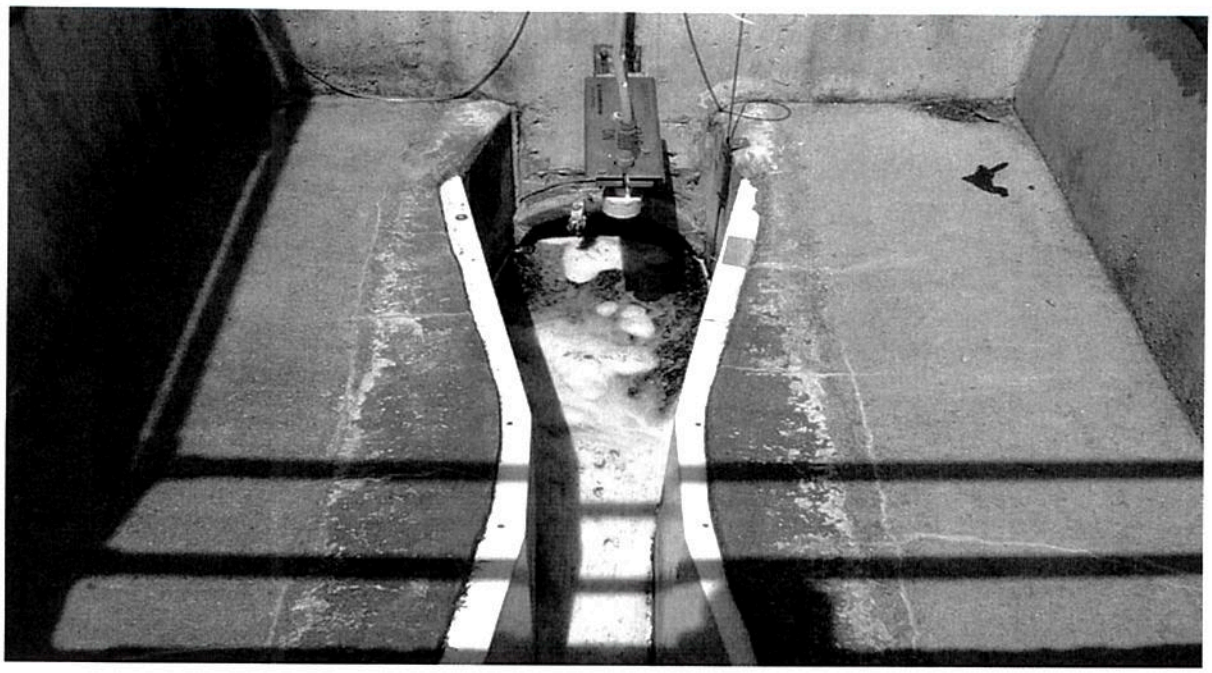
Photo Number: 29
Direction: Facing west
Photographer: Jeremy Hogard
Date: 6/2/2004
Description: View of weir and effluent from the surface water impoundment (SWMU 12)

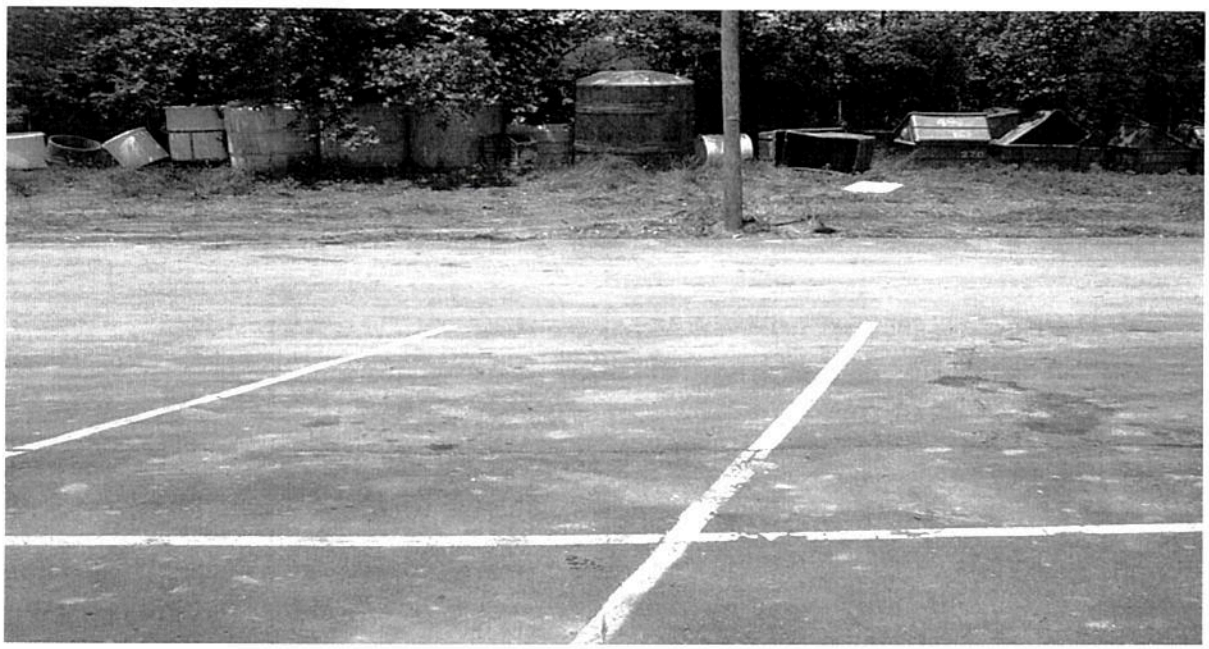
Photo Number: 38
Direction: Facing north
Photographer: Jeremy Hogard
Date: 6/2/2004
Description: Historic area of the Former Drum Storage Area (SWMU 16) that is now a paved asphalt parking lot

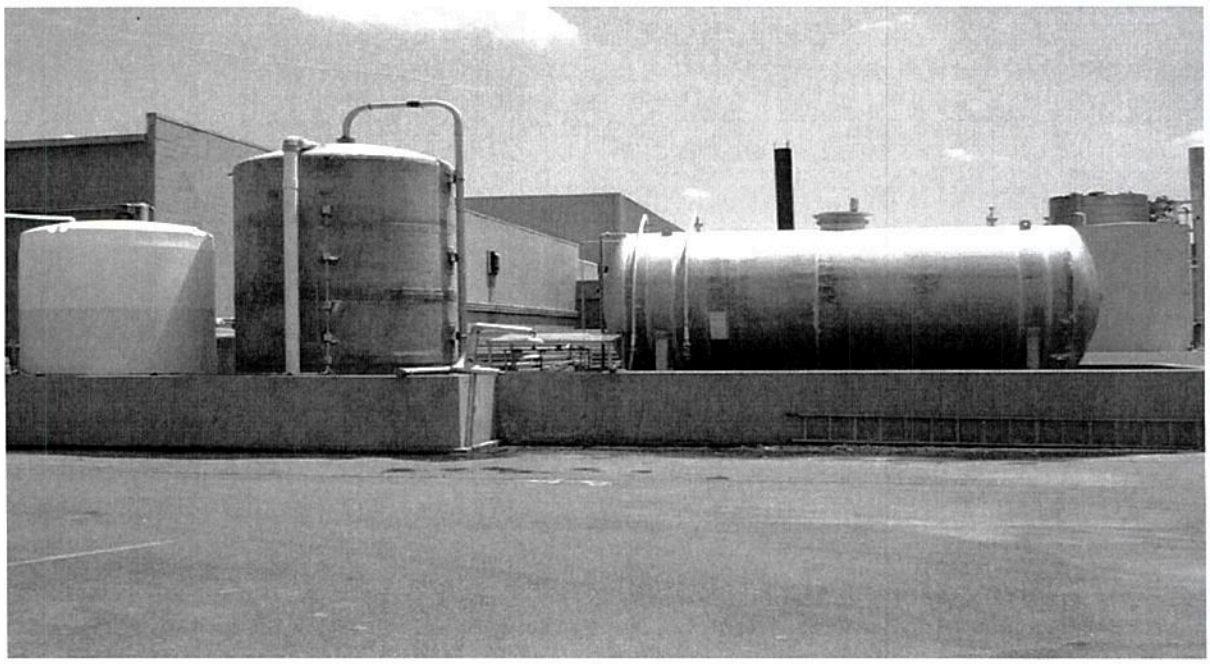
Photo Number: 39 **Photographer:** Jeremy Hogard
Direction: Facing south **Date:** 6/2/2004
Description: Four chemical ASTs and secondary containment containing Hydrogen Peroxide, Acetic Acid, and Salt Brine (SWMU 17)

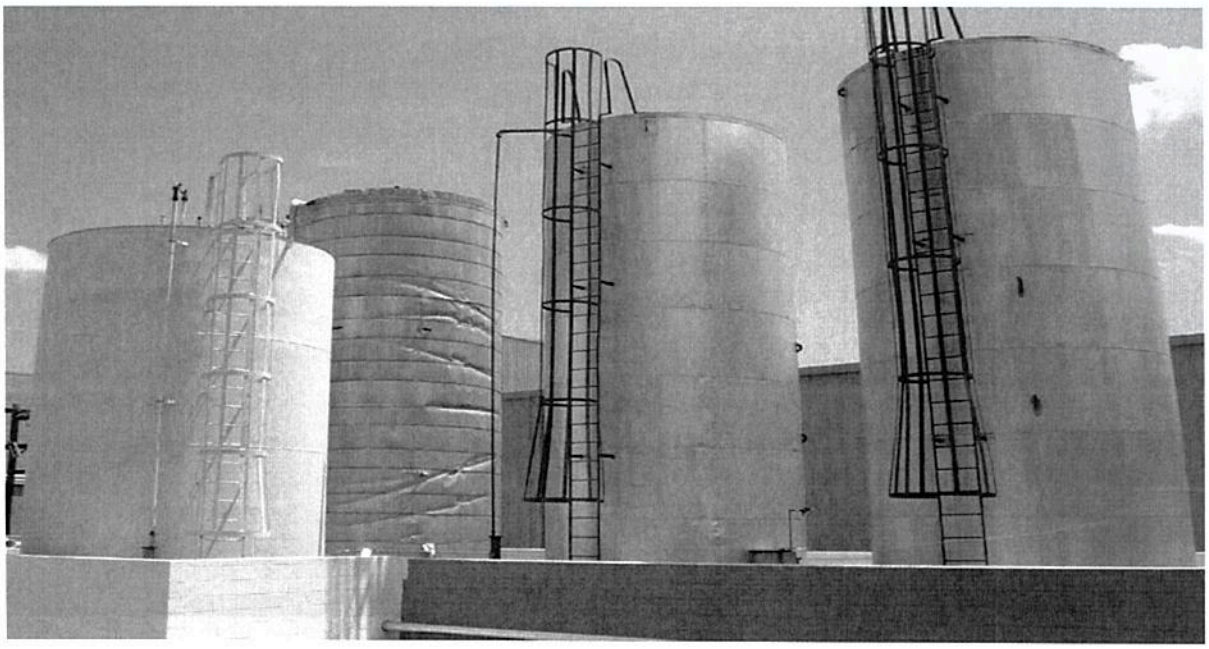
Photo Number: 40 **Photographer:** Jeremy Hogard
Direction: Facing south **Date:** 6/2/2004
Description: Four 20,000 gallon ASTs and secondary containment containing # 2 and # 6 fuel oil (SWMU 18)

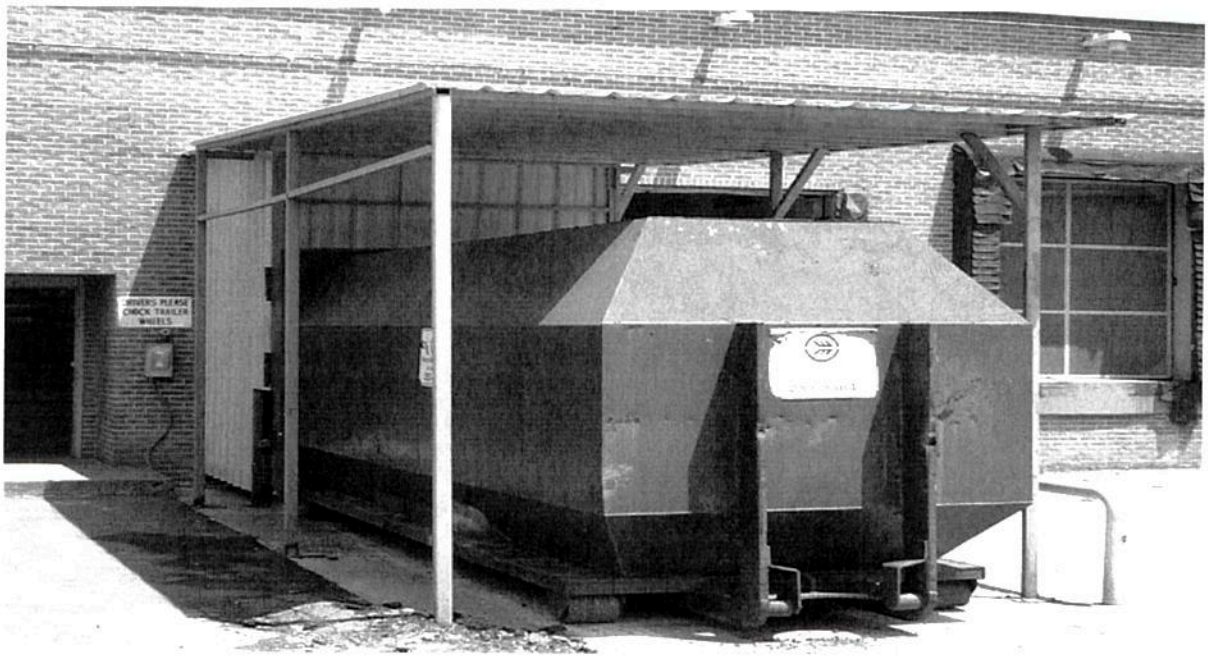
Photo Number: 42
Direction: Facing east
Photographer: Jeremy Hogard
Date: 6/2/2004
Description: Roll-off container with compactor located on the west side of the manufacturing building (SWMU 20)

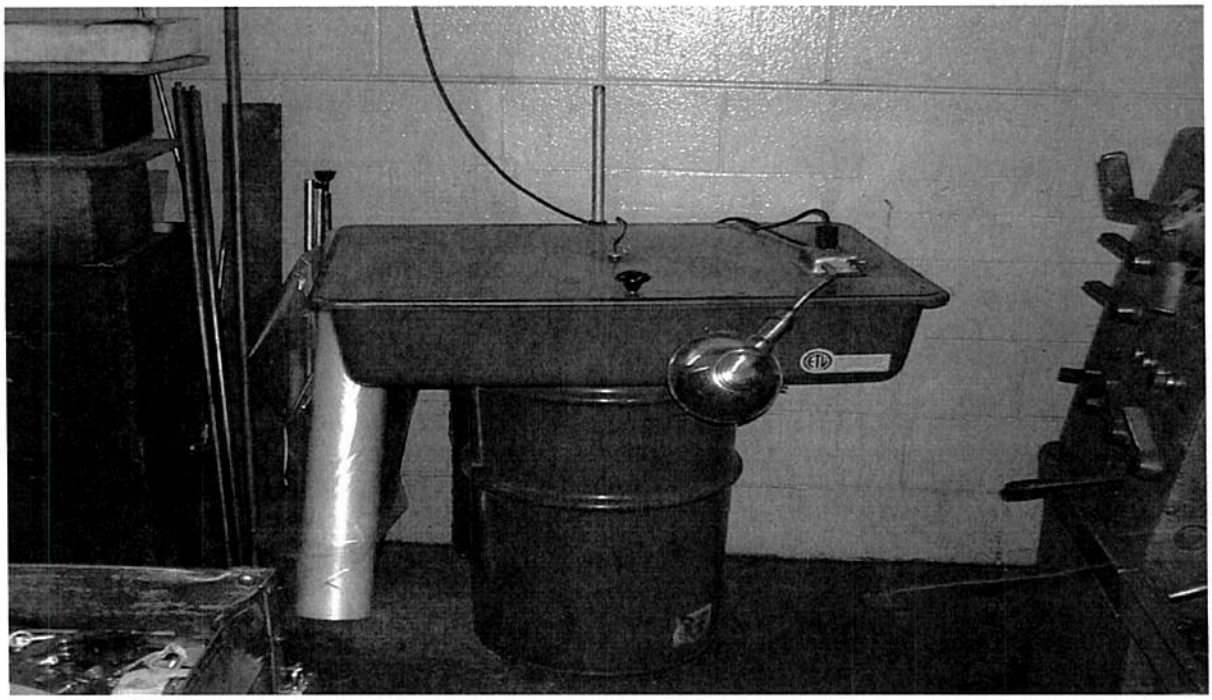
Photo Number: 43 **Photographer:** Jeremy Hogard
Direction: Facing west **Date:** 6/2/2004
Description: Small parts washer located inside of the Maintenance Shop (SWMU 5).

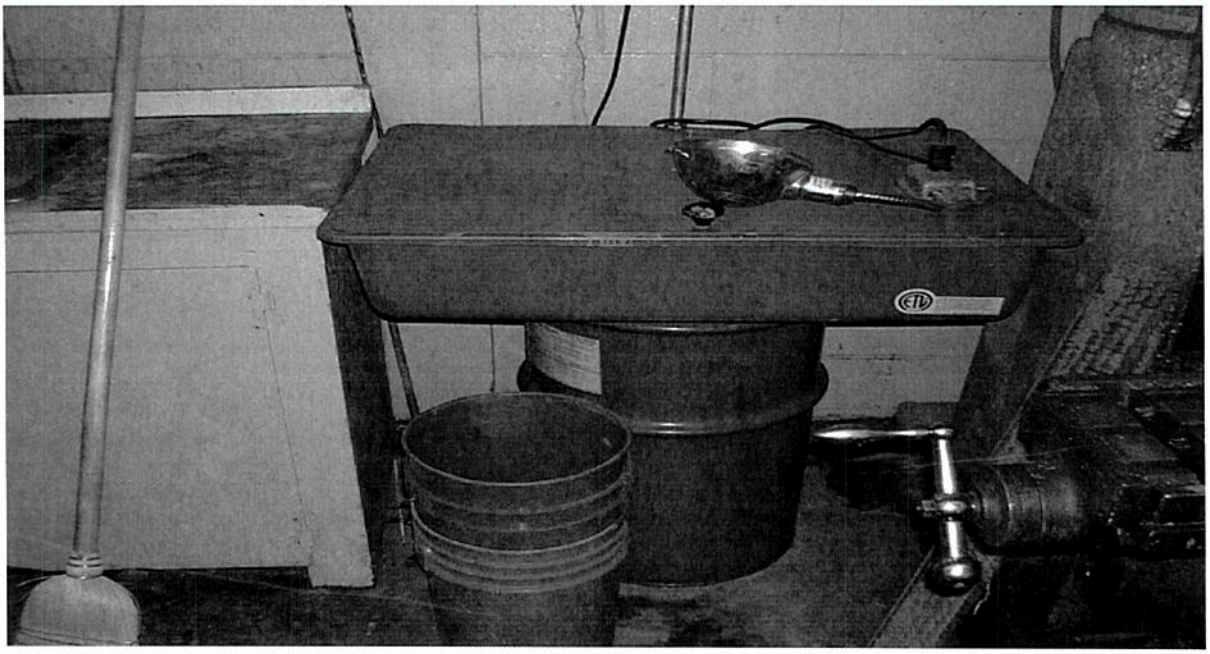
Photo Number: 44 **Photographer:** Jeremy Hogard
Direction: Facing east **Date:** 6/2/2004
Description: Small parts washer located inside of the Maintenance Shop (SWMU 5)
