TETRA TECH

Subject: **Final Emergency Response Letter Report**
Wingate Farms Pesticide Site
Leesburg, Lee County, Georgia
EPA Contract No. EP-W-05-054
TDD No. TTEMI-05-001-0196

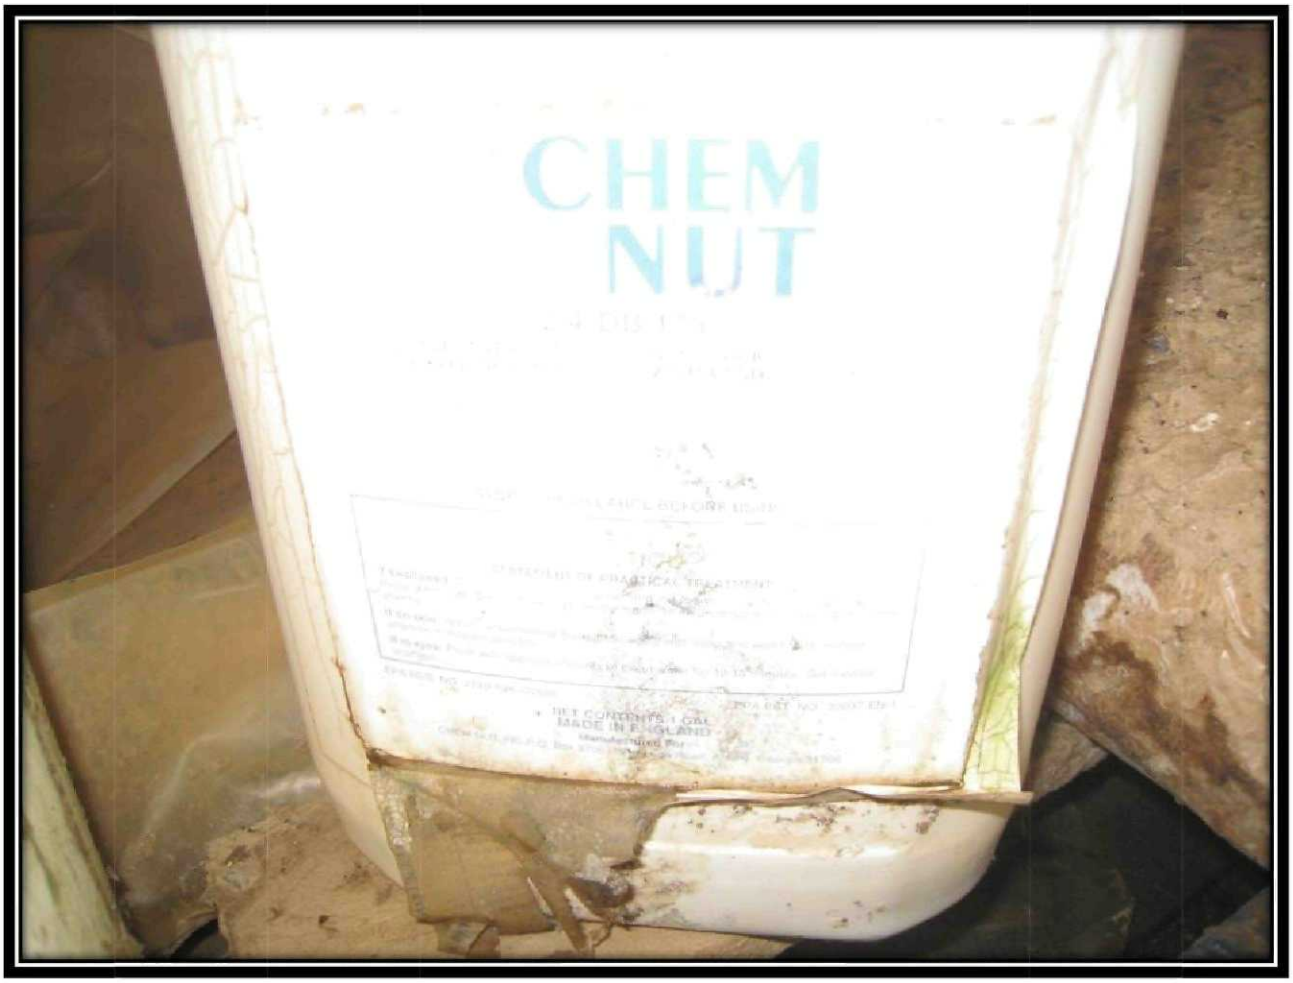
OFFICIAL PHOTOGRAPH NO. 16
U.S. ENVIRONMENTAL PROTECTION AGENCY

TDD Number:	TTEMI-05-001-0196	**Location:**	Wingate Farms Pesticide Site
Orientation:	NA	**Date:**	May 31, 2013
Photographer:	Brian Croft, Tetra Tech	**Witness:**	Chris Jones, Tetra Tech
Subject:	Chem Nut Butyrac 175™ container located inside Building 1.

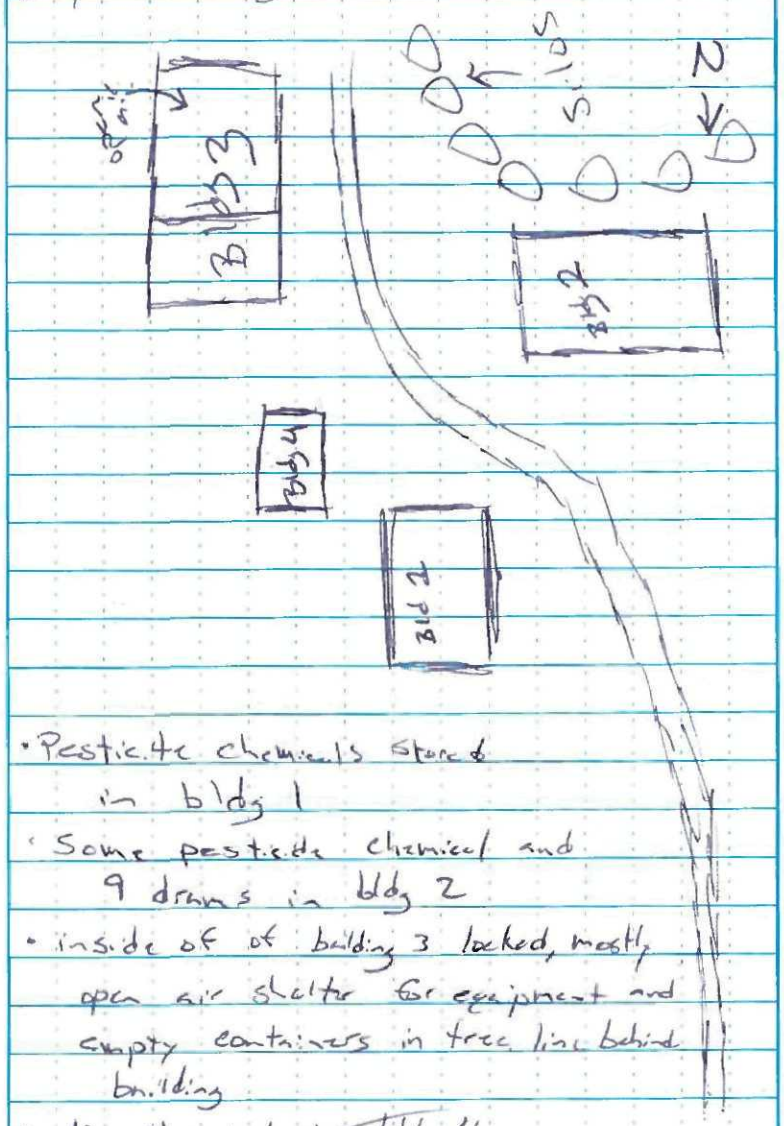
5/31/13 Wingate Farms CJ

- Pesticide chemicals stored in bldg 1
- Some pesticide chemical and 9 drums in bldg 2
- inside of of building 3 locked, mostly open air shelter for equipment and empty containers in tree line behind building
- No chemical ~~in~~ bldg 4
