Navajo Abandoned Uranium Mine

Site Screen Report

Mine Name: **A & B No. 13**
Mine ID: **452**

August 2011

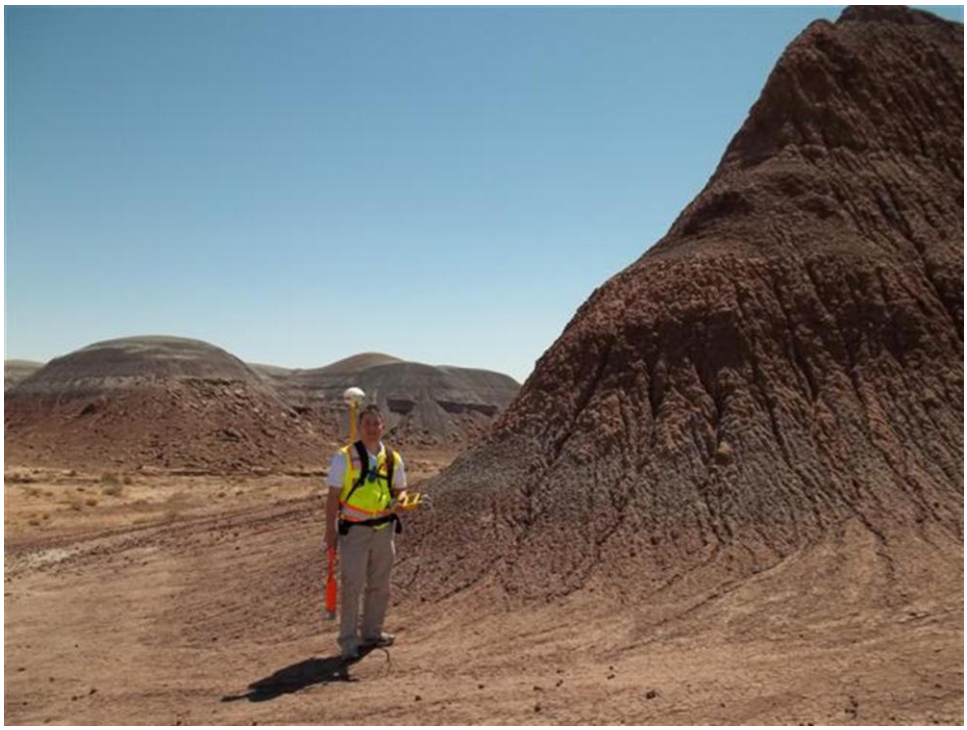
Photo 6: Mine Site #452; Wood debris
