MasiMax
Resources, Inc.

Subject: Contract Number: GS11P07YAD0036
Delivery Order Number: GSP1107DC0340
ACT Number: PJ7N02797
Annual Fiber-in-Air Sampling at New Executive Office Building, Washington, D.C.

MasiMax Resources, Inc. received a delivery order from GSA, NCR, Service Delivery Support Safety, Environmental and Fire Protection Branch to conduct the Annual Fiber-In-Air (FIA) Survey at the New Executive Office Building (NEOB) located at 1725 17th Street, NW, Washington D.C.

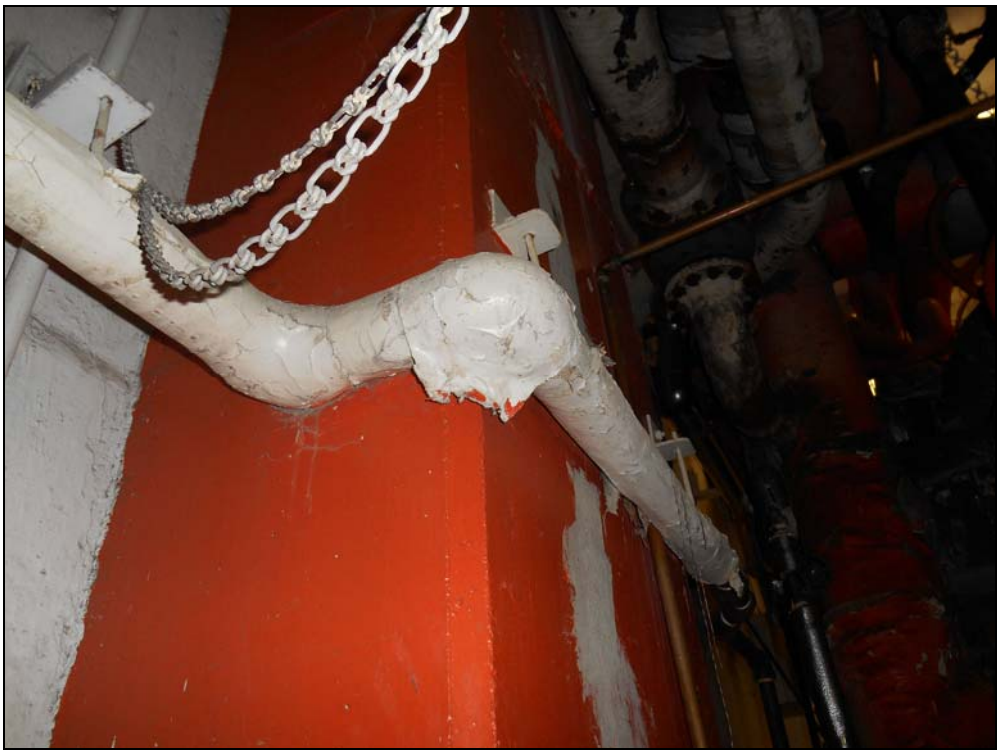
Photo 2: Chiller Room Mudded Elbows (2) Damaged
