Project: Rm 9208K, NEOB
Fan Coil Replacement

Attachment 1
Representative Photographs
And
AML Laboratory Reports

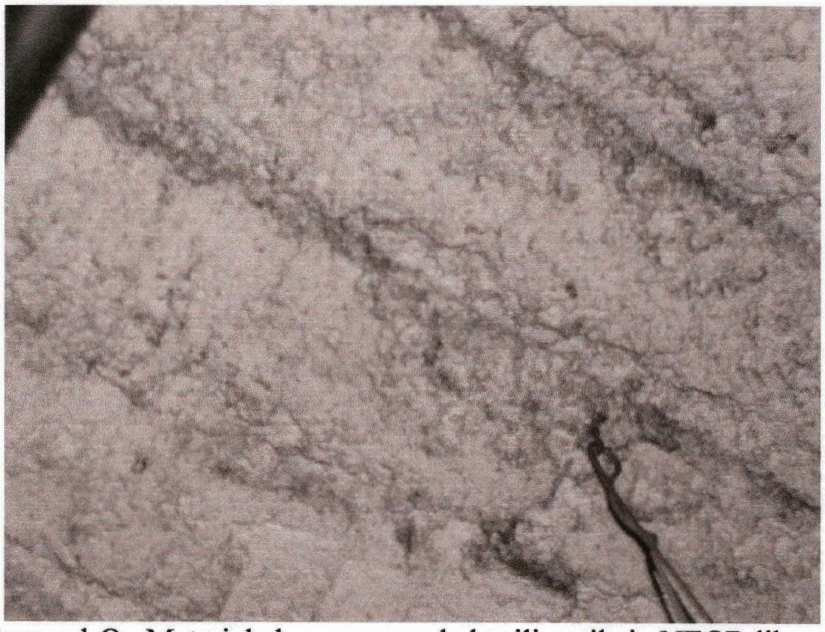
Sprayed-On Material above suspended ceiling tile in NEOB library

Sprayed-On Material on concrete ceiling and metal I-beams
