Figure X:
Concrete Scans

Niagara Falls Boulevard Site
Niagara Falls, New York

U.S. ENVIRONMENTAL PROTECTION AGENCY
REMOVAL SUPPORT TEAM 3
CONTRACT # EP-S2-14-01

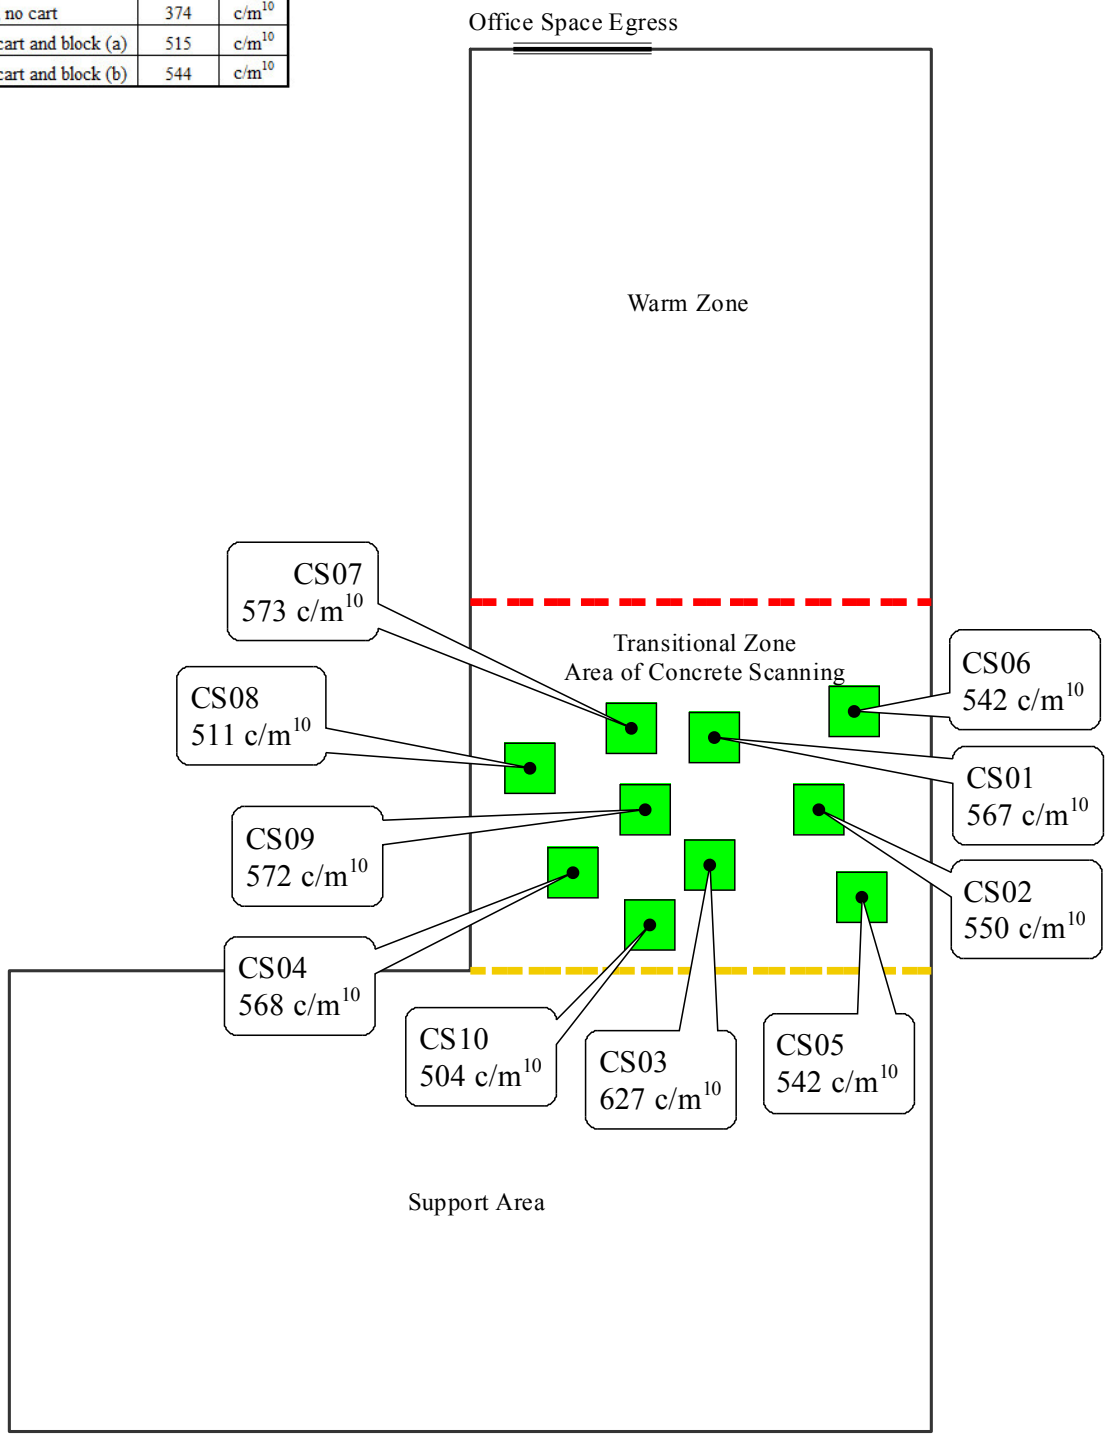
Location	Reading	Units
Adjacent to CS03, no block, no cart	374	c/m^{10}
Church Background Area, cart and block (a)	515	c/m^{10}
Church Background Area, cart and block (b)	544	c/m^{10}
