Figure X:
ST-5 Gamma Survey

Niagara Falls Boulevard Site
Niagara Falls, New York

U.S. ENVIRONMENTAL PROTECTION AGENCY
REMOVAL SUPPORT TEAM 3
CONTRACT # EP-S2-14-01

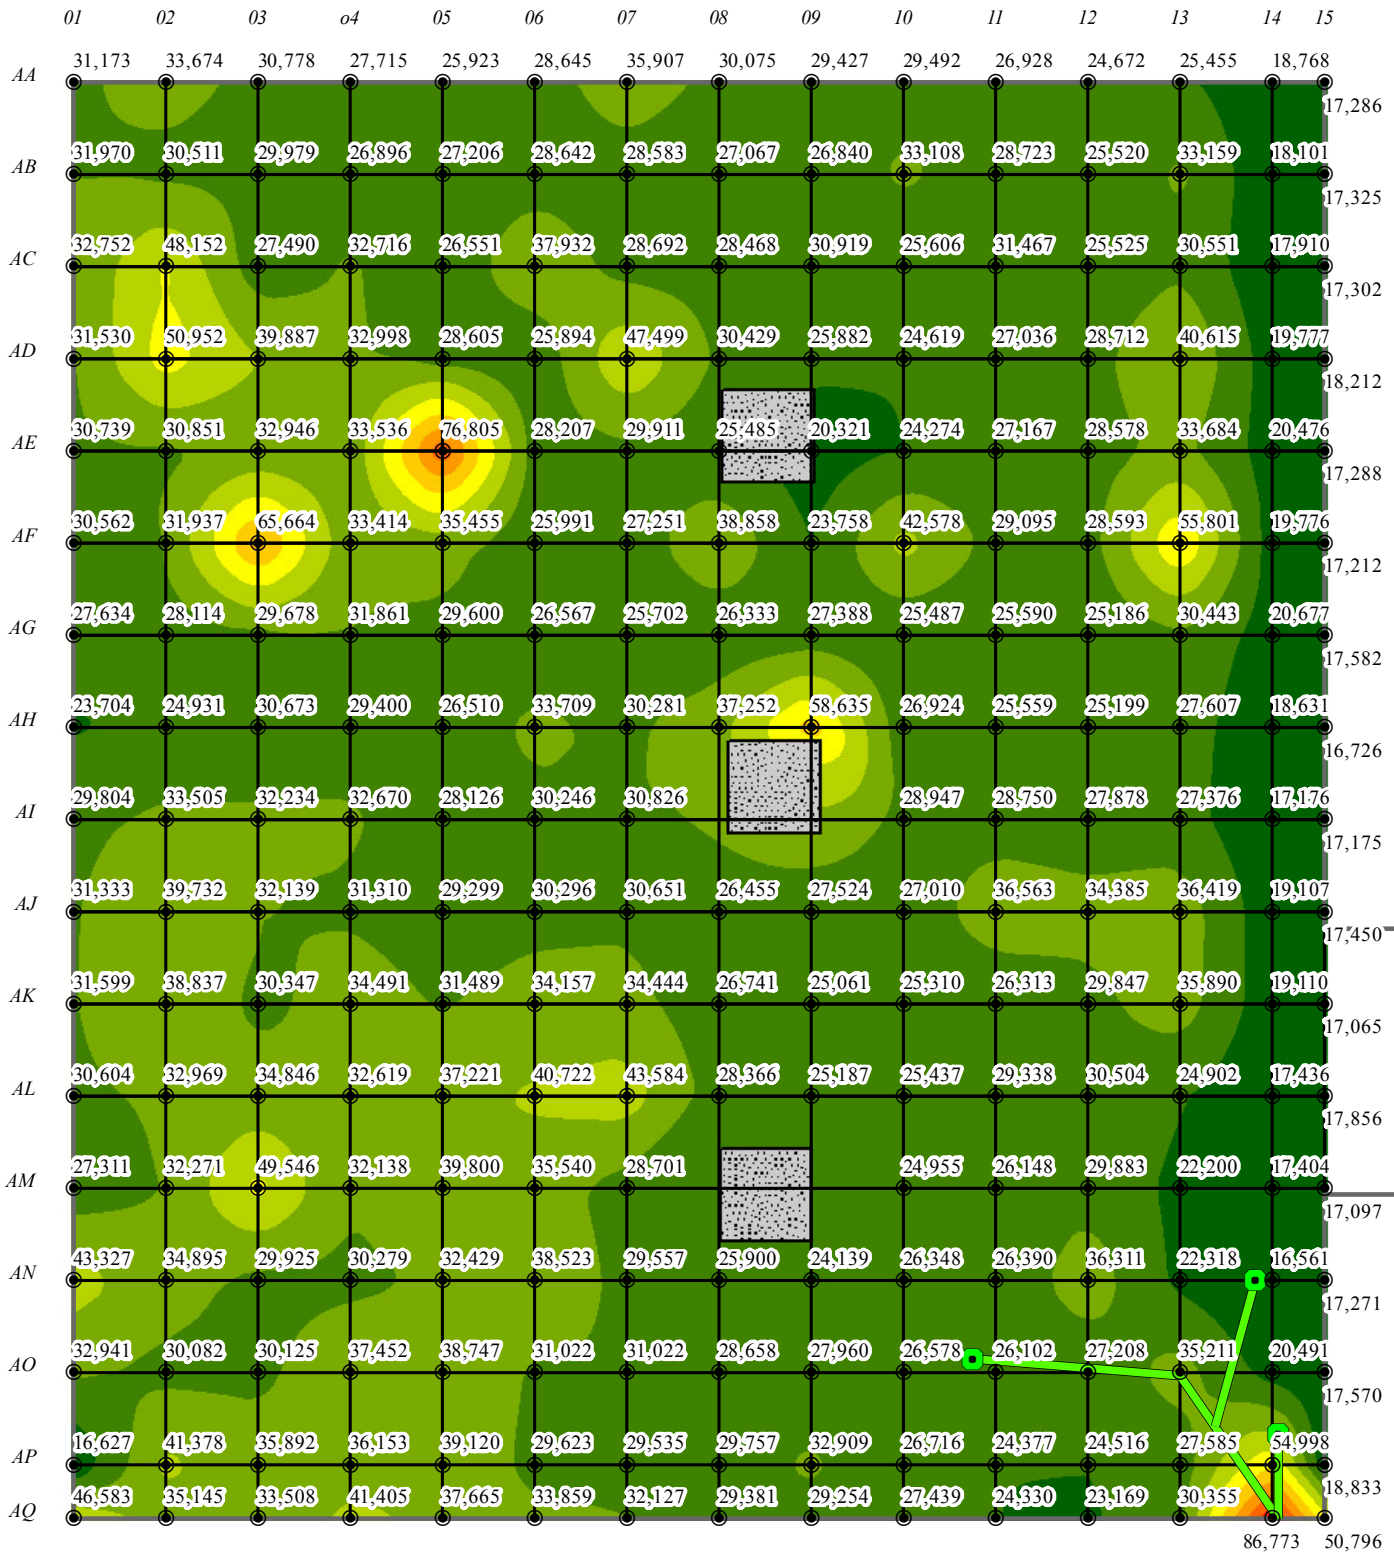
Distance measurements presented in feet.
Gamma measurements presented in counts per minute (CPM).
Measurements captured over a one minute interval.
