PHASE I AND LIMITED PHASE II
ENVIRONMENTAL SITE ASSESSMENT
WAYNE DIVISION, DRESSER EQUIPMENT GROUP, Inc.

124 West College Avenue
Salisbury, Maryland

December 22, 2000

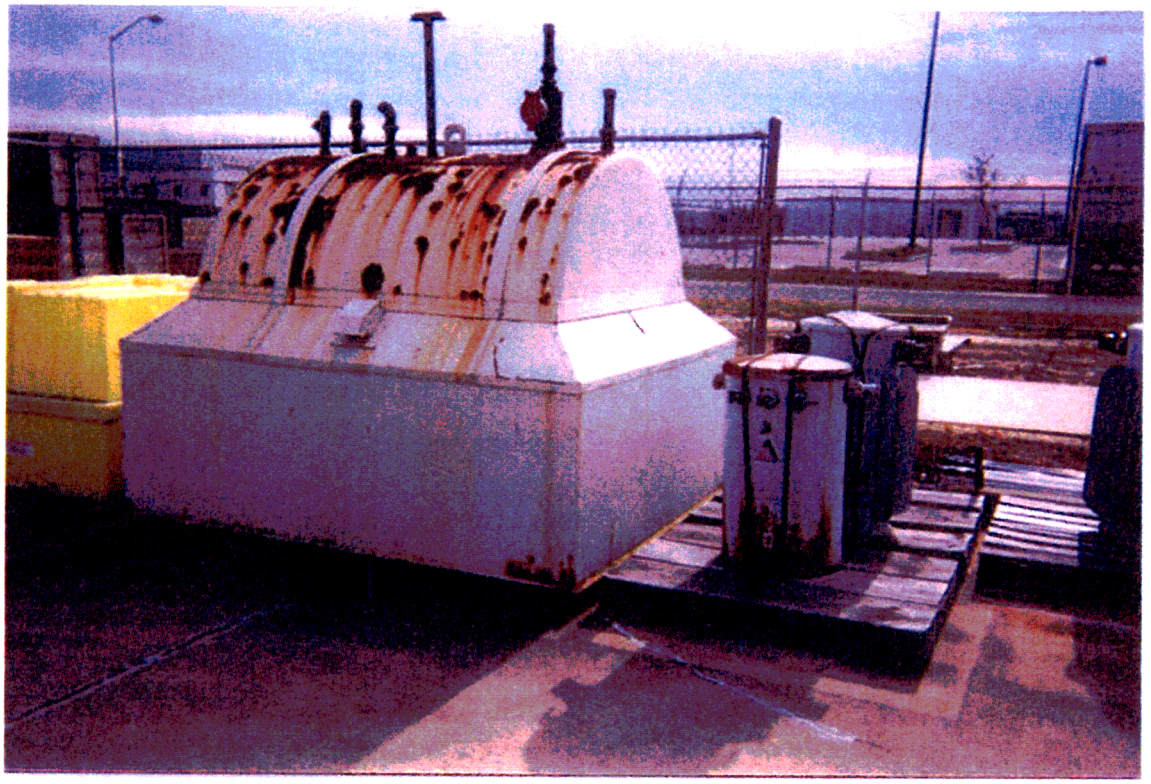
PHOTO 7: These bulk storage containers and drums are empty and are waiting to be sent off site.

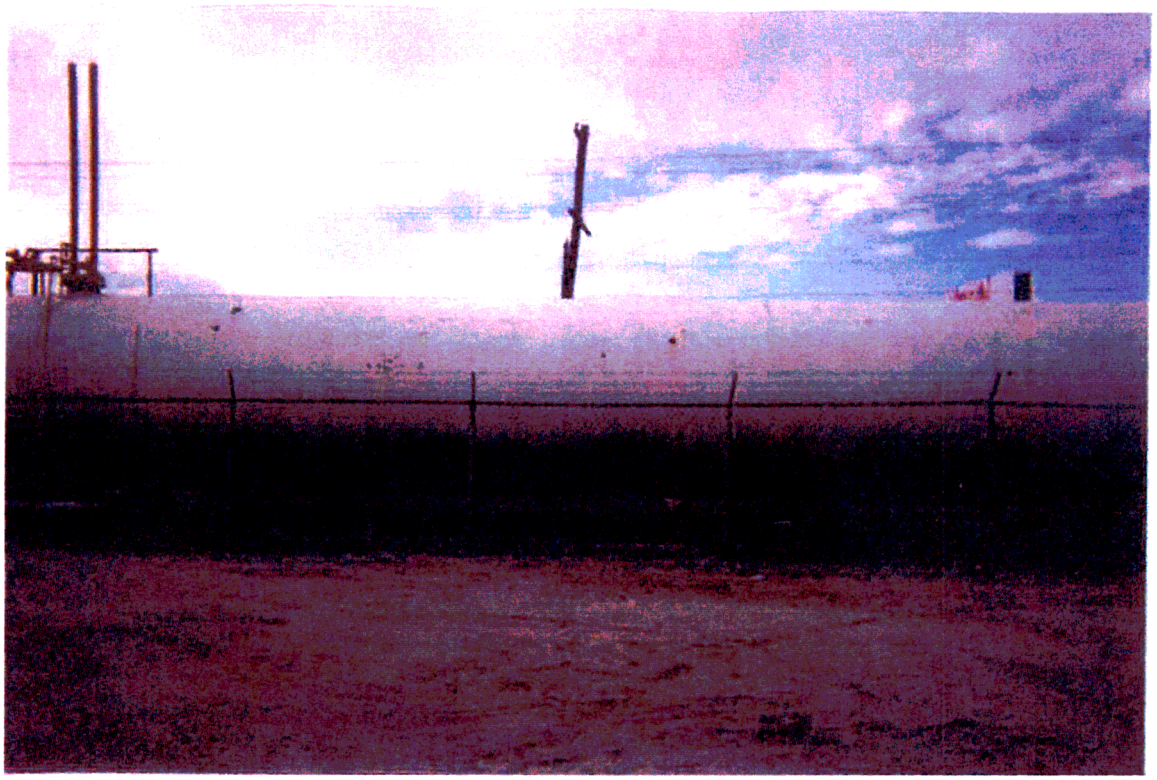
PHOTO 12: The two 10-000-gallon AST used to store process water generated at the facility. It is enclosed in a mote that is lined. This was necessary when the facility maintained its pre-treatment plant. The process water is discharged to the City of Salisbury POTW.

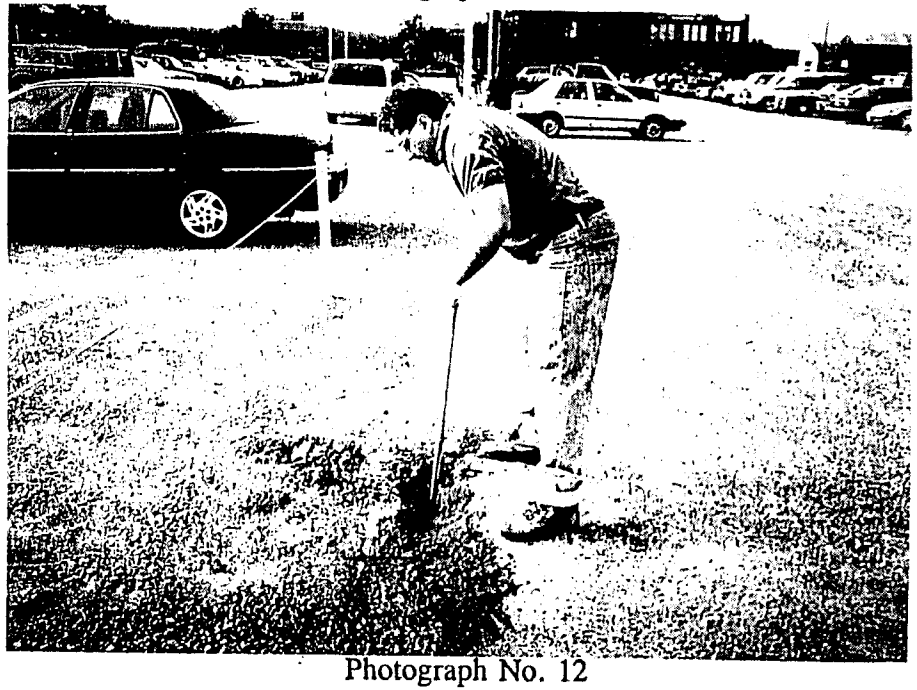
Photograph No. 12

12. EME personnel employing a hand auger to drill boring 1-3.
