Subject: **Removal Site Evaluation Report (Revision 1)**
Nelson Knitting Removal Assessment Site
Rockford, Winnebago County, Illinois
EPA Contract No. 68HE0519D0005
Task Order No.: 68HE0520F0032
Task Order Line Item No.: 0001BI104
Document Tracking No. 0497a

REMOVAL SITE EVALUATION REPORT
NELSON KNITTING SITE
ROCKFORD, WINNEBAGO COUNTY, ILLINOIS
REVISION 1

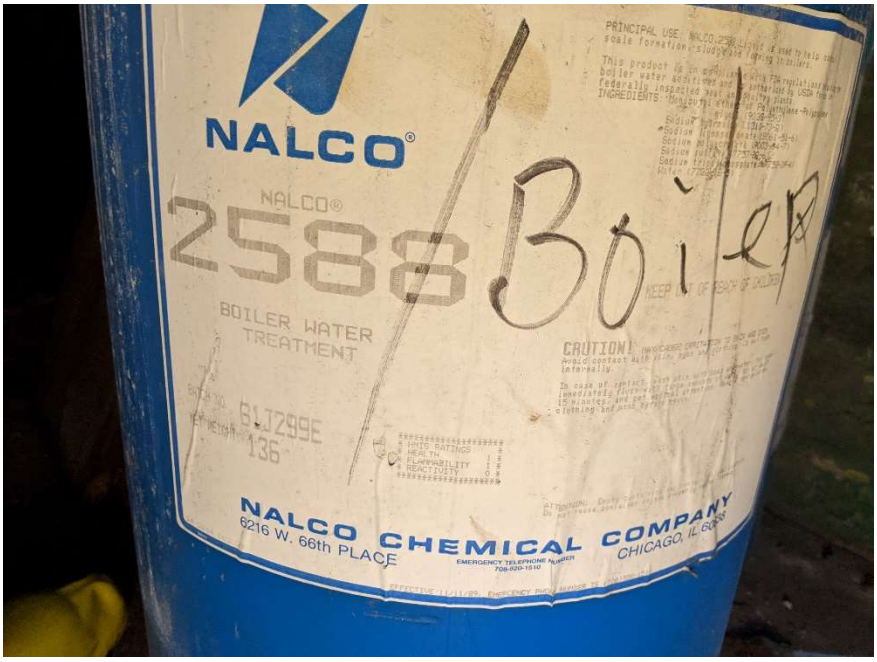
Photograph No. 9 **Date:** 10/8/2020 **Description:** 25% full medium sized barrels inside the building. **Direction:** East

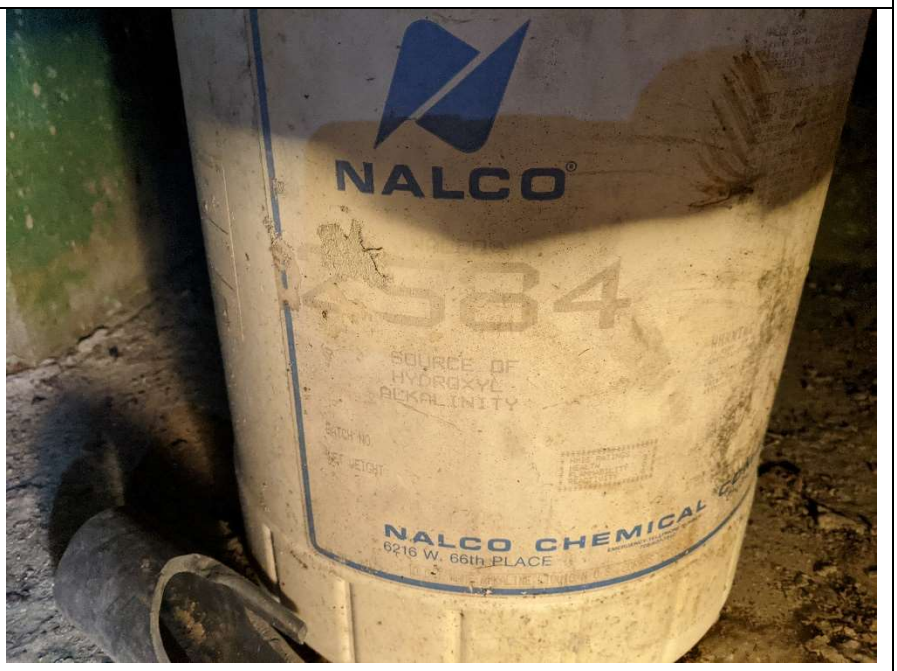
Photograph No. 10 **Date:** 10/8/2020 **Description:** 25% full medium sized barrels inside the building **Direction:** East

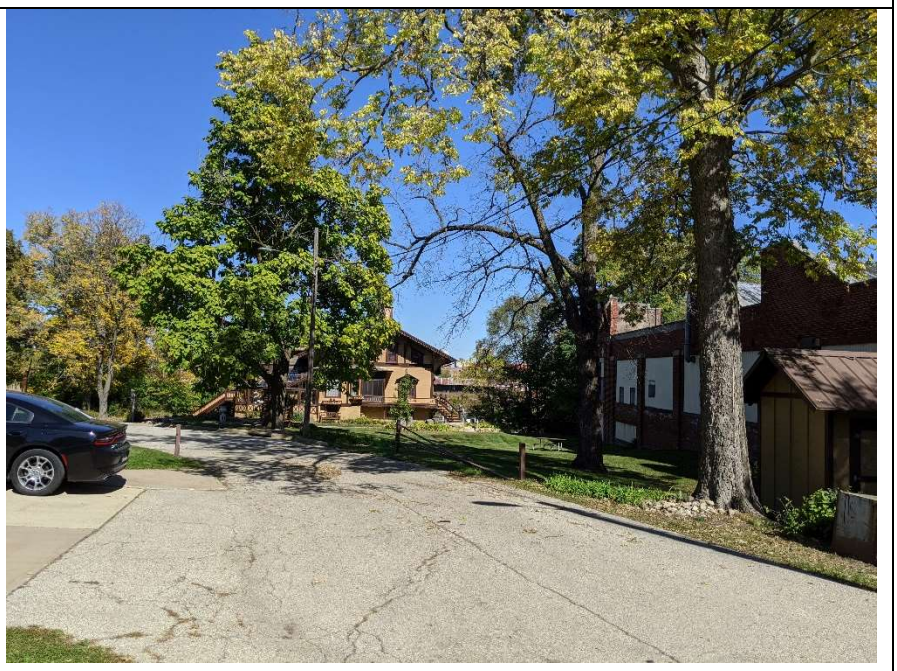
Photograph No. 11 **Date:** 10/8/2020 **Description:** Area surrounding the former Nelson Knitting Facility. **Direction:** Southeast	
Photograph No. 12 **Date:** 10/8/2020 **Description:** Area surrounding the former Nelson Knitting Facility. **Direction:** North

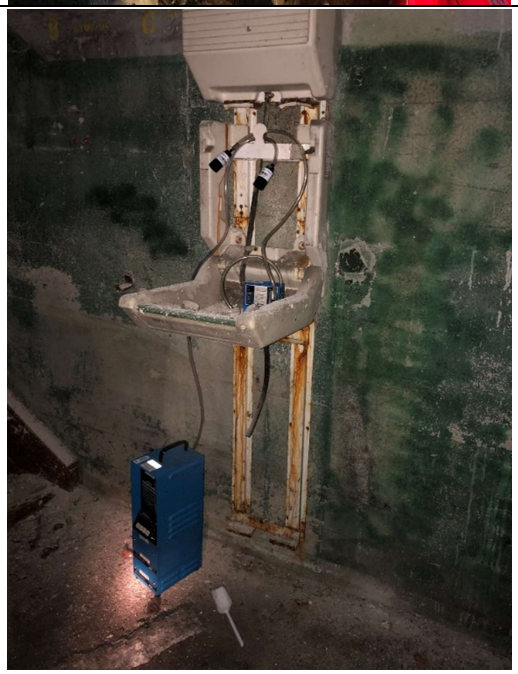
Photograph No. 19 **Date:** 10/8/2020 **Description:** Bulk asbestos sample 007 taken in the boiler room. south. **Direction:** South	
Photograph No. 20 **Date:** 10/8/2020 **Description:** Air samples in the Boiler room NS-AA-010-20201008 NS-AA-005-20201008 **Direction:** Northeast

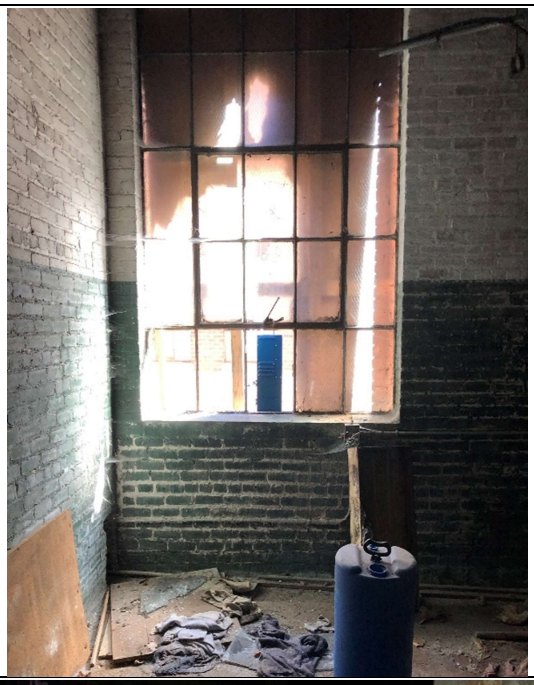
Photograph No. 21 **Date:** 10/8/2020 **Description:** Outdoor air sample NS-AA-002-20201008 **Direction:** East

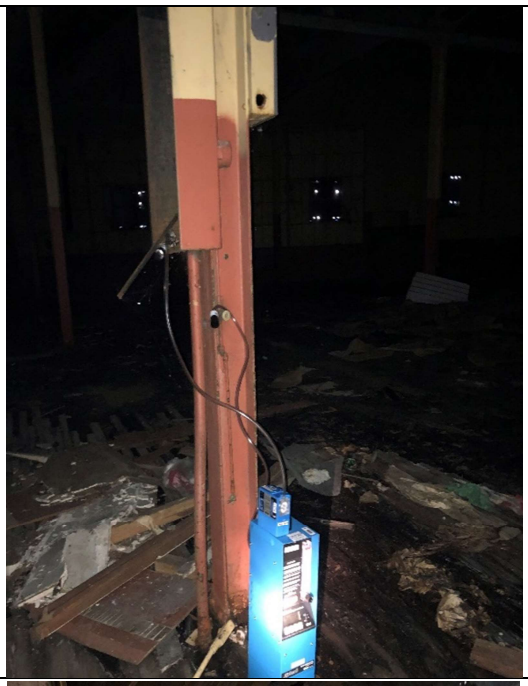
Photograph No. 24 **Date:** 10/8/2020 **Description:** Indoor Air sample NS-AA-003-20201008 NS-AA-008-20201008 **Direction:** Northeast
