PCB REMEDIATION COMPLETION REPORT

Amistad Academy

223019.00
Achievement First
New Haven, CT
October 2010

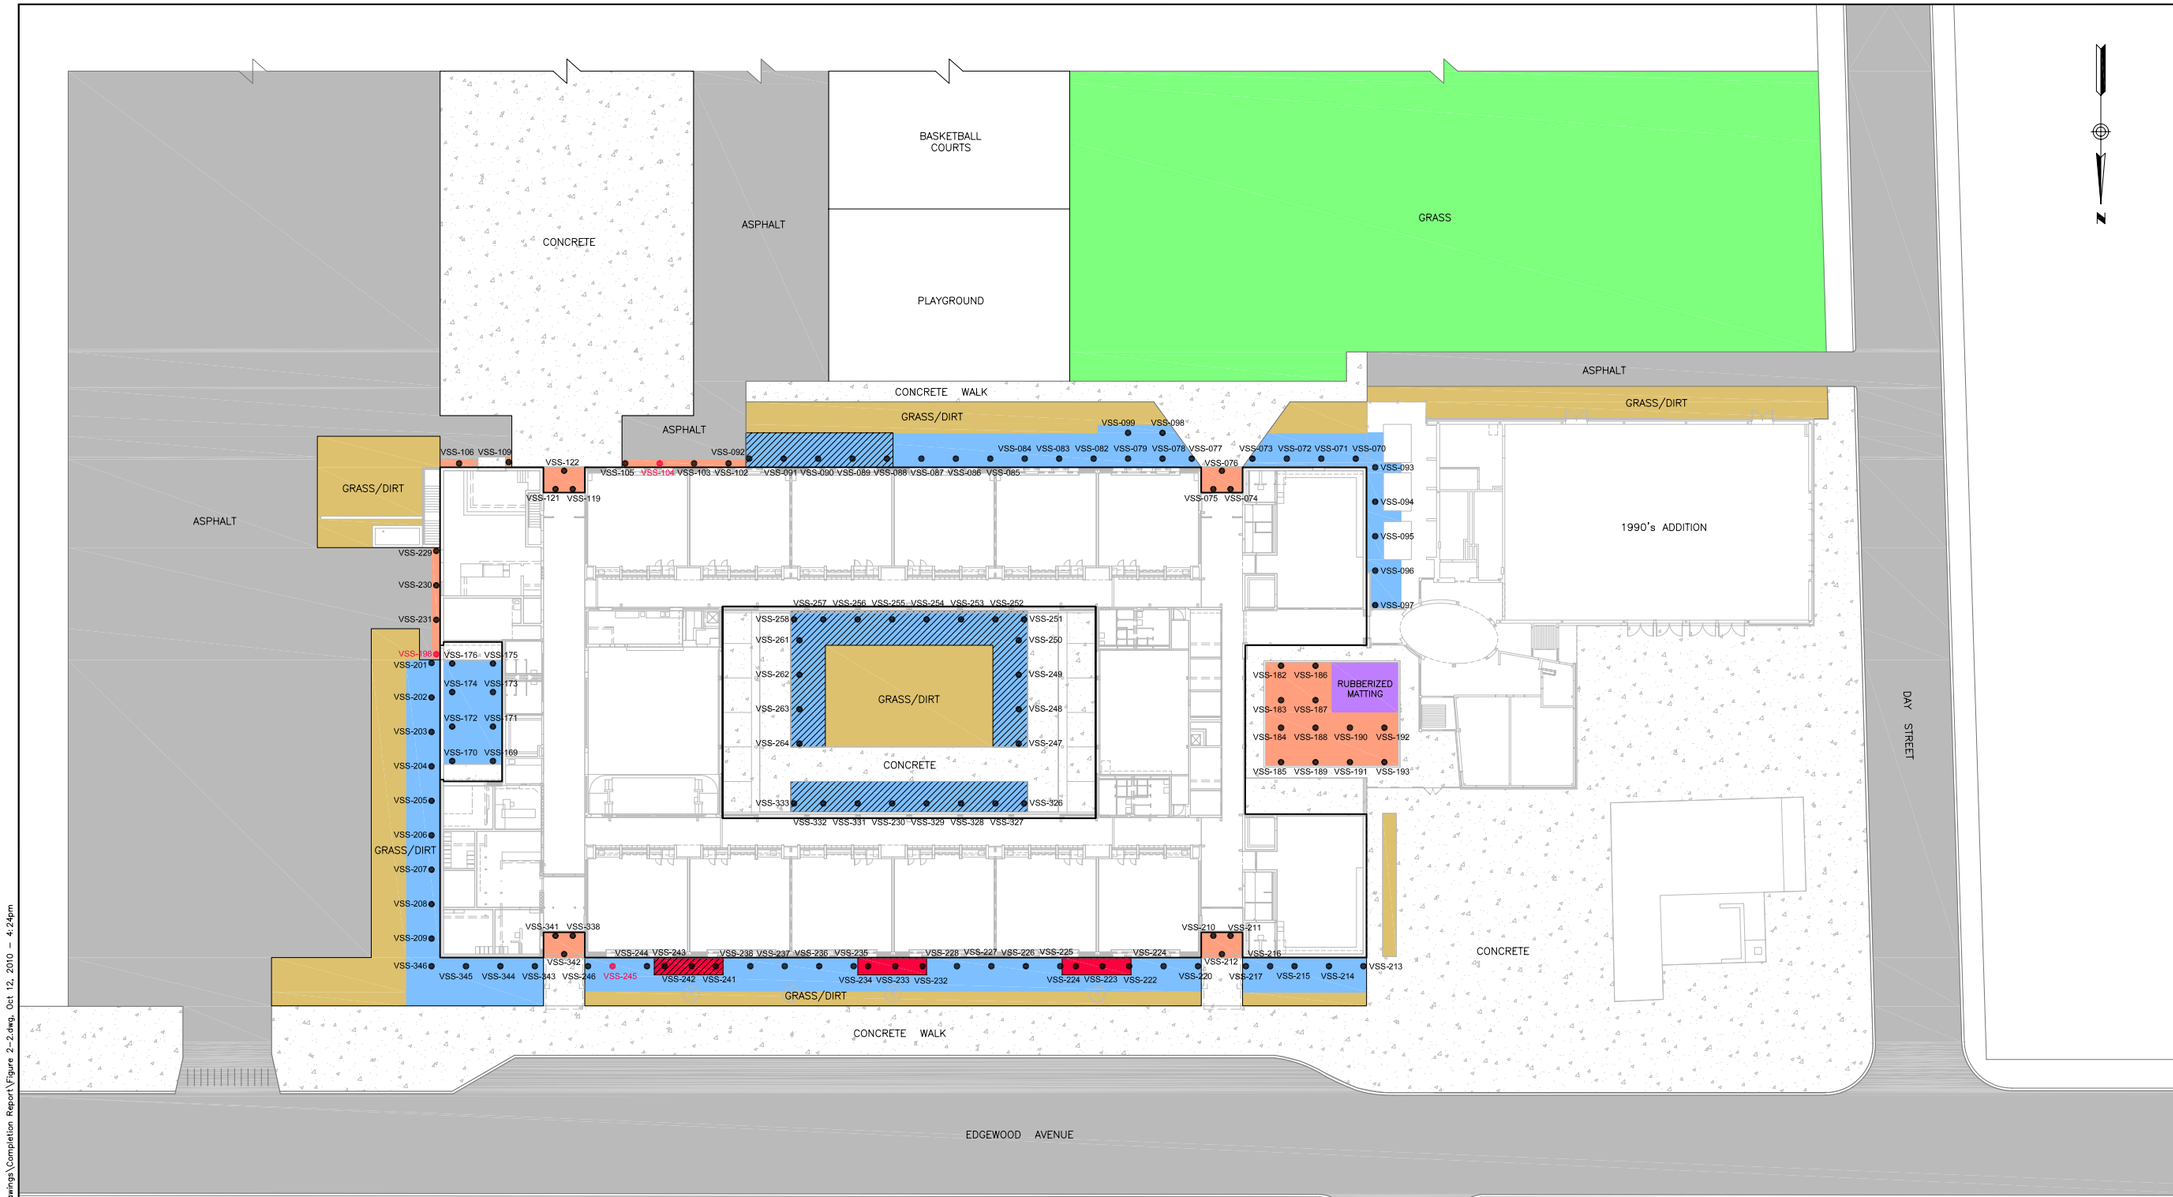
- Excavation of soils from three areas on the northern side of the building was conducted to a depth of 1 foot below ground surface (ft bgs) to a distance of 5 feet from the building foundation for off-site disposal as ≥ 50 ppm PCB waste (total of 11.1 yd^3);

- Excavation of soils to a distance of 10 feet from the building foundation was conducted to a depth of up to 24 inches bgs as shown on Figures 2-2 and 2-3 for disposal as > 1 and < 50 ppm PCB wastes (total of 323 yd^3). The excavation area was extended to 12.5 feet along 23 feet of the south side of the building and 13.5 feet along 30 feet of the north side of the building based on results of additional characterization sampling as reported in the July 2, 2010 Notification; and

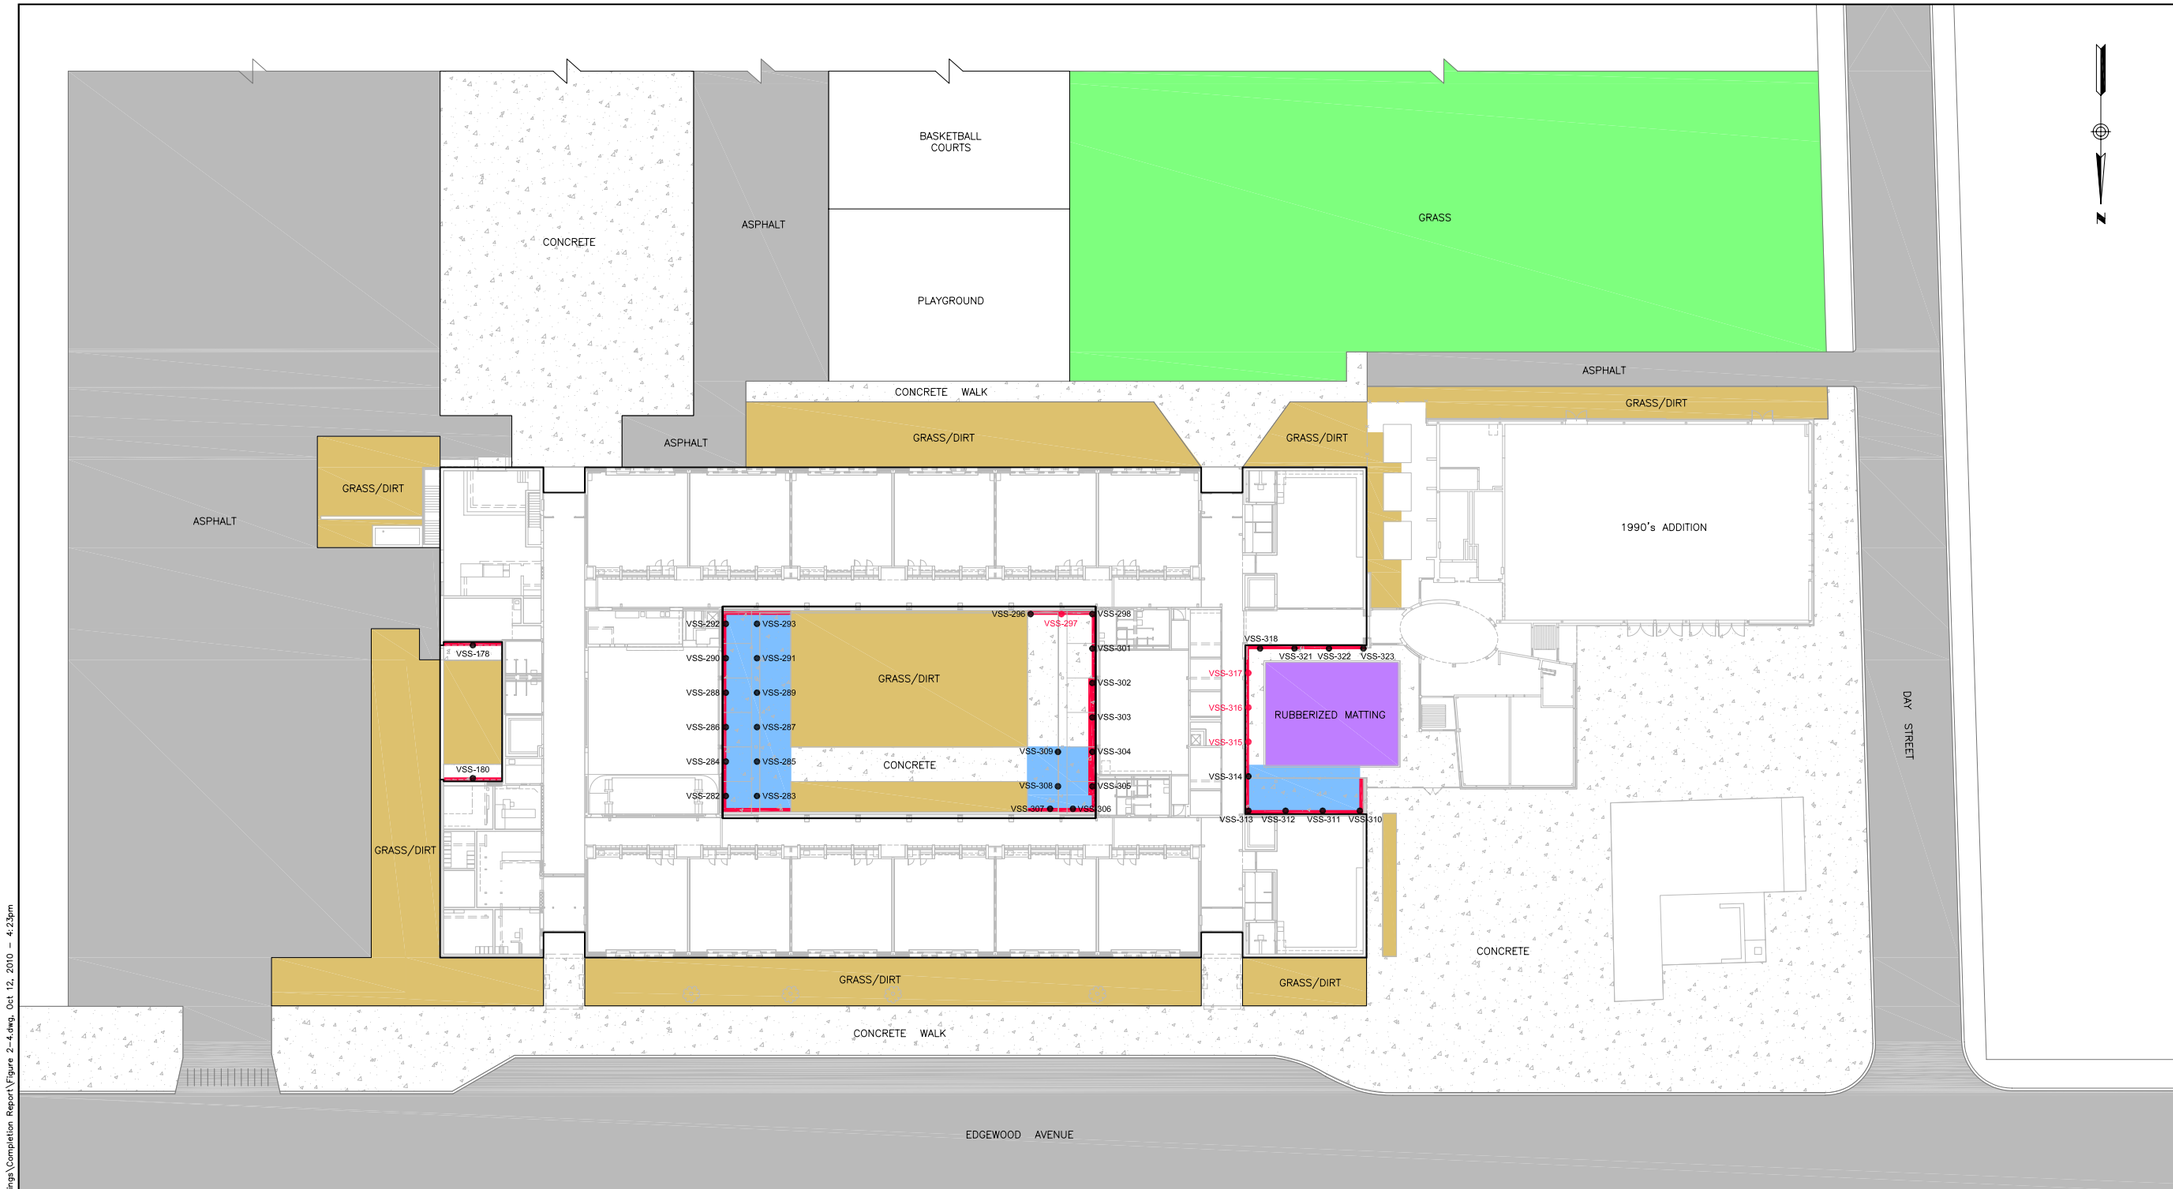
- Removal of rubberized matting materials in the western courtyard for off-site disposal as > 1 and < 50 ppm PCB waste (total of 3.7 yd^3);
- Removal of concrete walkways, as depicted on Figure 2-4, within the three courtyard areas to a distance of 12" from the building foundation, curtain wall window sills, and doorways for off-site disposal as $\geq$ 50 ppm PCB wastes. The distance was increased to 24 inches along approximately 35 feet on the western side of the central courtyard based on results of the additional characterization testing (total of 2.8 yd^3);

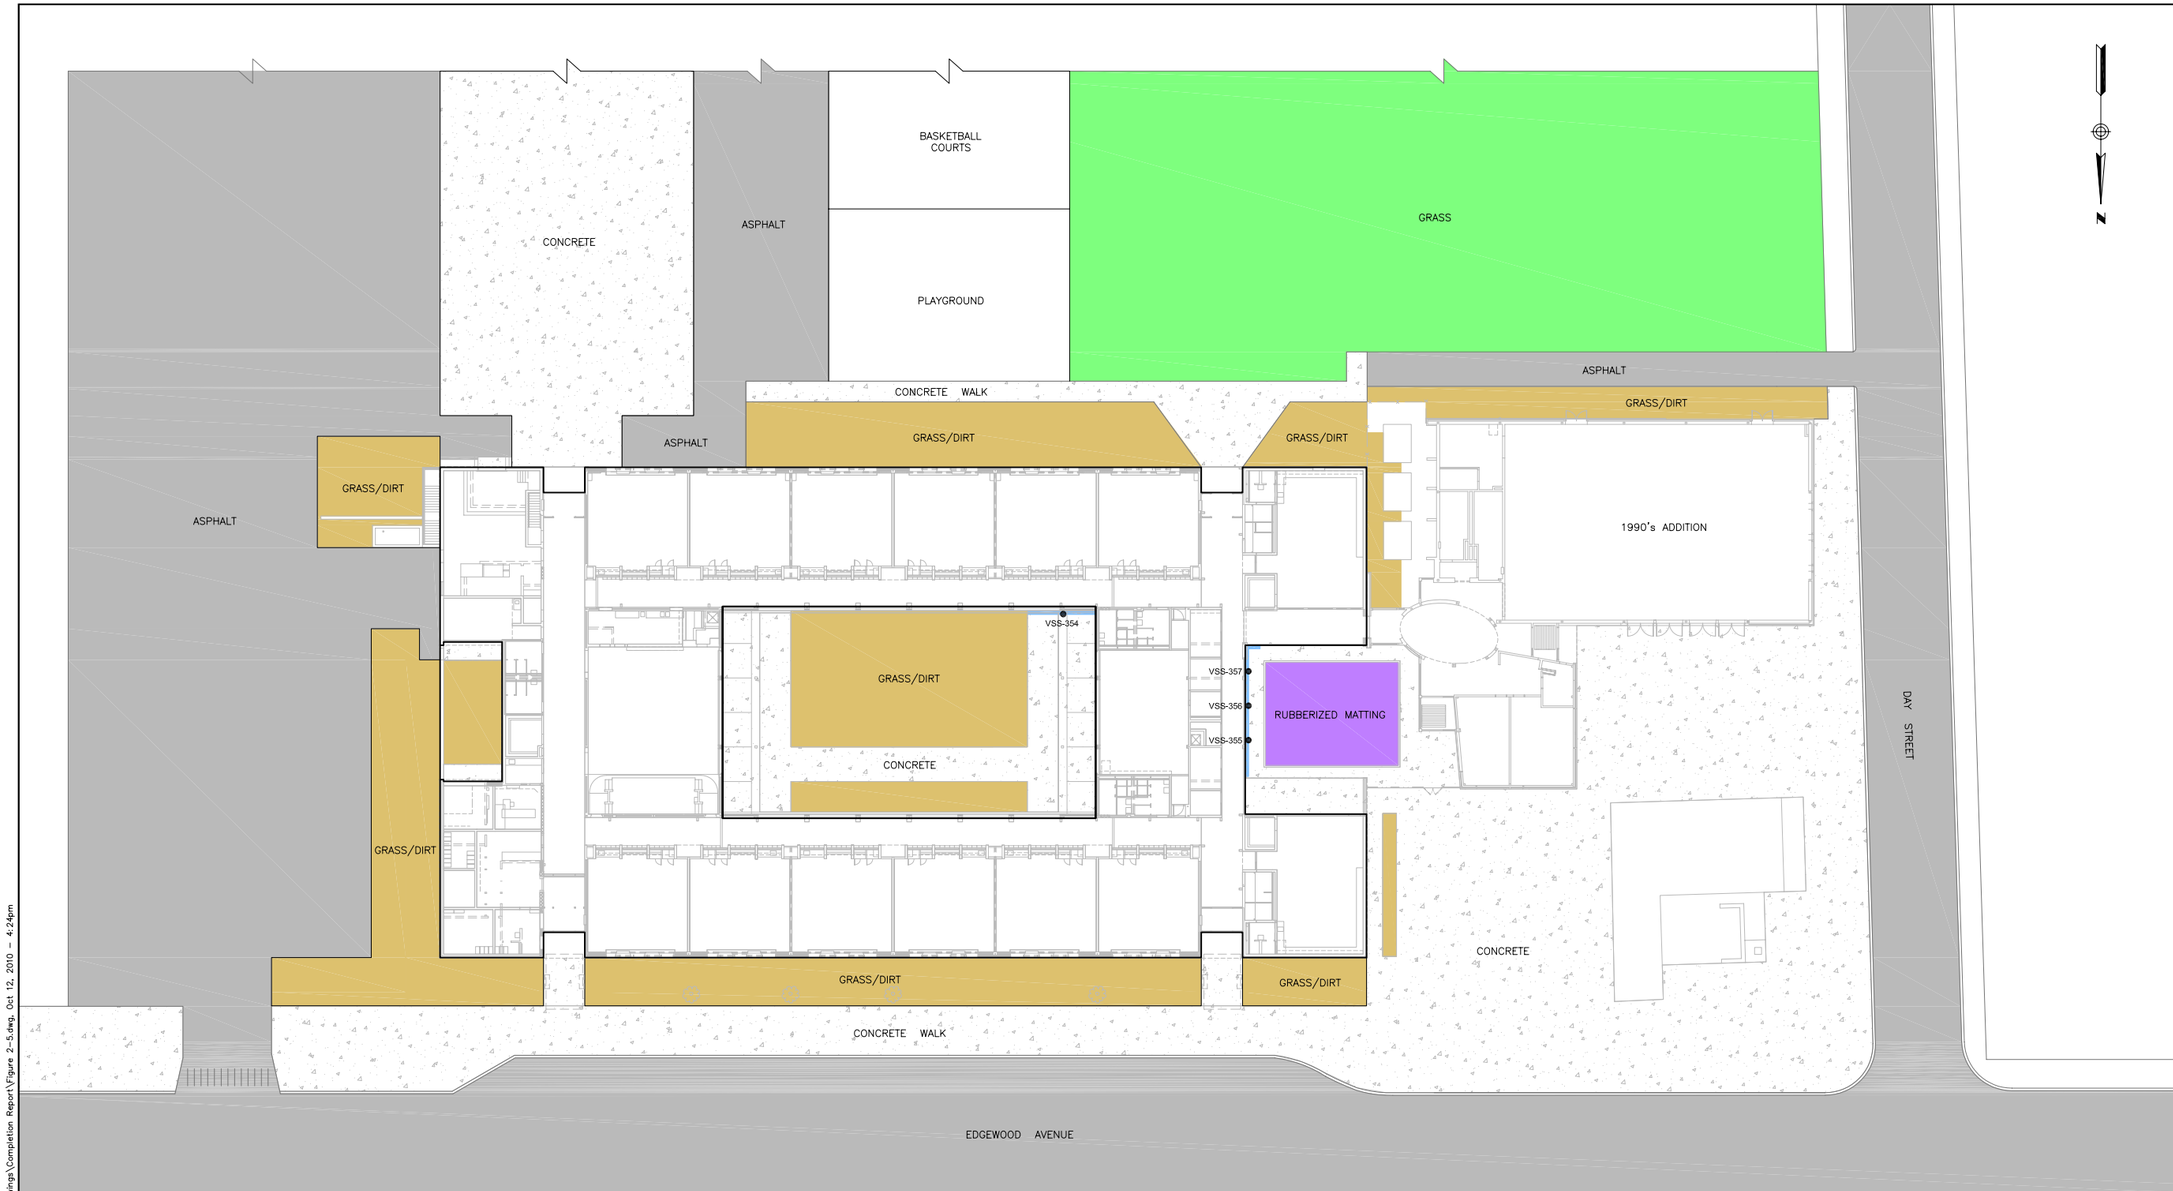
FIGURE 2-4

- Removal of concrete walkway materials in the central and western courtyards as depicted on Figure 2-4 for disposal as > 1 and < 50 ppm PCB wastes (total of 22.3 yd^3);
