Mobil Exploration & Producing U.S., Inc.
Jalk Fee
Santa Fe Springs, California

Figure 7 :
SITE PLAN SHOWING APPROXIMATE EXTENT OF AFFECTED AREAS

Project No. 2193
Date SEPT 1991
Sheet 7 of 7

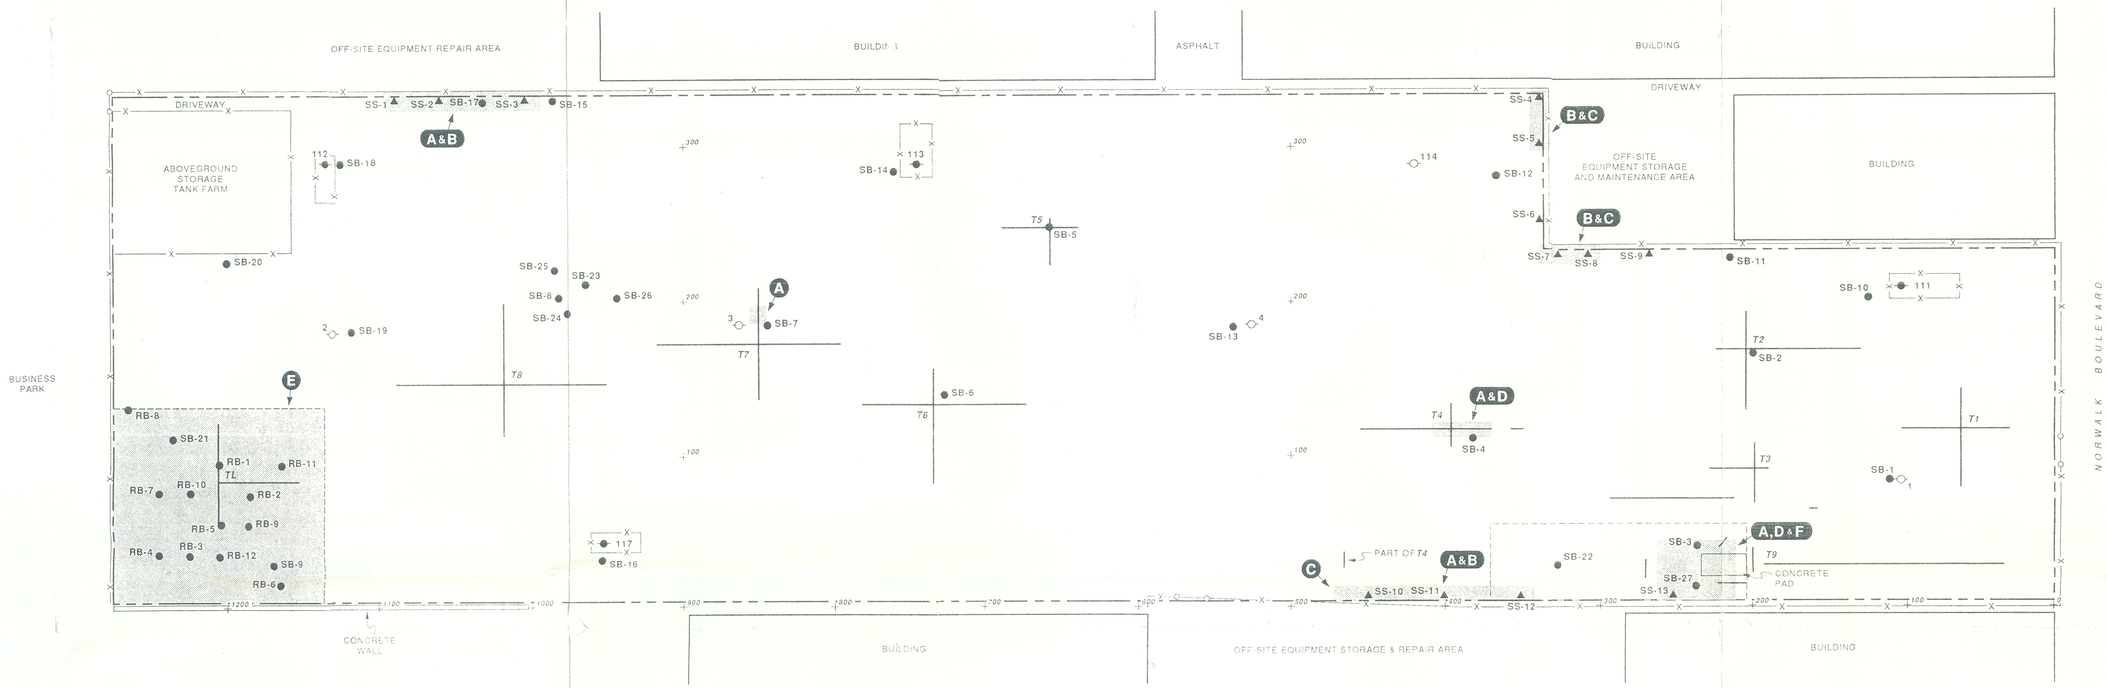
A	Approximate Areas of Crude Oil-Affected Soils Above Typical Action Levels (1,000 ppm TPH) Requiring Remediation
B	Approximate Areas of TPH-Affected Soils Apparently Due to Off-Site Sources
C	Approximate Areas of TPH-Affected Soils Below Typical Action Levels (1,000 ppm TPH) Requiring Remediation
D	Approximate Area of Fuel-Affected Soils
E	Approximate Area of Metals (Pb, Zn & Cu) in Soils Exceeding STLC Limits
F	Approximate Area of PCE & TCE-Affected Soils

NOTES: All area approximations are based on analytical results. Area estimations concerning active oil wells, existing tank farm, and "B" areas are also based on visual observations.
