RE: 2013-2014 Annual Report for United Heckathorn Superfund Site
Upland Capping System
Richmond, California

2013-2014 ANNUAL REPORT

UNITED HECKATHORN SUPERFUND SITE
UPLAND CAPPING SYSTEM
RICHMOND, CALIFORNIA

Weiss Job No. 426.1966.14

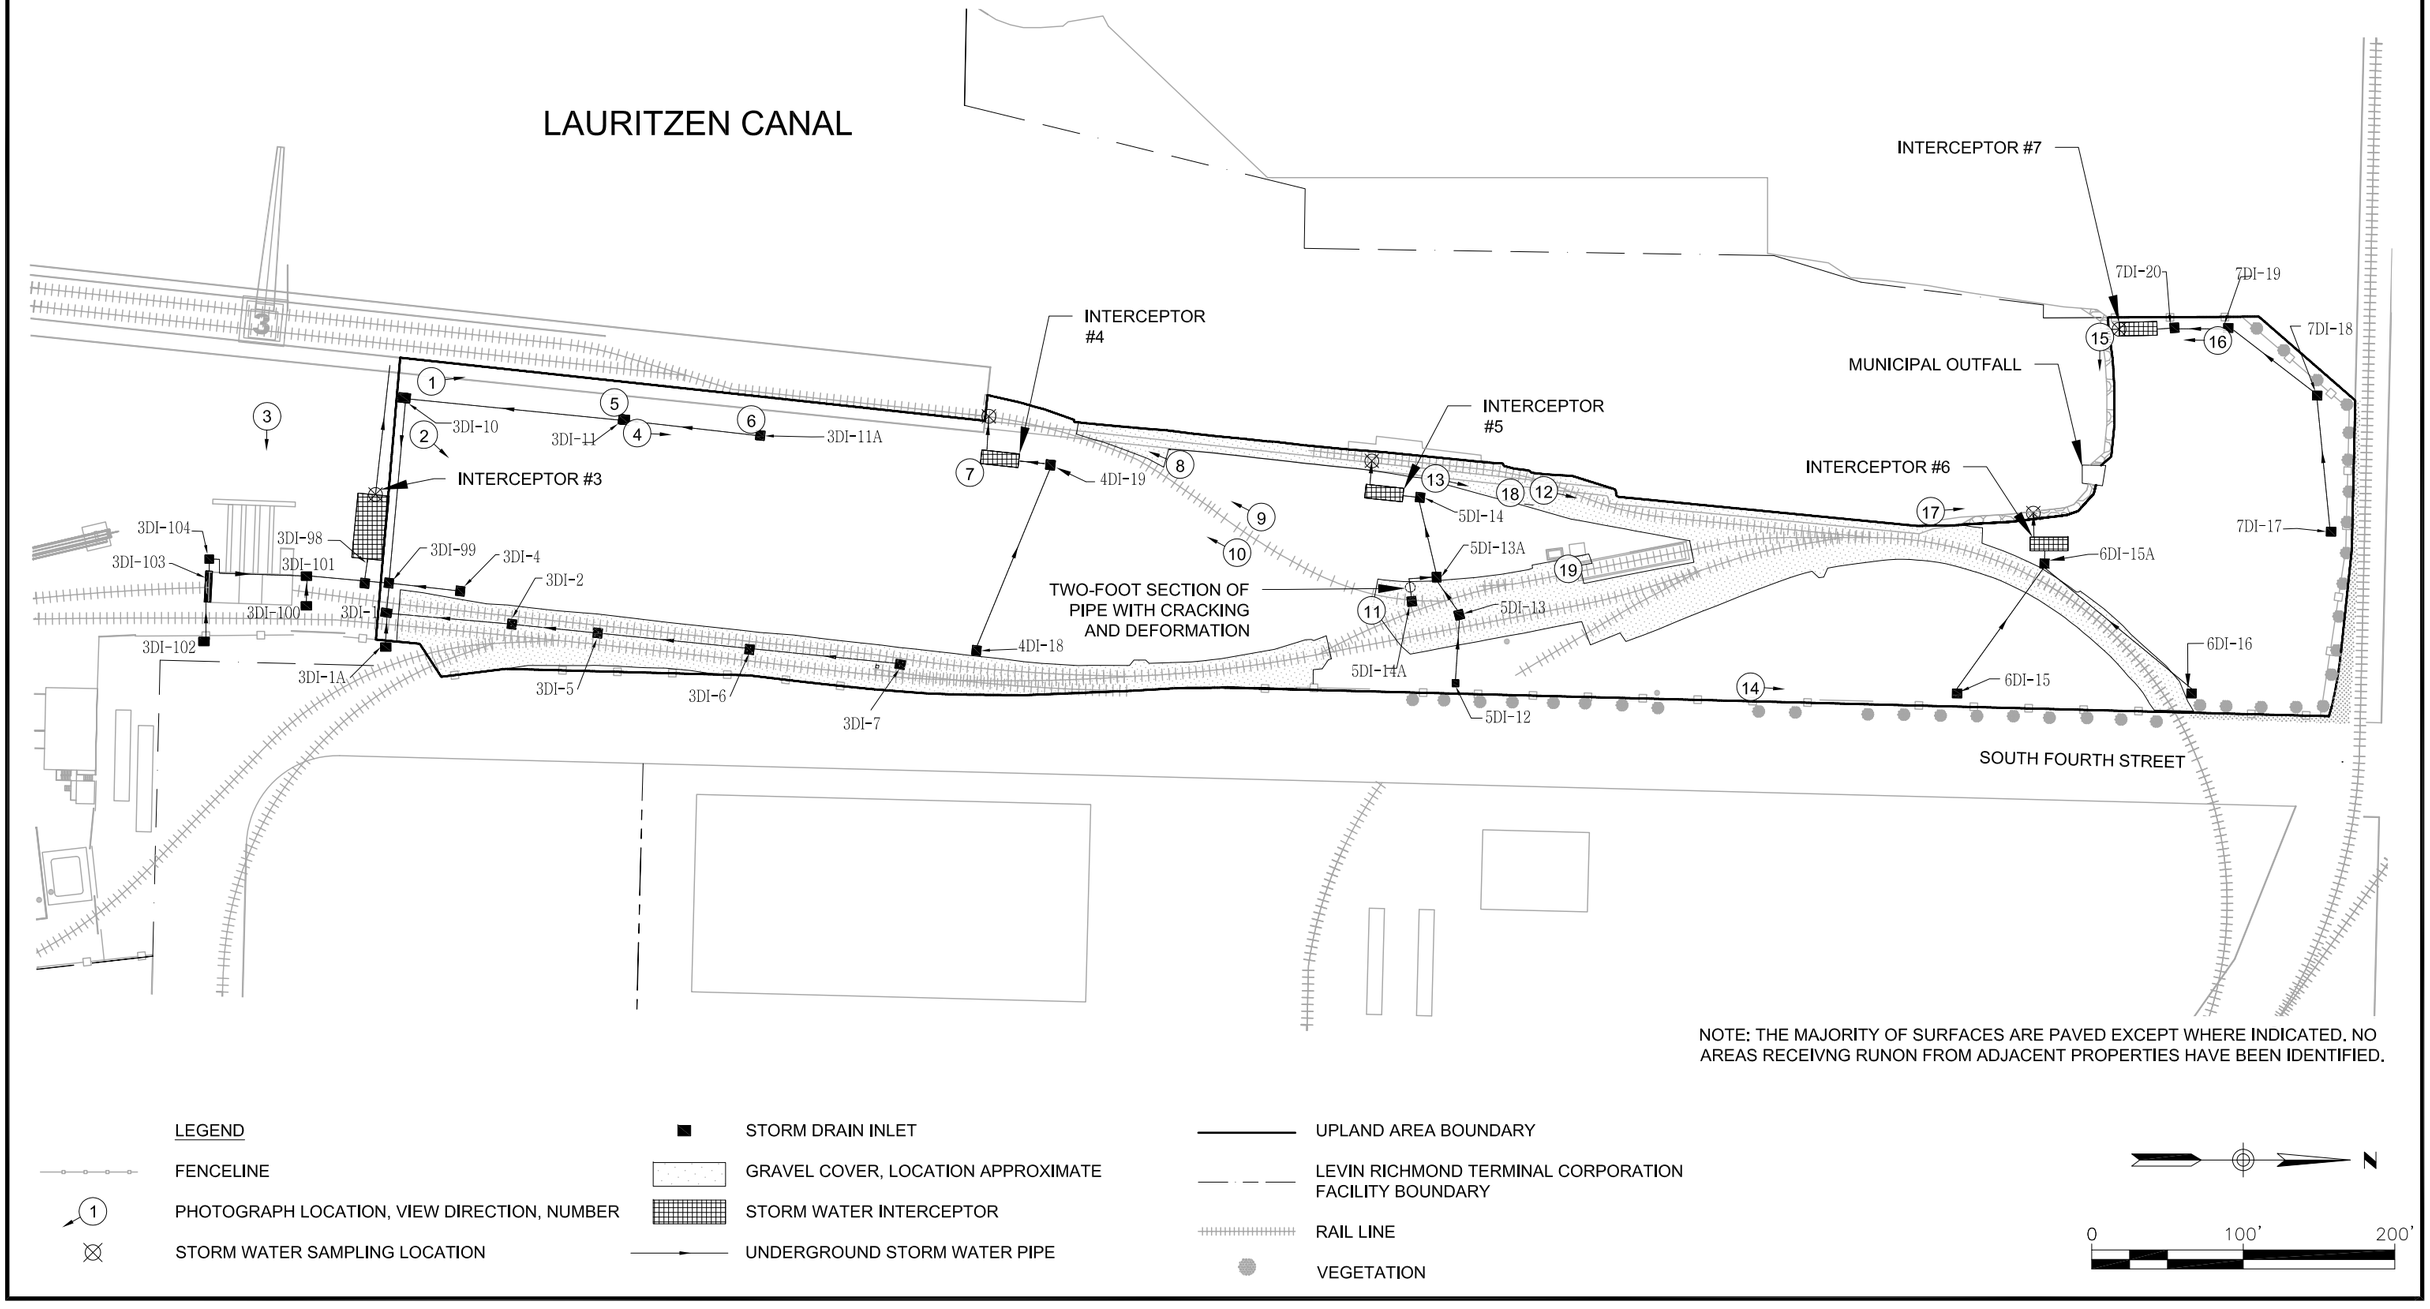
Figure 2. Site Layout — United Heckathorn Superfund Site, Richmond, California

LRTC storm water systems in the Upland Area discharge directly to the Lauritzen Channel (Figure 2), which receives urban and industrial storm water runoff from the City of Richmond's (City's) 30-inch diameter storm water outfall at the north end of the canal. The Larutizen Canal is connected to the San Francisco Bay via the Santa Fe Channel and Richmond Inner Harbor.

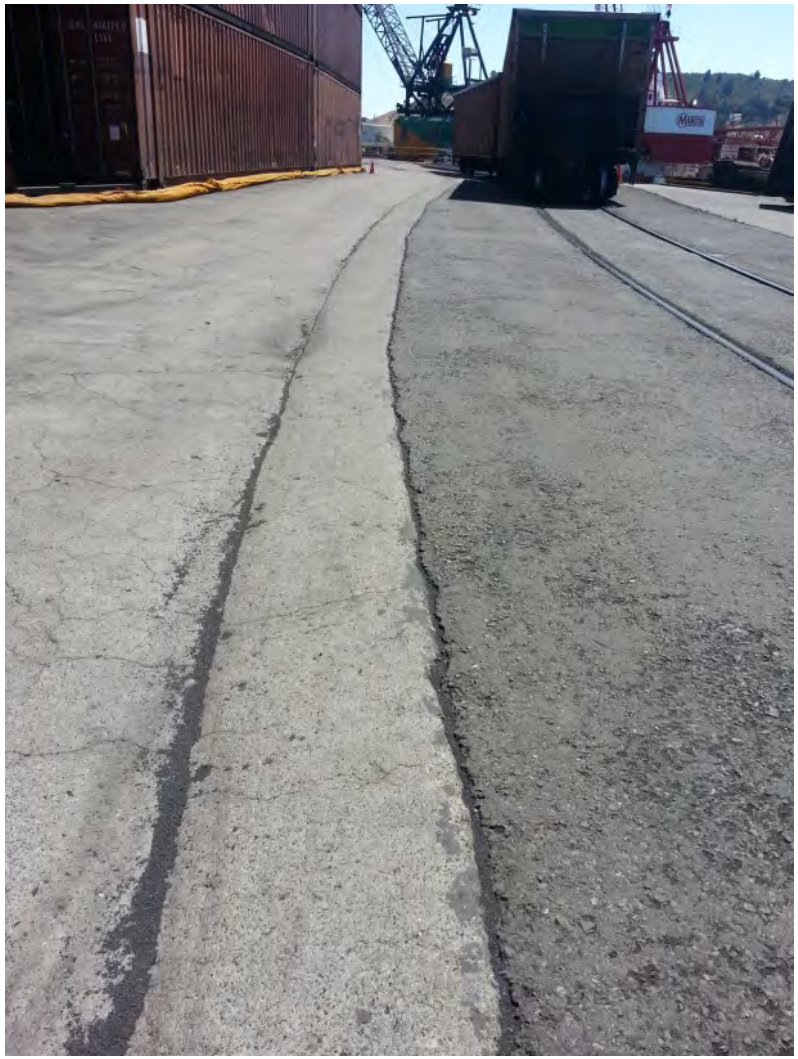
- **SW-4 Area** – Sealant was noted extending from the southeast corner of interceptor SW-4 toward the east (Appendix B; Photo 7). Gaps were observed in the asphalt-concrete interfaces along the rail line running northeast toward the center of the Main Terminal (Appendix B; Photos 8, 9, and 10). New shotcrete was observed along the top of the embankment.

Photo 9 - Looking southwest: Seam at concrete-asphalt interface along rail line which runs northeast to southwest.
