Subject: November 2013 Monthly Progress Report at Schaefer Road Waste Water Treatment Plant ('SRWWTP')

THE MONTHLY PROGRESS REPORT
FOR
November 2013

SCHAEFER ROAD WASTE WATER TREATMENT PLANT

SEVERSTAL DEARBORN, LLC

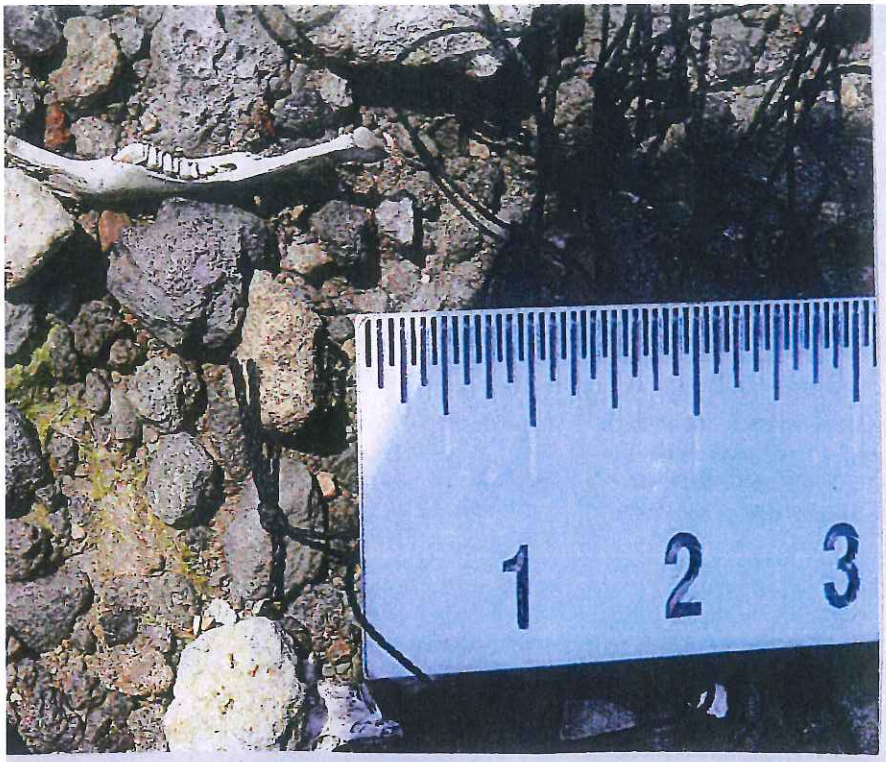
#9: Close-up of residual bones from young Eastern Cottontail at top of south bank of East Sludge Pond. Note fore foot of Eastern Cottontail as well as probable radius & ulna at center, maxilla (right), & inch ruler for sizing.

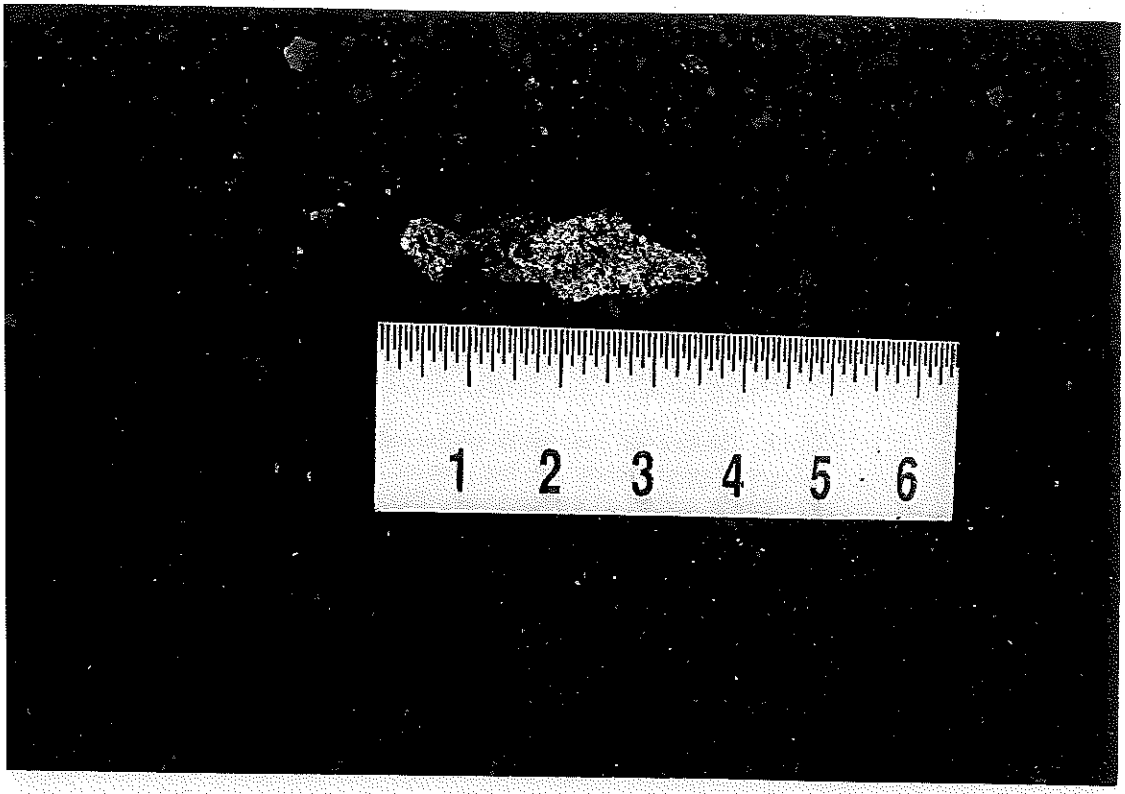
#12: Ground at top of southwest bank of Secondary Lagoon, looking down and north from approximately 13 feet south of power pole. Note down feather of probable Canada Goose and inch ruler for sizing.

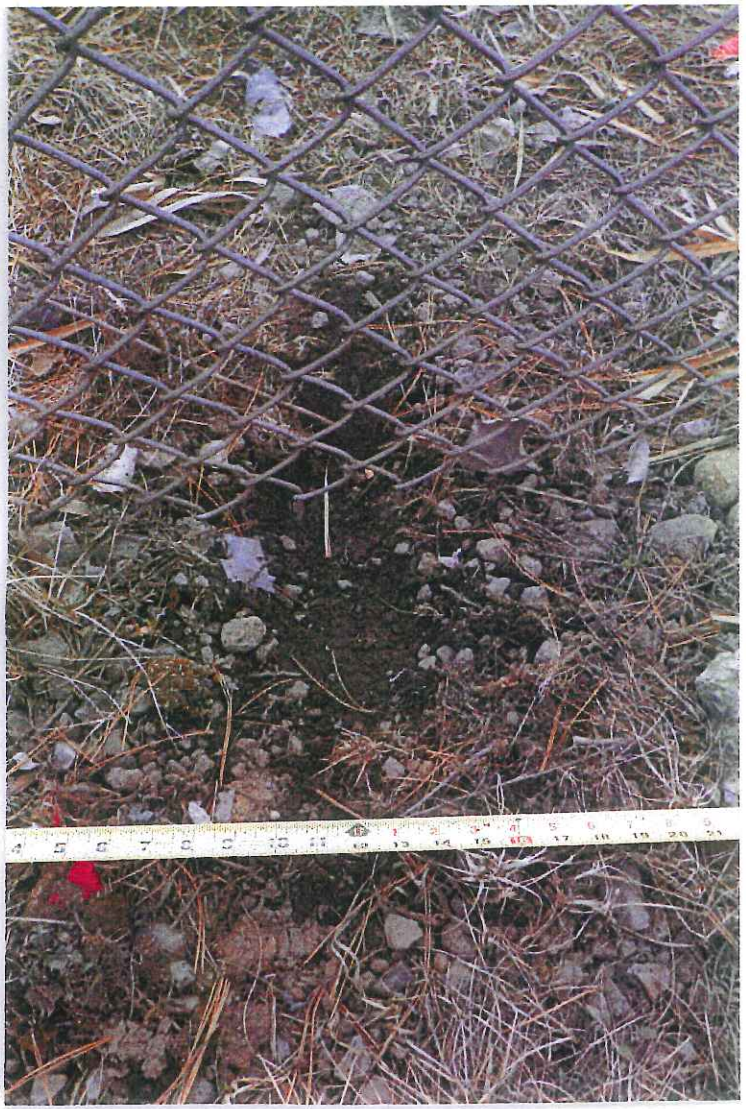
#6: Ground at lower mid-slope of southwest bank of Secondary Lagoon approximately 8 feet northwest of west end of north diagonal boom. Note loose fur of Eastern Cottontail from form and inch tape measure for sizing.

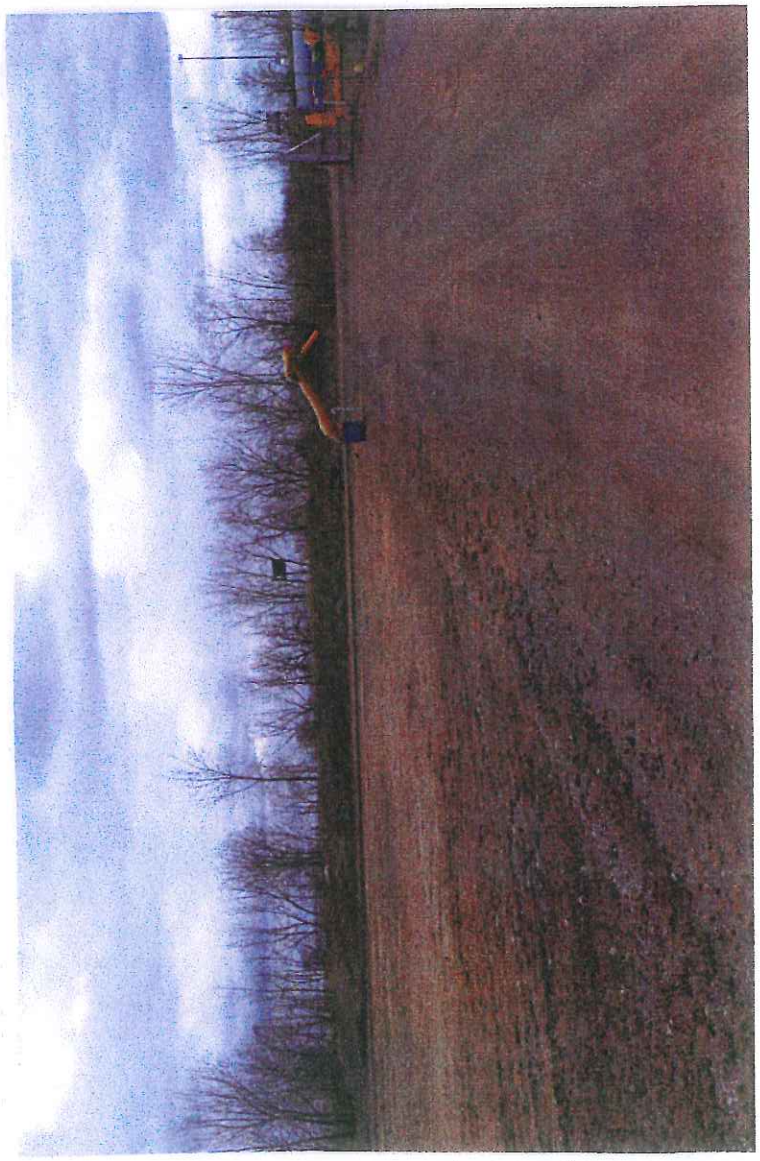
#12: Primary Lagoon, looking north-northwest from southeast corner of Primary Lagoon. Note propane cannons and Primary Lagoon fence in-place. Weir and baffle at center; TVT and bridge in right background.
