TSD File Inventory Index

Facility Name: Hoge Lumber Company (One Folder Site)			
Facility Identification Number: OHD 005 045 729			
A.1 General Correspondence		**B.2 Permit Docket (B.1.2)**	
A.2 Part A / Interim Status	X	.1 Correspondence	
.1 Correspondence	X	.2 All Other Permitting Documents (Not Part of the ARA)	
.2 Notification and Acknowledgment	X	**C.1 Compliance - (Inspection Reports)**	X
.3 Part A Application and Amendments	X	**C.2 Compliance/Enforcement**	X
.4 Financial Insurance (Sudden, Non Sudden)		.1 Land Disposal Restriction Notifications	
.5 Change Under Interim Status Requests		.2 Import/Export Notifications	
.6 Annual and Biennial Reports		**C.3 FOIA Exemptions - Non-Releasable Documents**	
A.3 Groundwater Monitoring		**D.1 Corrective Action/Facility Assessment**	X
.1 Correspondence		.1 RFA Correspondence	
.2 Reports		.2 Background Reports, Supporting Docs and Studies	
A.4 Closure/Post Closure	X	.3 State Prelim. Investigation Memos

3.1 Facility Description

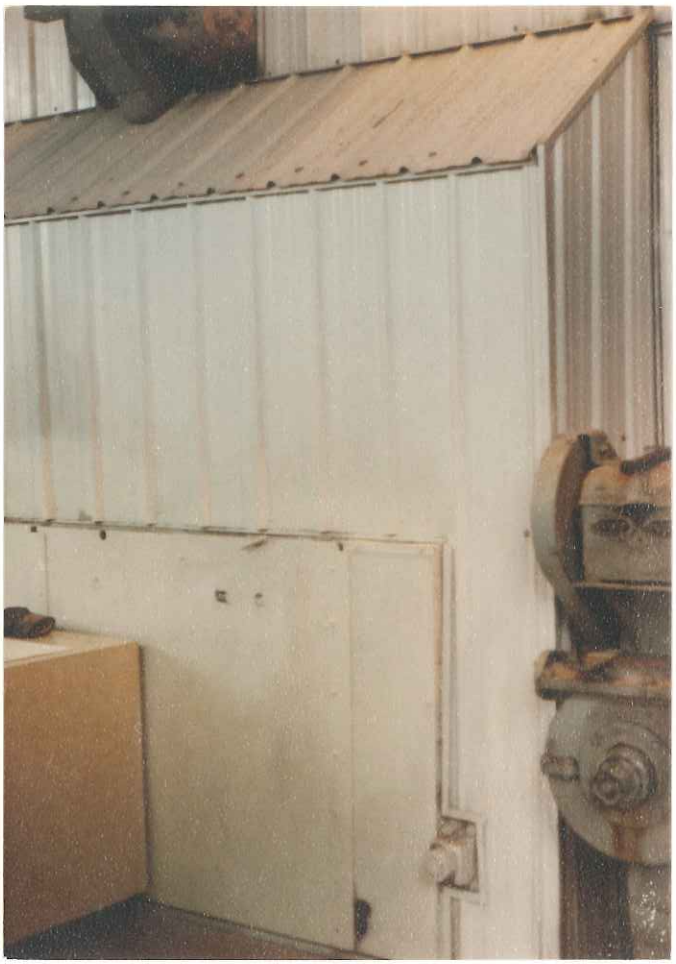
Photograph 1-1 Hoge Lumber, April 8, 1991

Looking northwest at Wood-Fired Boiler No. 4 (SWMU No. 17).

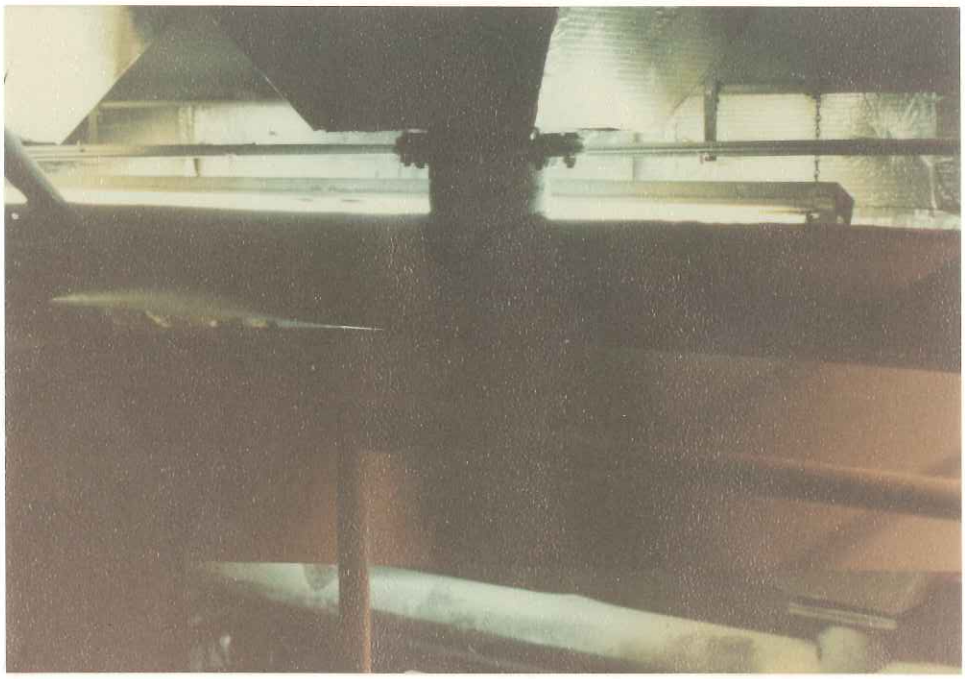
Photograph 1-4 Hoge Lumber, April 8, 1991

Looking northwest at the hopper and dropout point for the firebox grates which is part of the Wood-Fired Boiler No. 4 Ash Collection System (SWMU No. 4).

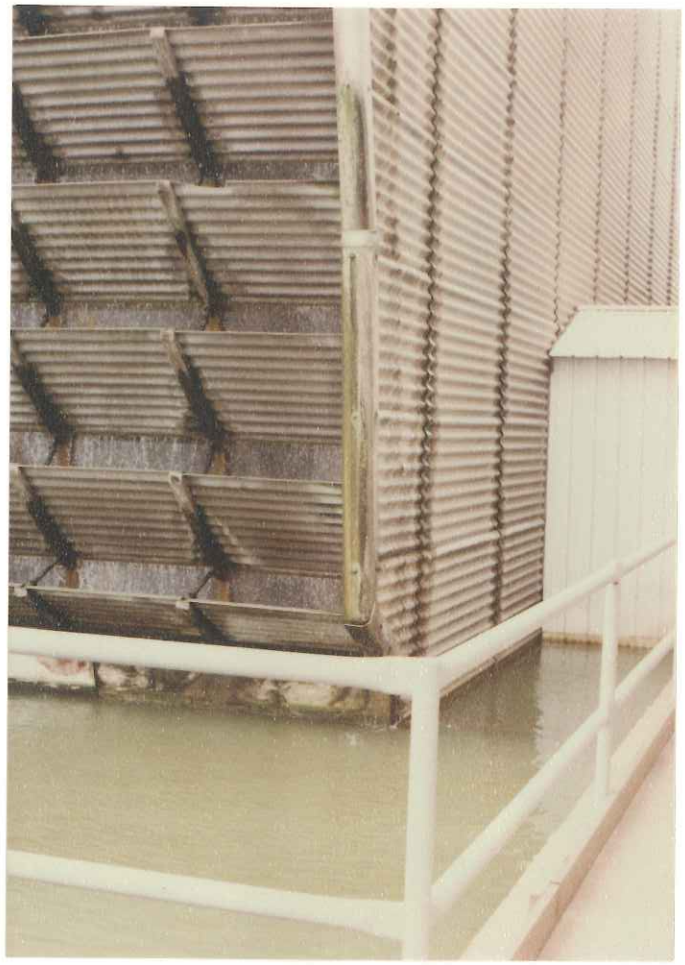
Photograph 1-5 Hoge Lumber, April 8, 1991

Looking west at the cooling tower for Wood-Fired Boiler No. 4 (SWMU No. 17).

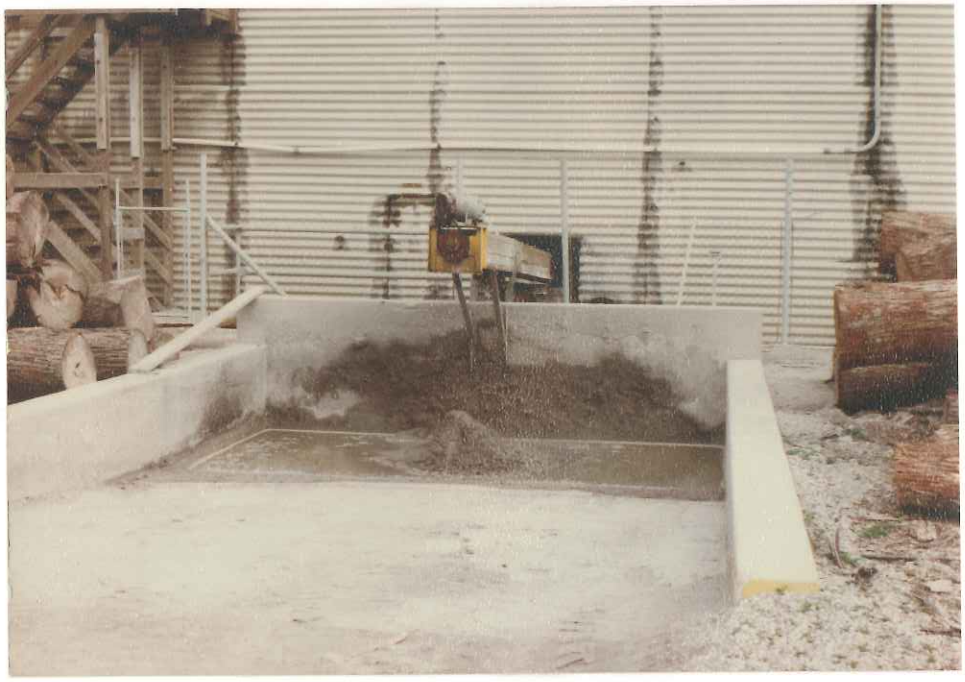
Photograph 1-6 Hoge Lumber, April 8, 1991

Looking North at the Wood Ash Loading Area (SWMU No. 5). The standing water in the unit is from precipitation. The unit has no outlet and the water is allowed to evaporate.

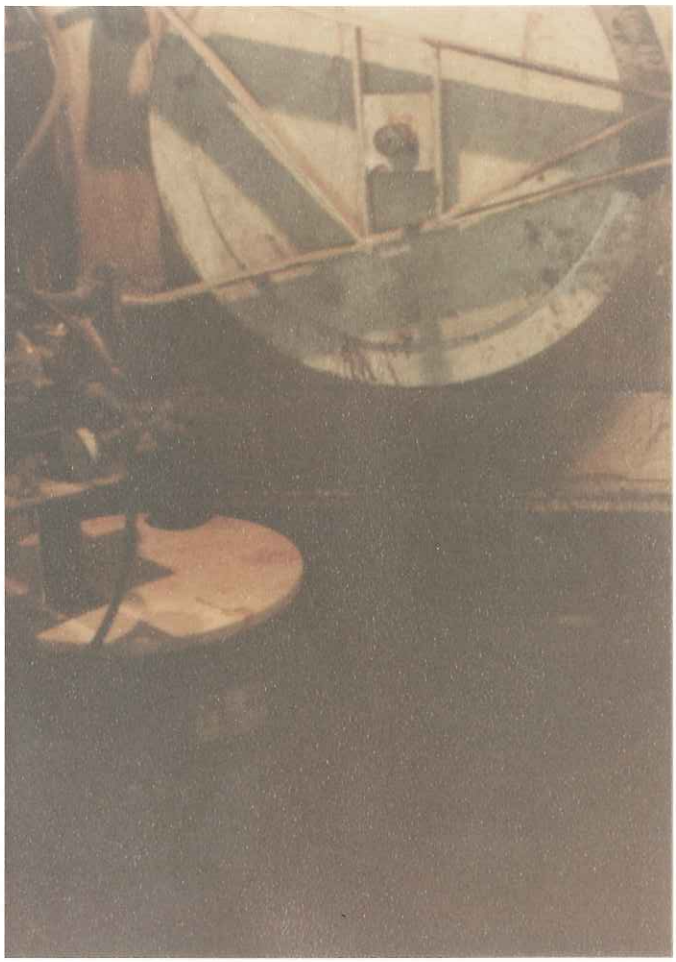
Photograph 1-11 Hoge Lumber, April 8, 1991

Looking south at the Nordson spray chamber used to apply a lacquer finish to final products.

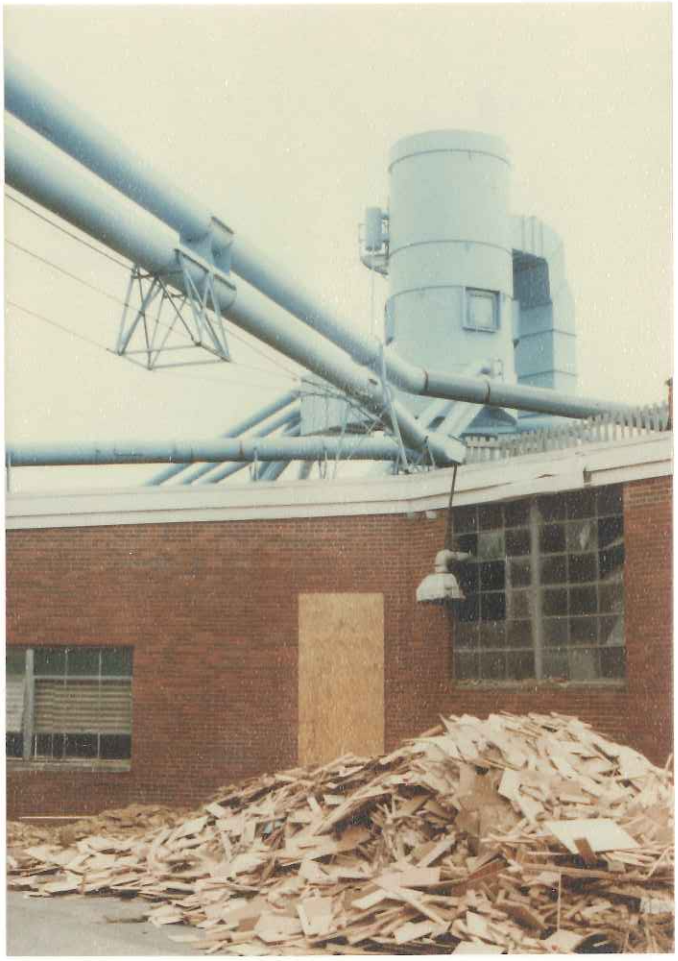
Photograph 1-18 Hoge Lumber, April 8, 1991

Looking southwest at the baghouse and piping for the Wood Parts Manufacturing Dust Collection System (SWMU No. 2).

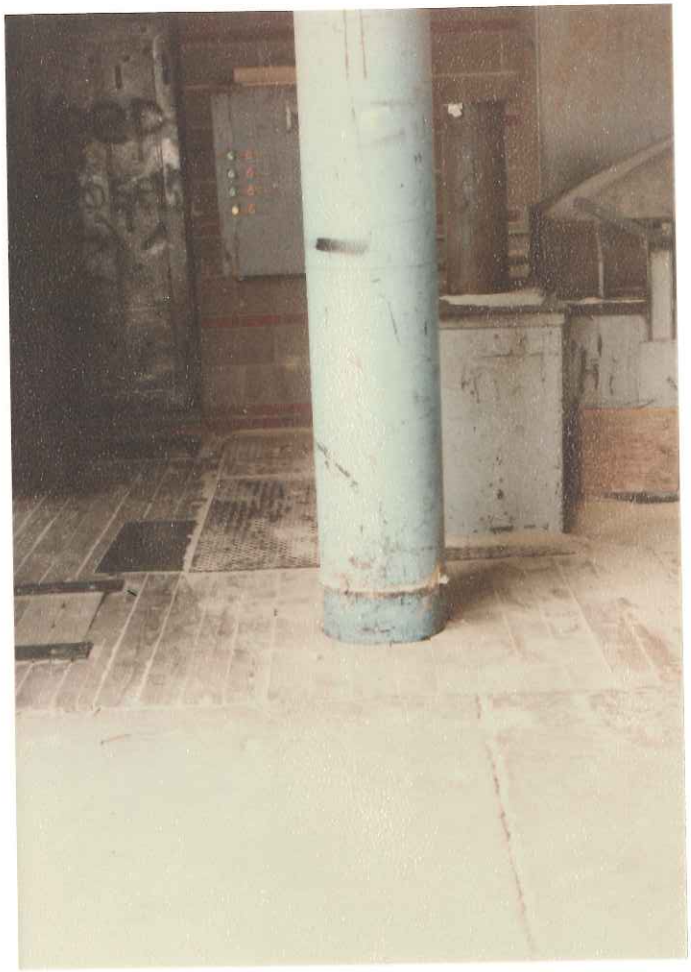
Photograph 1-19 Hoge Lumber, April 8, 1991

Looking north at the dropout for the Green Wood Sawmill Dust Collection System (SWMU No. 1) into the screw conveyor of the Wood Refuse Feed System and Silos (SWMU No. 3).

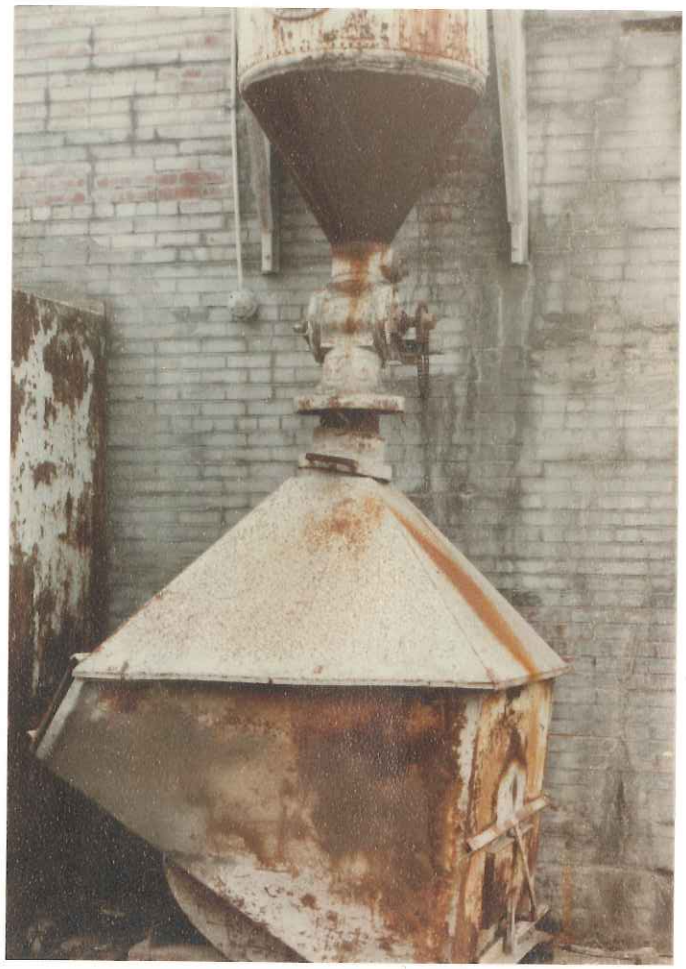
Photograph 1-20 Hoge Lumber, April 8, 1991

Looking southwest at the outdoor cyclone and hopper of the Former Wood-Fired Boiler Nos. 1 and 2 Flyash Collection System (SWMU No. 12).

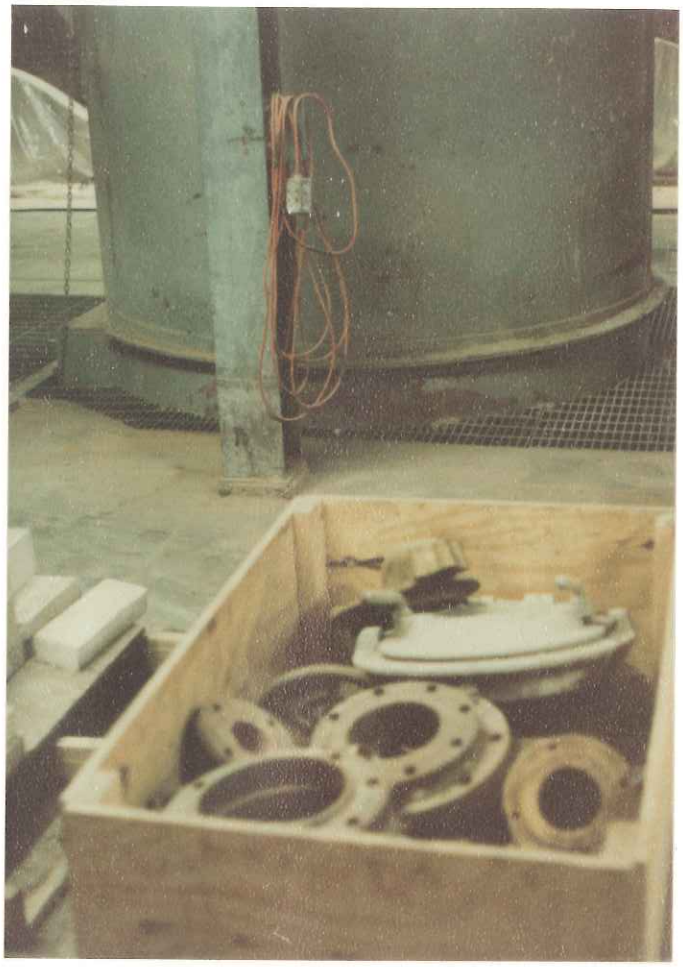
Photograph 1-22 Hoge Lumber, April 8, 1991

Looking south at the location of the Former Wood-Fired Boiler Nos. 1 and 2 (SWMU No. 16). Boiler No. 2 was located beneath Boiler No. 1.

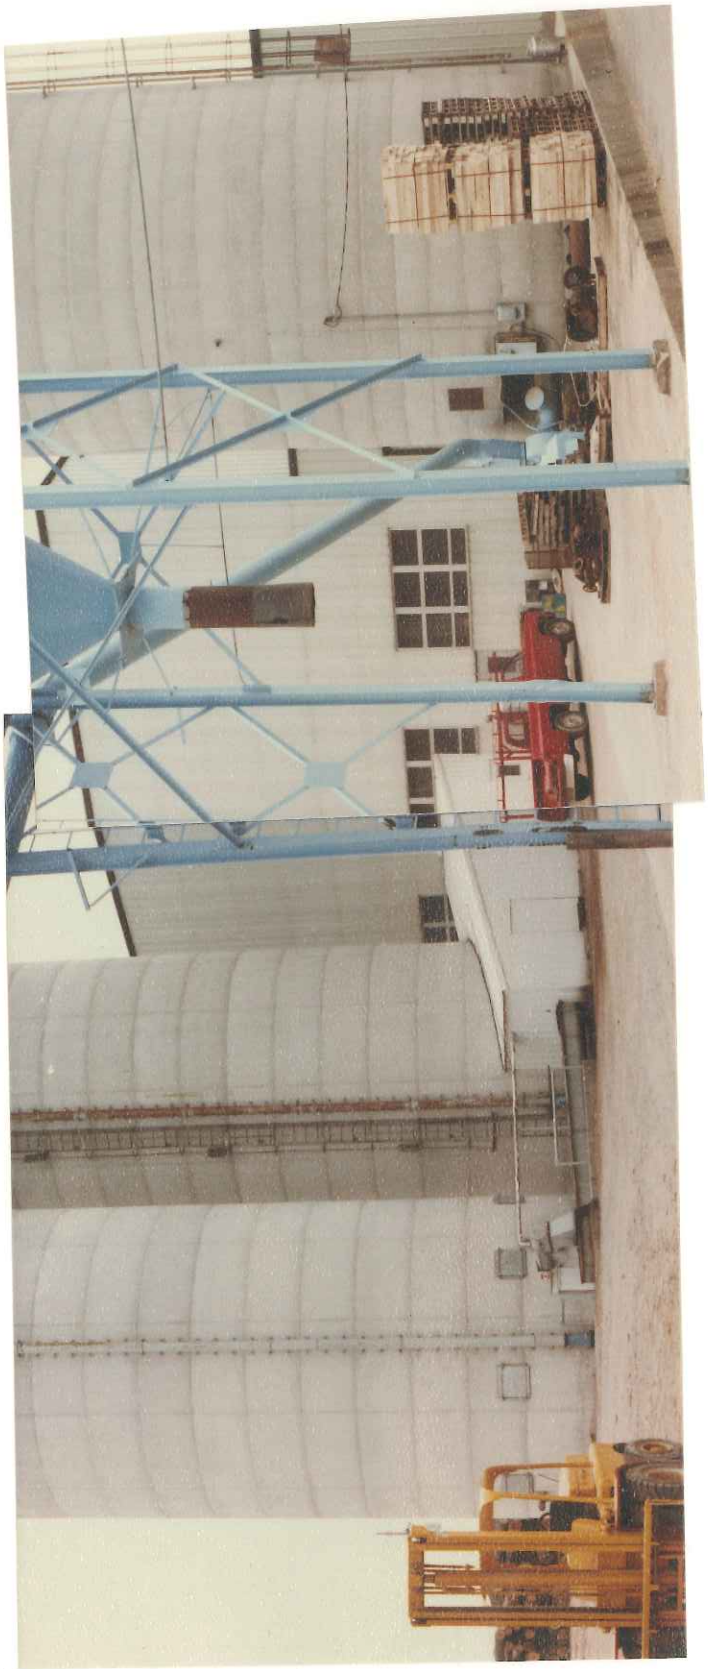
Photograph 1-23 and 1-24 Hoge Lumber, April 8, 1991

Looking southeast at the concrete storage silos which are part of the Wood Refuse Feed System and Storage Silos (SWMU No. 3).

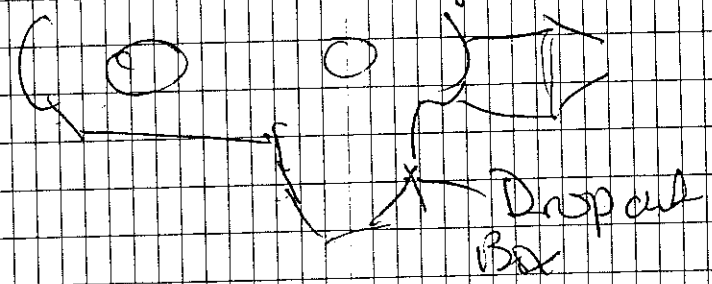
Photo 1-4
Looking Northwest
at the dropouts
for the Firebox
grate. and
the dropouts
for.
Steel into steel
pipes with screw
conyeros.
above concrete
Floor.

Drop out Breacher - Double

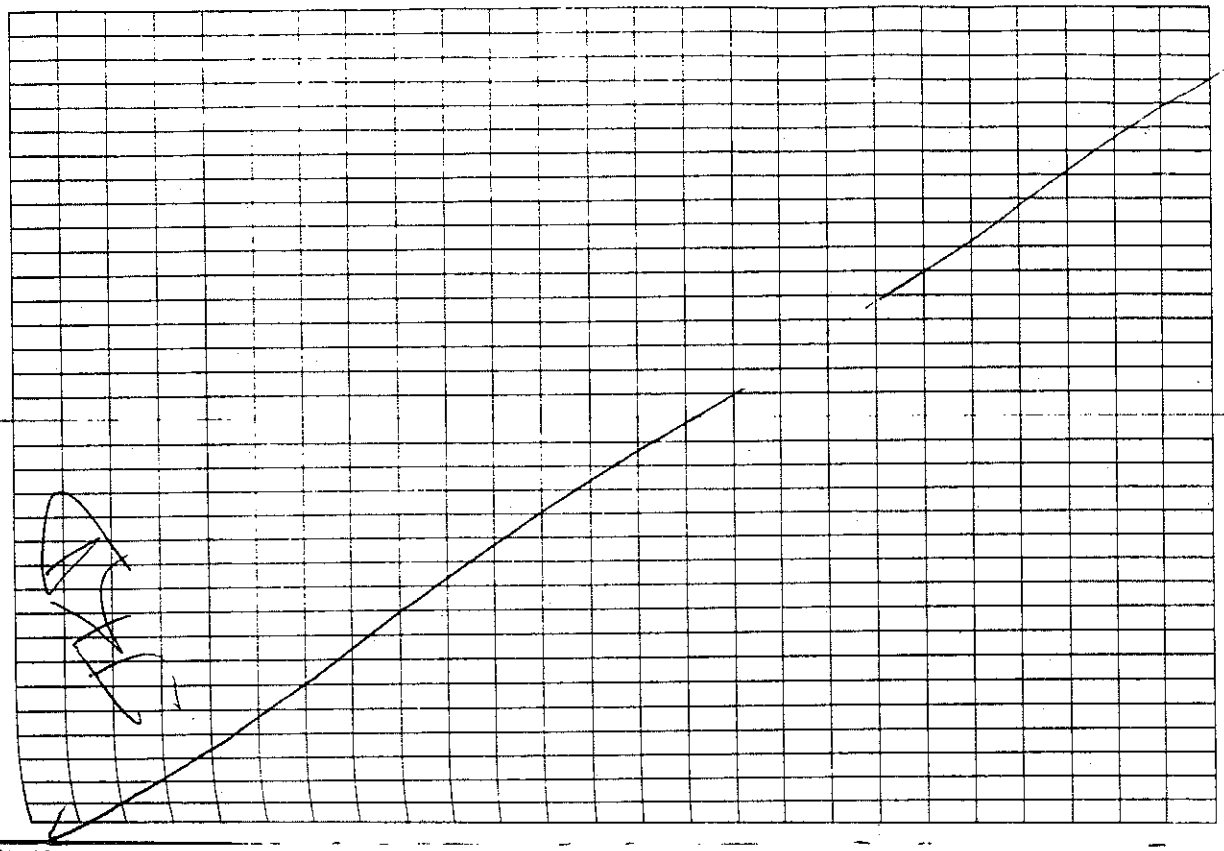
1-26( )
Area were solvent (lanquer
thinner was dumped.
