RE: Administrative Order on Consent Docket Number CWA-02-2015-3102 – Compliance with AOC Section VII, ¶70

Administrative Order on Consent
AES Puerto Rico Coal Fired Power Plant
Docket Number CWA-02-2015-3102
NPDES Tracking Number PRU020663

BMP Matrix Table

BMP's Implemented Detailed Photographs & Explanation

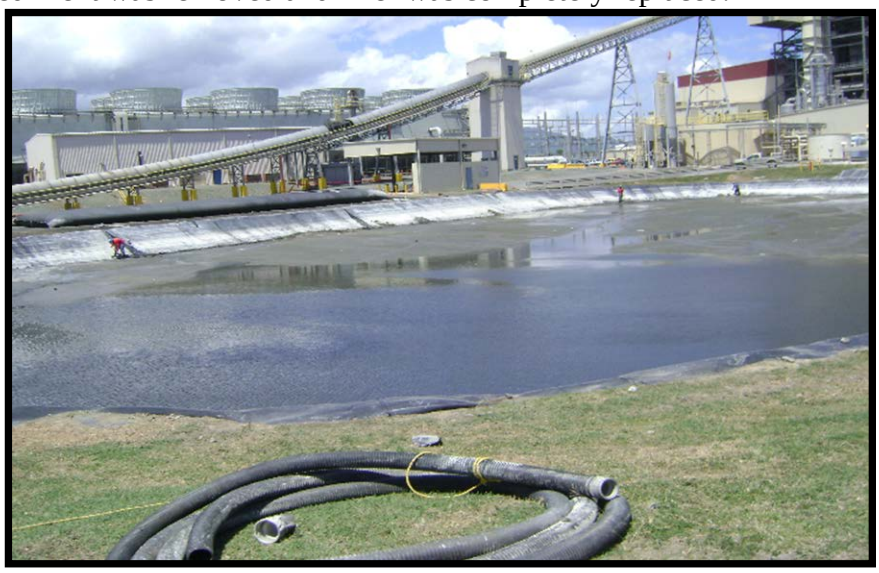
Action No: 37 Before

11- Action No.: 37
Subbasin: 16
Observation: Sedimentation in storm water pond
Proposed Action: As described on action No. 20 through 21
Actual Action: Installation of catch basin filters and routine inspection. Storm Water pond sediment was removed and liner was completely replaced.

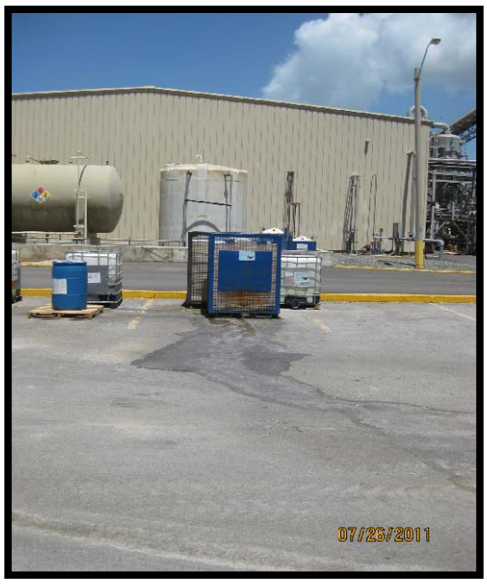
Action No: 45 - 46 Before

15- Action No.: 45 - 46
Subbasin: 5
Observation: Storage of chemical containers/vessels without secondary containment and exposed to rainwater
Proposed Action: Storage inside roofed areas of the Water Treatment Building
Actual Action: Storage inside roofed areas of the Water Treatment Building or secondary containment area.
