RE: Leaking Underground Storage Tank
Sac & Fox Truck Stop
1346 US Hwy 75
Powhattan, Kansas 66527

Here is a timeline of events and actions taken regarding the ruptured fuel tank at Sac and Fox Truck Stop. Attachment number 1 is a diagram of the Truck Stop and where tanks set on the property for reference.

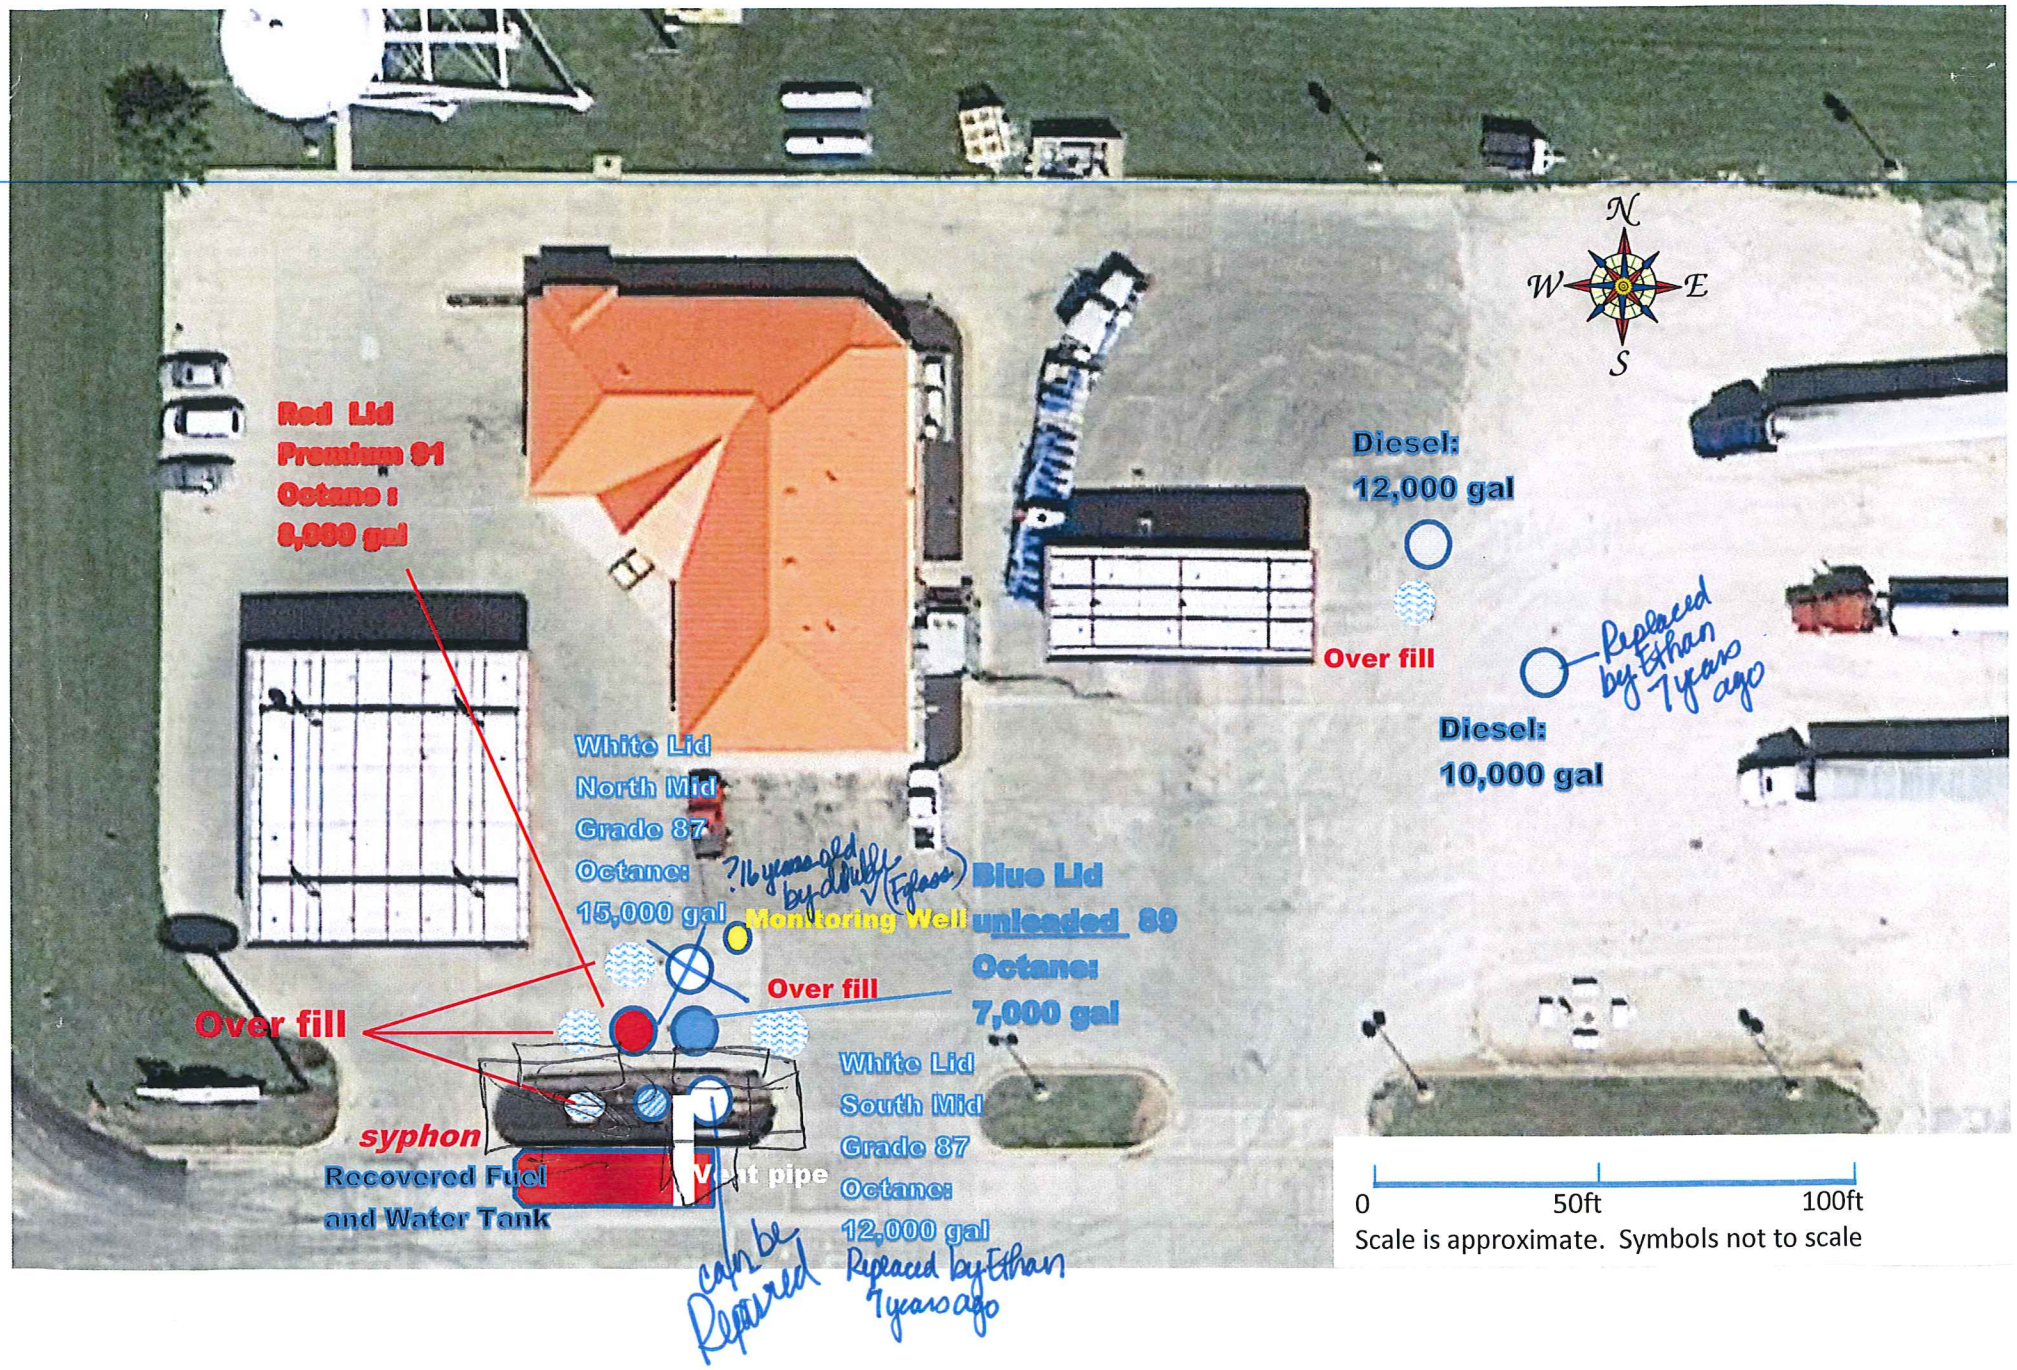
#1

The diagram below shows the location of tank failure at the Sac and Fox Truck Stop, 1375 US HWY 75. An estimated 1400 gallons of 87 octane gasoline (10%) ethanol remains unrecovered from the underground storage tank. 2 inches of gasoline remain suspended on approximately 60" of water in the monitoring well. It is assumed this relationship exists within the confines of the original tank enclosure. The water table is estimated to be 24-36 inches below the surface currently.

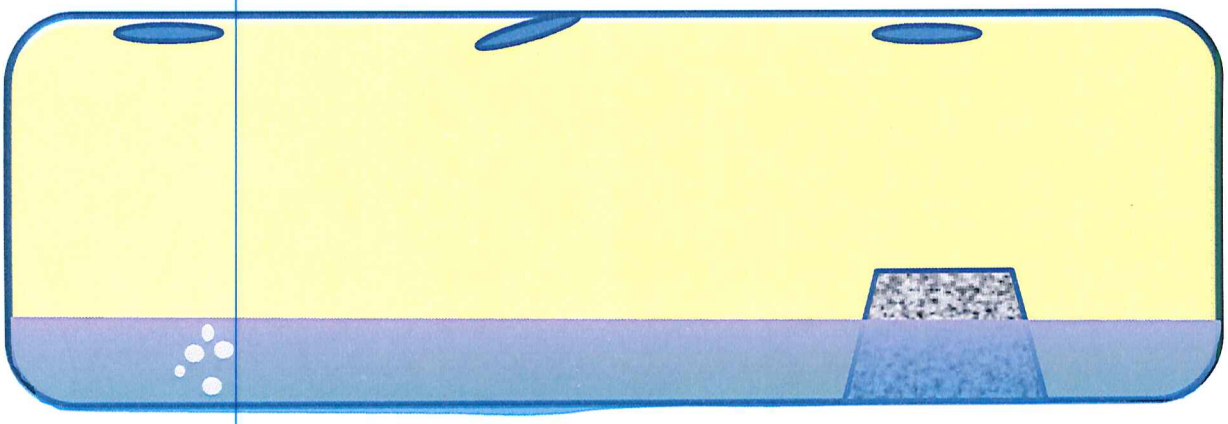
2

- July 27, 2015 Tankology Inc. comes to scope tanks and determine possible cause and damage. See attached diagram labeled 2. North midgrade tank is ruptured and south midgrade has a crack on top where vent pipe had been run over recently. South and north tanks are manifolded. Appears water pressure from excessive ground water caused pea gravel to erode, allowing tank to rupture.

White Lid North- Mid Grade 87 Octane

A simple diagram showing the pea gravel pile from the tank rupture and the separated riser in the tank. Bubbles and ripples were also noted at the west end.
