Interim Action Completion Report
Removal of Debris
232 Monroe Street
Saline, Michigan

USEPA ID No. MID980795512

Johnson Controls, Inc.
49200 Halyard Drive
Plymouth, MI 48170

22 January 2016

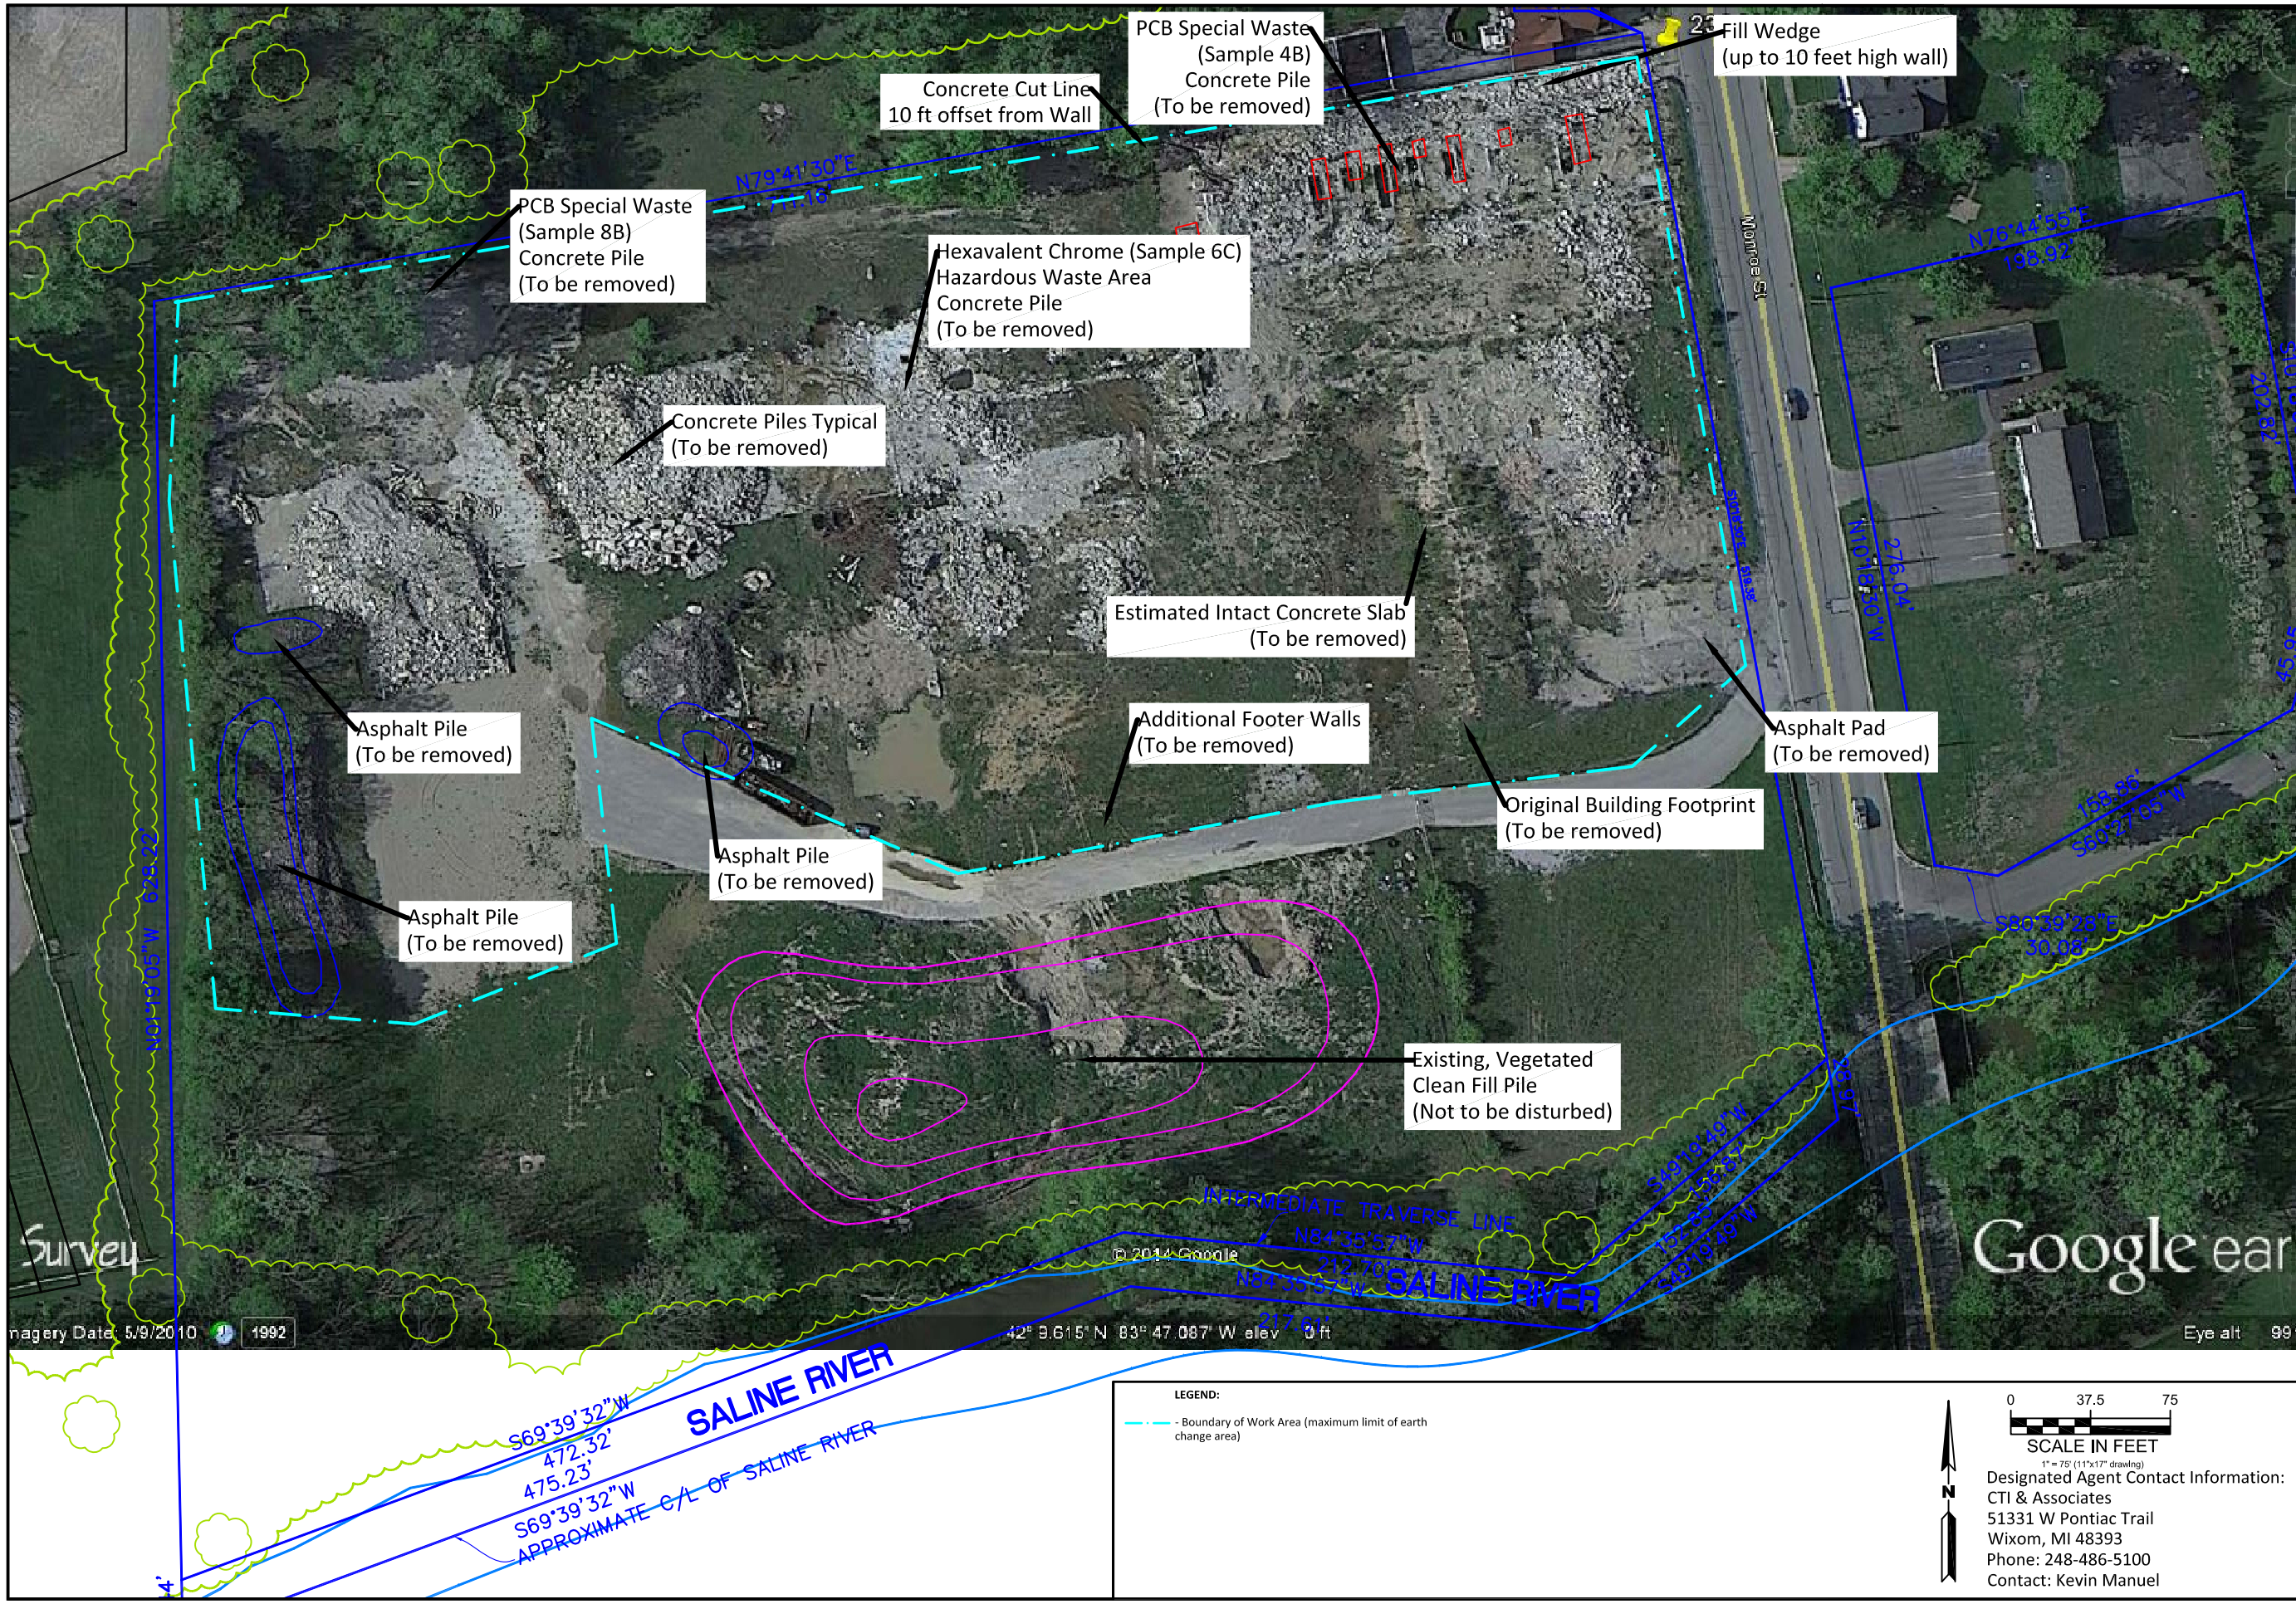
A visual representation of the Scope of Work can be found on Figure 2 – Debris and Slab Removal Map.

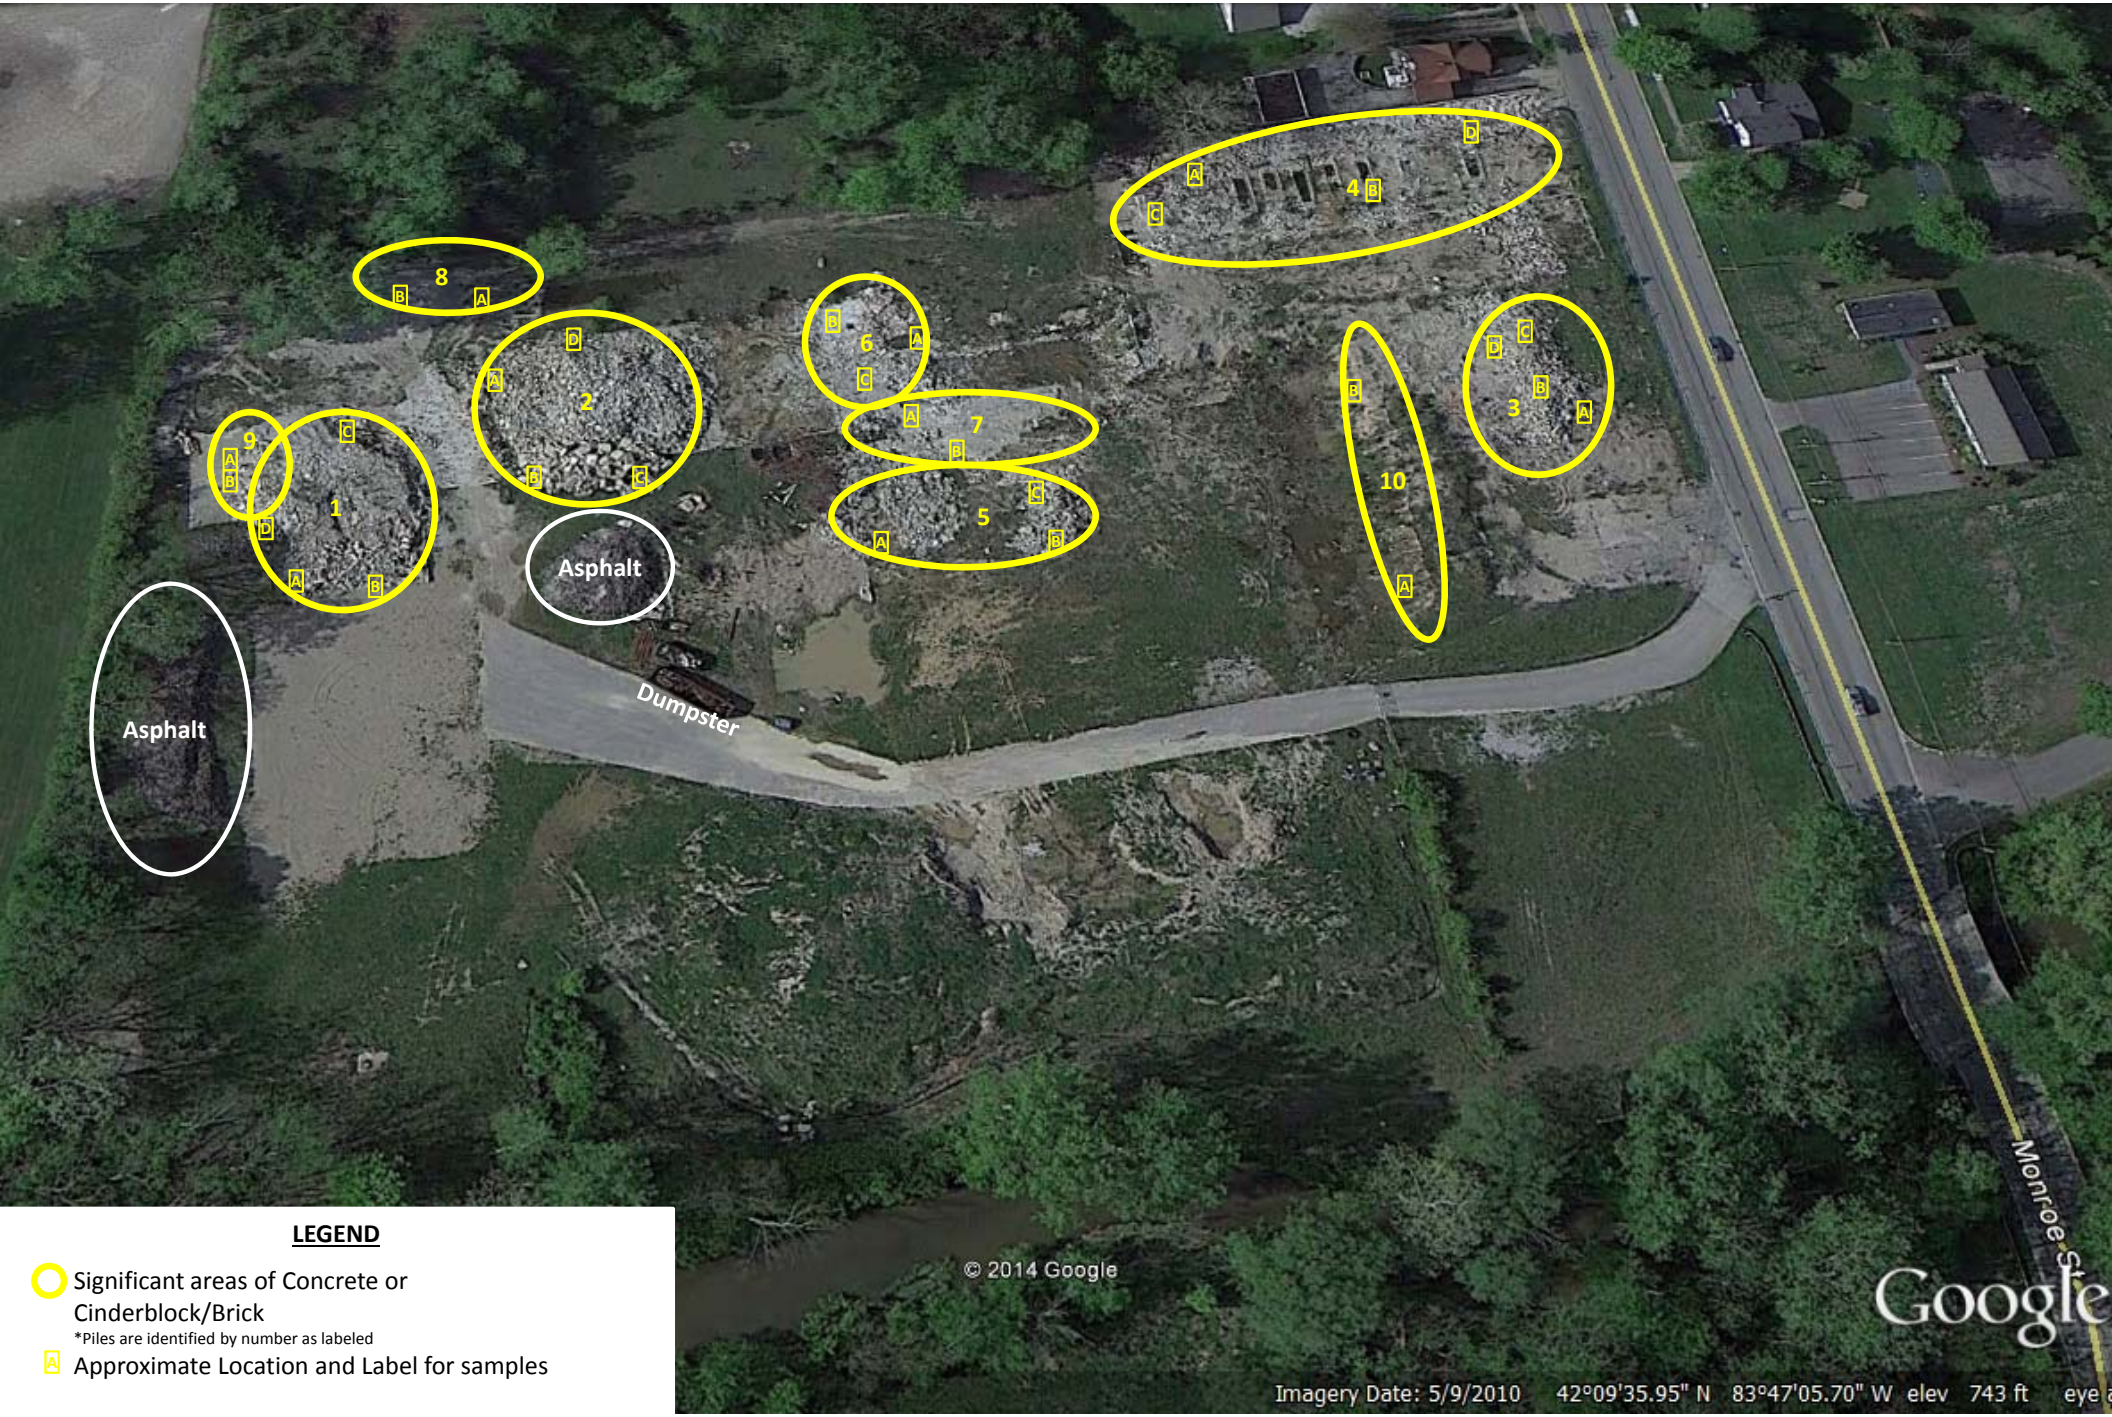
Figure 1 – Site and Sample Location Map

Site Evaluation
Upon arrival to the site, CTI walked through the entire site to visually inspect the location and relative size and type of debris. Ten (10) distinct areas of concrete debris were identified, as well as two (2) piles of asphalt debris. Debris locations are shown on **Figure 1**.

Samples from Areas 1, 2, 5, 6, 7, 8, and 9 were collected on October 9, 2014. Samples from Areas 3, 4, and 10 were collected on October 10, 2014. Approximate sample locations are shown on **Figure 1**. Sample descriptions and photolog of each location is included as **Attachment 1**.

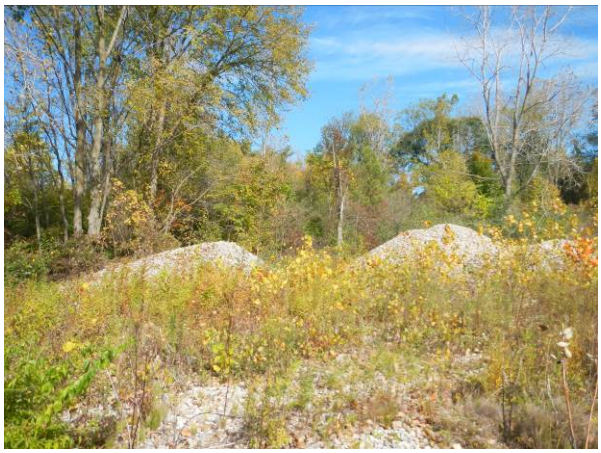
7A
Concrete collected from edge of floor slab on the side of a hole in the concrete in Area 7.

7B
Concrete with green discoloration collected from small pile on S side of Area 7.

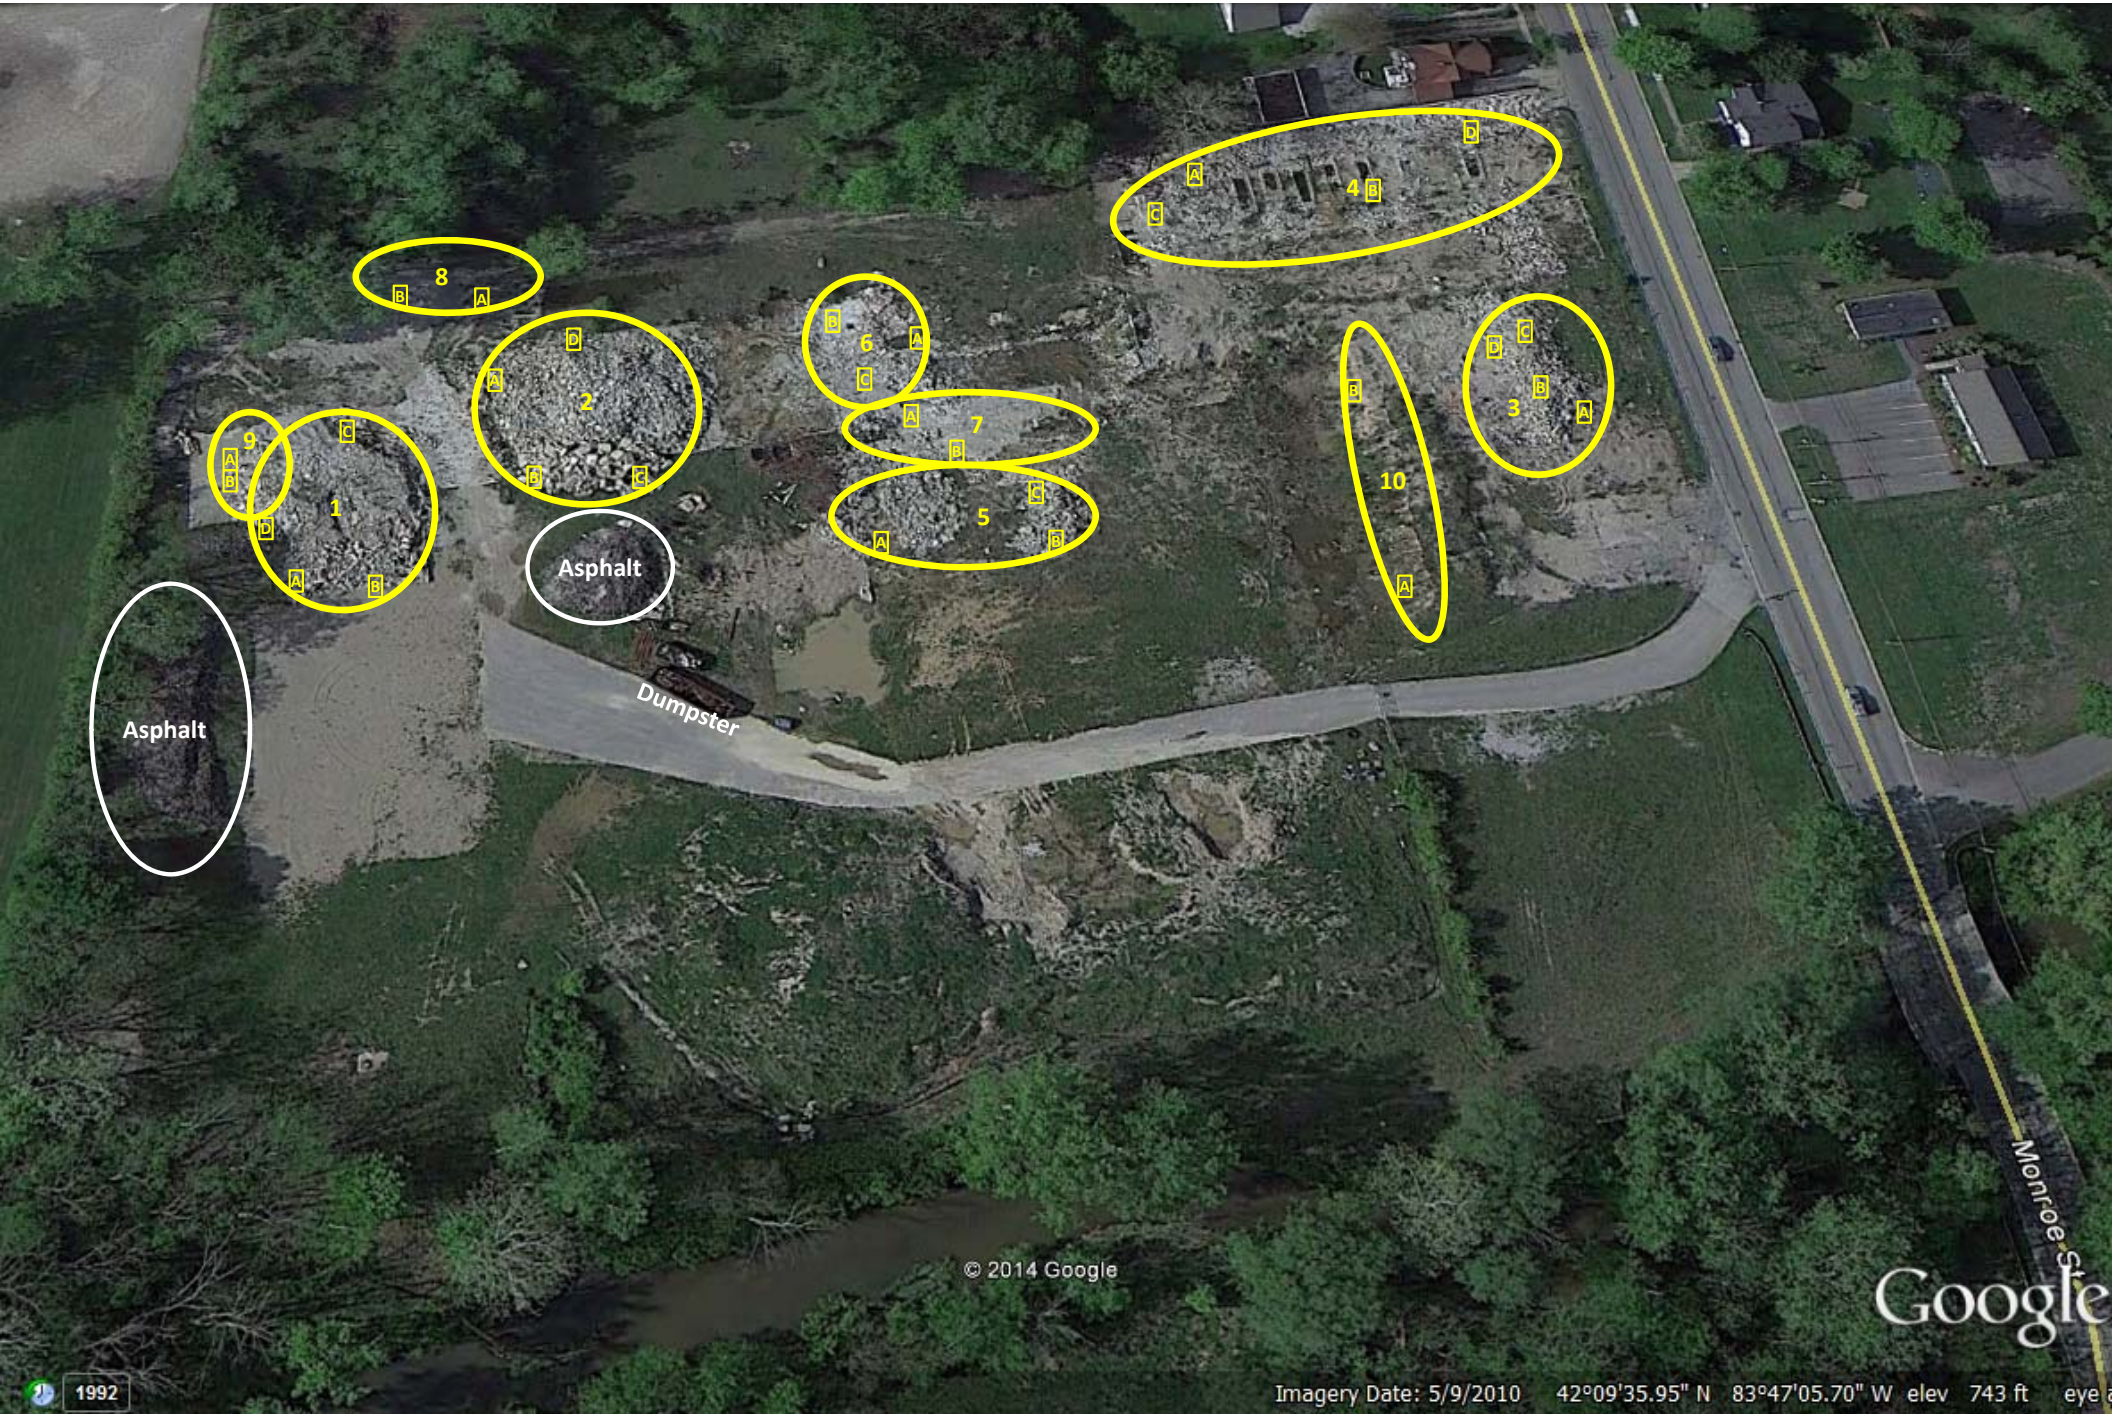
This report shall not be reproduced, except in full, without written authorization of TriMatrix Laboratories, Inc.
Individual sample results relate only to the sample tested.

1 (A) (B) (C) (D)
2 (A) (B) (C) (D)
3 (A) (B) (C) (D)
4 (A) (B) (C) (D)
5 (A) (B) (C)
6 (A) (B) (C)
7 (A) (B)
8 (A) (B)
9 (A) (B)
10 (A) (B)

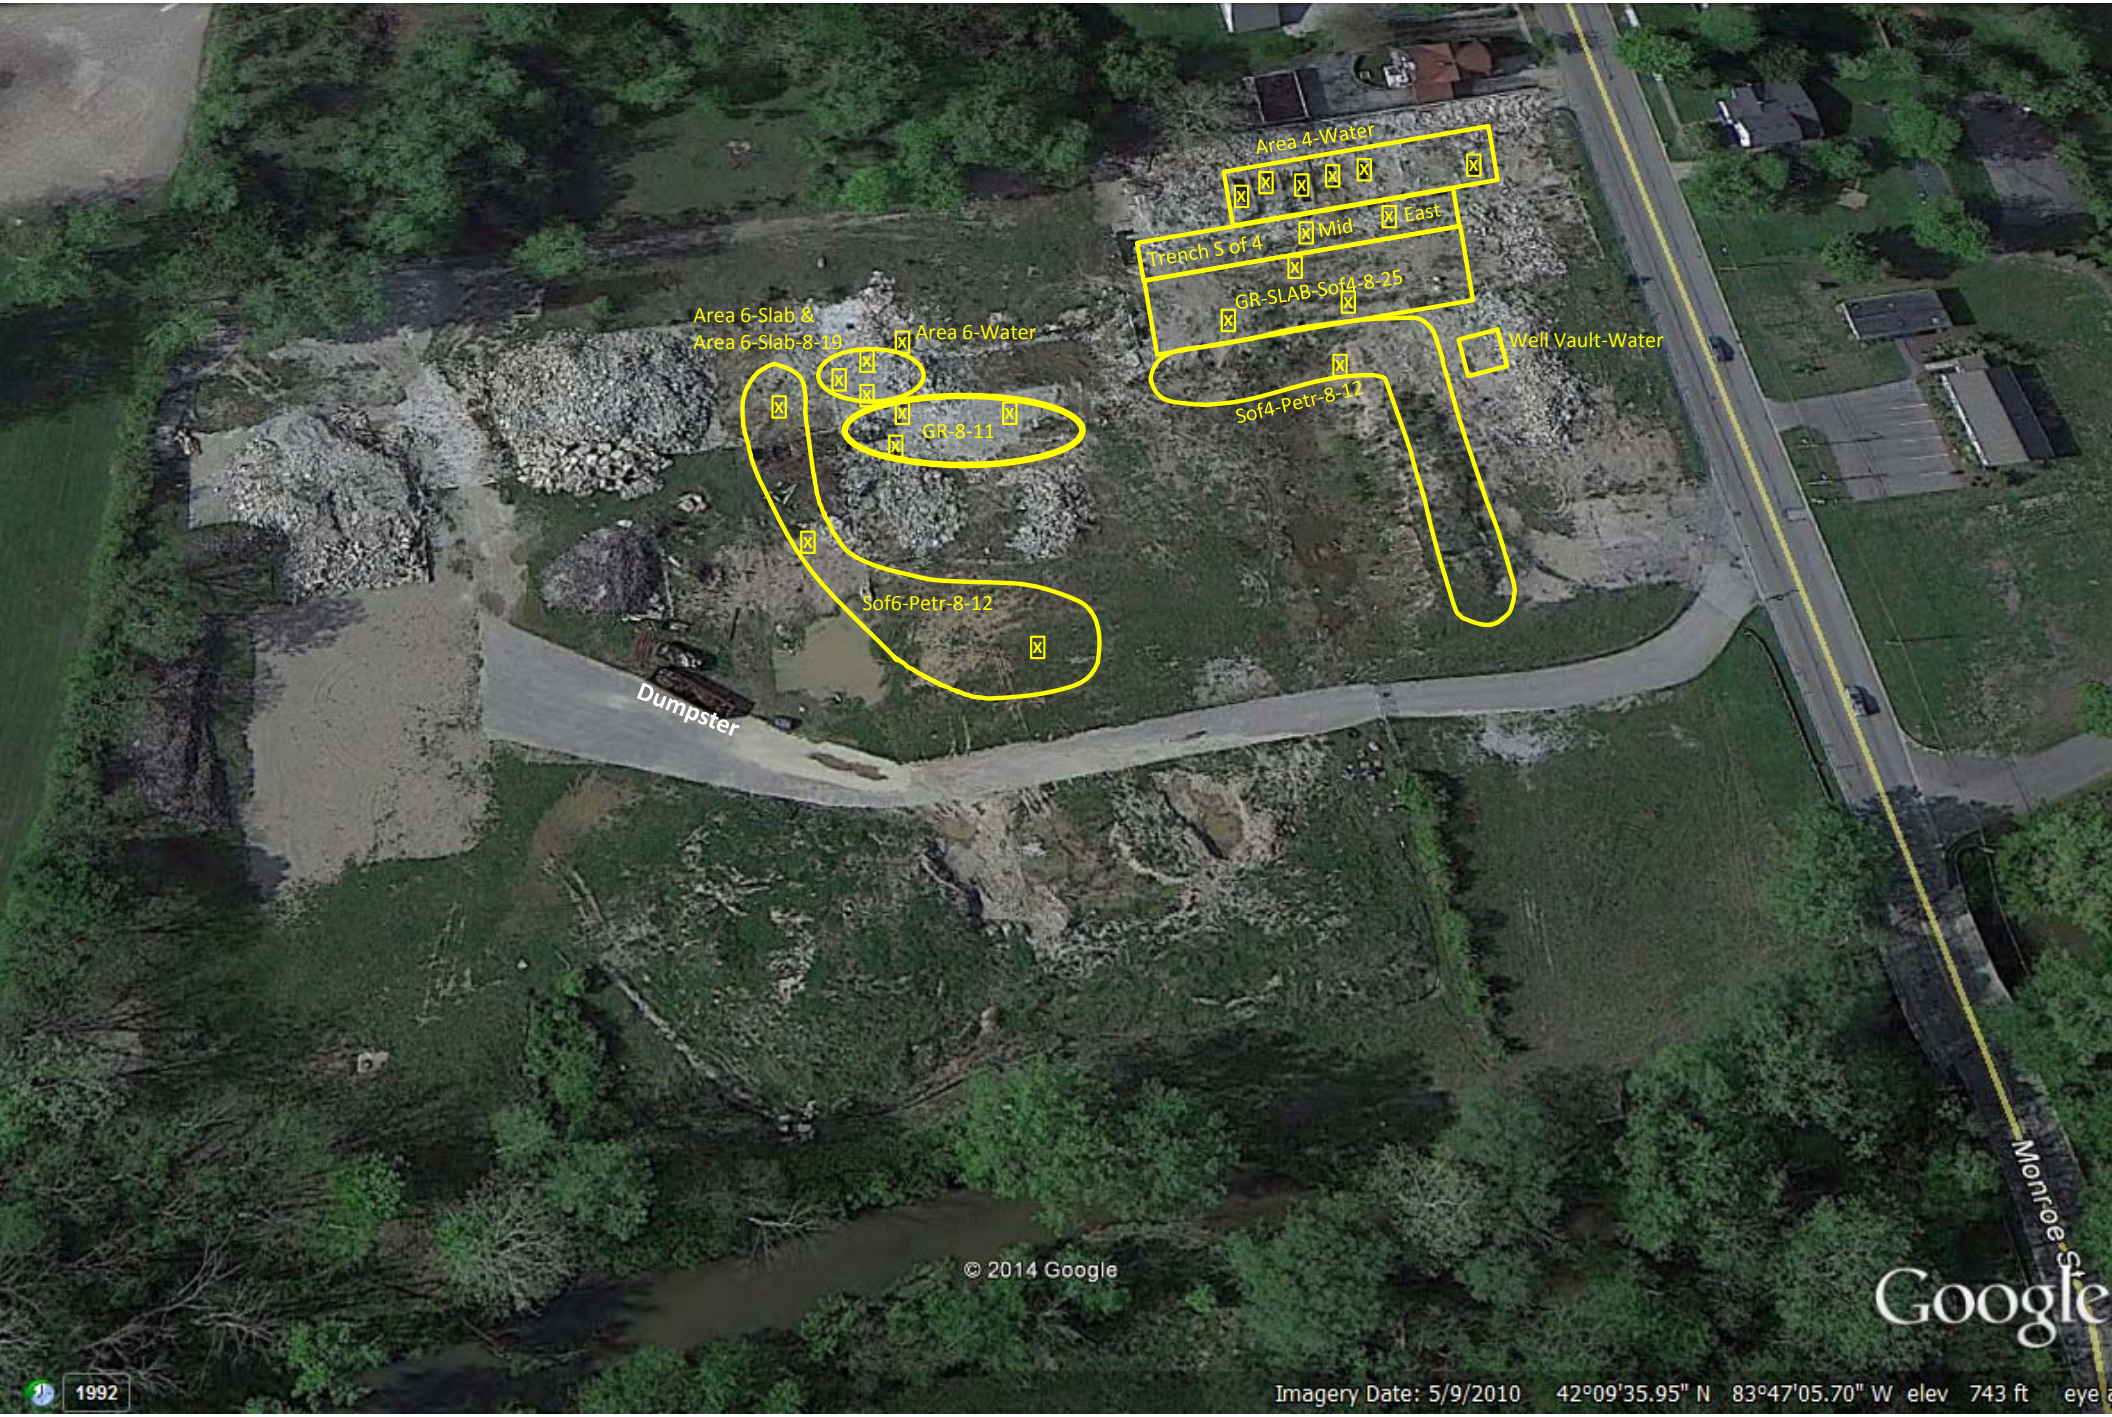
Sample Name	Sample Type	Sample Date	Sample Description
GR-8-11	Soil	8/11/2015	Composite sample from 3 locations within Area 7. Sample collected to test green discolored soil.
Area 6-Slab	Concrete	8/12/2015	Composite sample from 3 locations of slab under edge of Chromium impacted pile in Area 6.
Area 6-Water	Water	8/12/2015	Water from open concrete pit in area 6.
Area 4-Water	Water	8/12/2015	Composite sample, 150 ml from each of 5 water holding open concrete pits in area 4.
S of 4-Petr-8-12	Concrete	8/12/2015	Composite sample from pile. Sample collected to test black stained concrete with odor.
S of 6-Petr-8-12	Concrete	8/12/2015	Composite sample, 2 cups of crushed concrete from from each of 3 spoils piles. Sample collected to test black stained concrete with odor.
Area 6-Slab-8-19	Concrete	8/19/2015	Composite sample from 3 locations of slab under Chromium impacted pile in Area 6.
GR-SLAB-Sof4-8-25	Concrete	8/25/2015	Composite sample from three locations on green stained concrete slab.

Well Vault - Water	Water	8/28/2015	Water (with free product layer) from uncovered brick well vault.
Trench-Sof4-East	Concrete	9/1/2015	Sample from near east end of concrete trench found just south of the PCB affected area.
Trench-Sof4-Mid	Concrete	9/1/2015	Sample from middle section of concrete trench found just south of the PCB affected area.

Area 4-Water (8/12/15)
Area 6-Water (8/12/15)
Area 6-Slab (8/12/15)
Sof6-Petr-8-12 (8/12/15)
Sof4-Pert-8-12 (8/12/15)
GR-8-11 (8/11/15)
Area 6-Slab-8-19 (8/19/15)
GR-SLAB-Sof4-8-25 (8/25/15)
Well Vault - Water (8/28/15)
Trench-Sof4-East (9/1/15)
Trench-Sof4-Mid (9/1/15)
