REQUESTS FOR APPROVAL OF TSCA RISK-BASED MANAGEMENT OF PCB REMEDIAITON WASTE AT PS199M AND 309K

REQUEST FOR APPROVAL OF TSCA RISK-BASED MANAGEMENT OF PCB REMEDIATION WASTE AT P.S. 199M

NEW YORK CITY SCHOOL CONSTRUCTION AUTHORITY

October 17, 2016

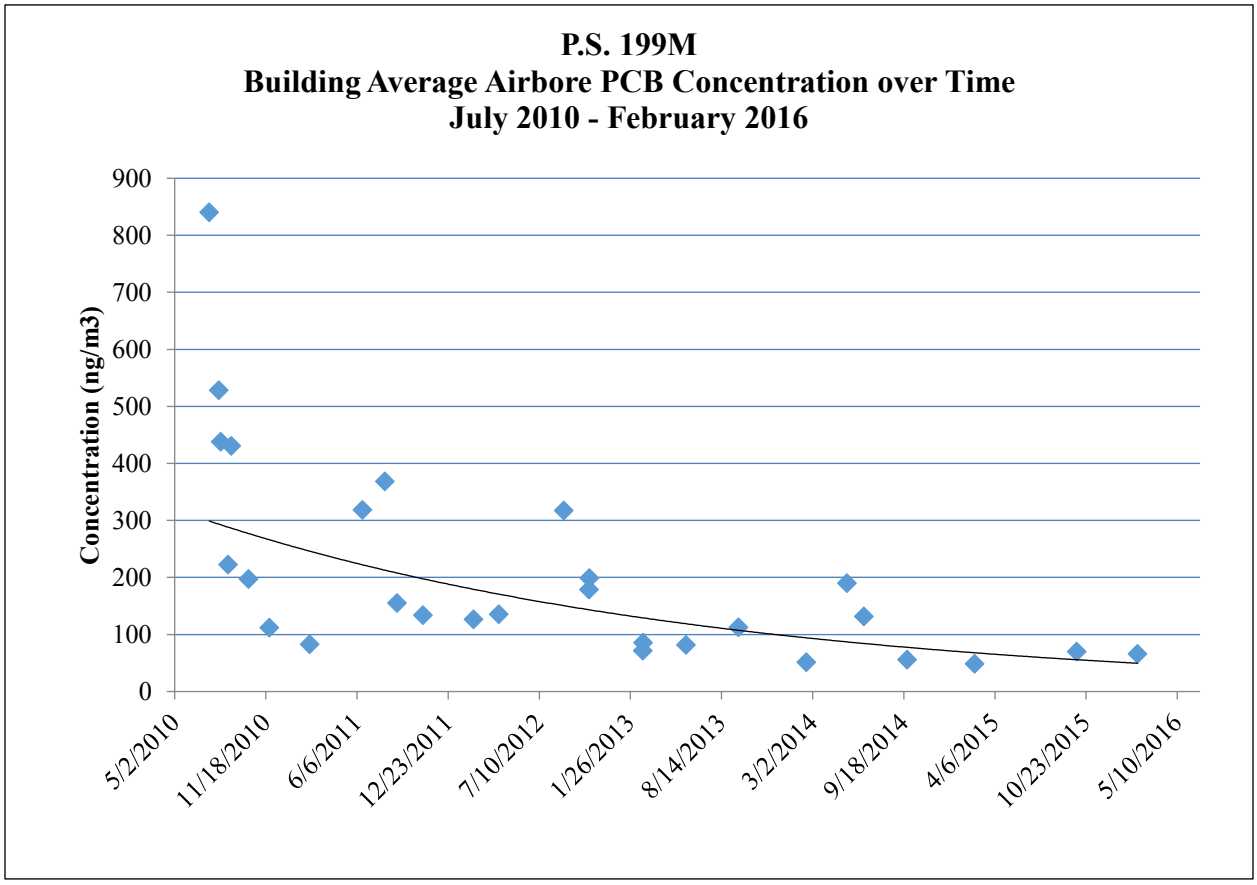
Figure 5.1

Based on the data presented, the potential human exposure to PCBs via dermal absorption, ingestion, and inhalation from the PCB remediation replacement caulk left in place is considered very low.

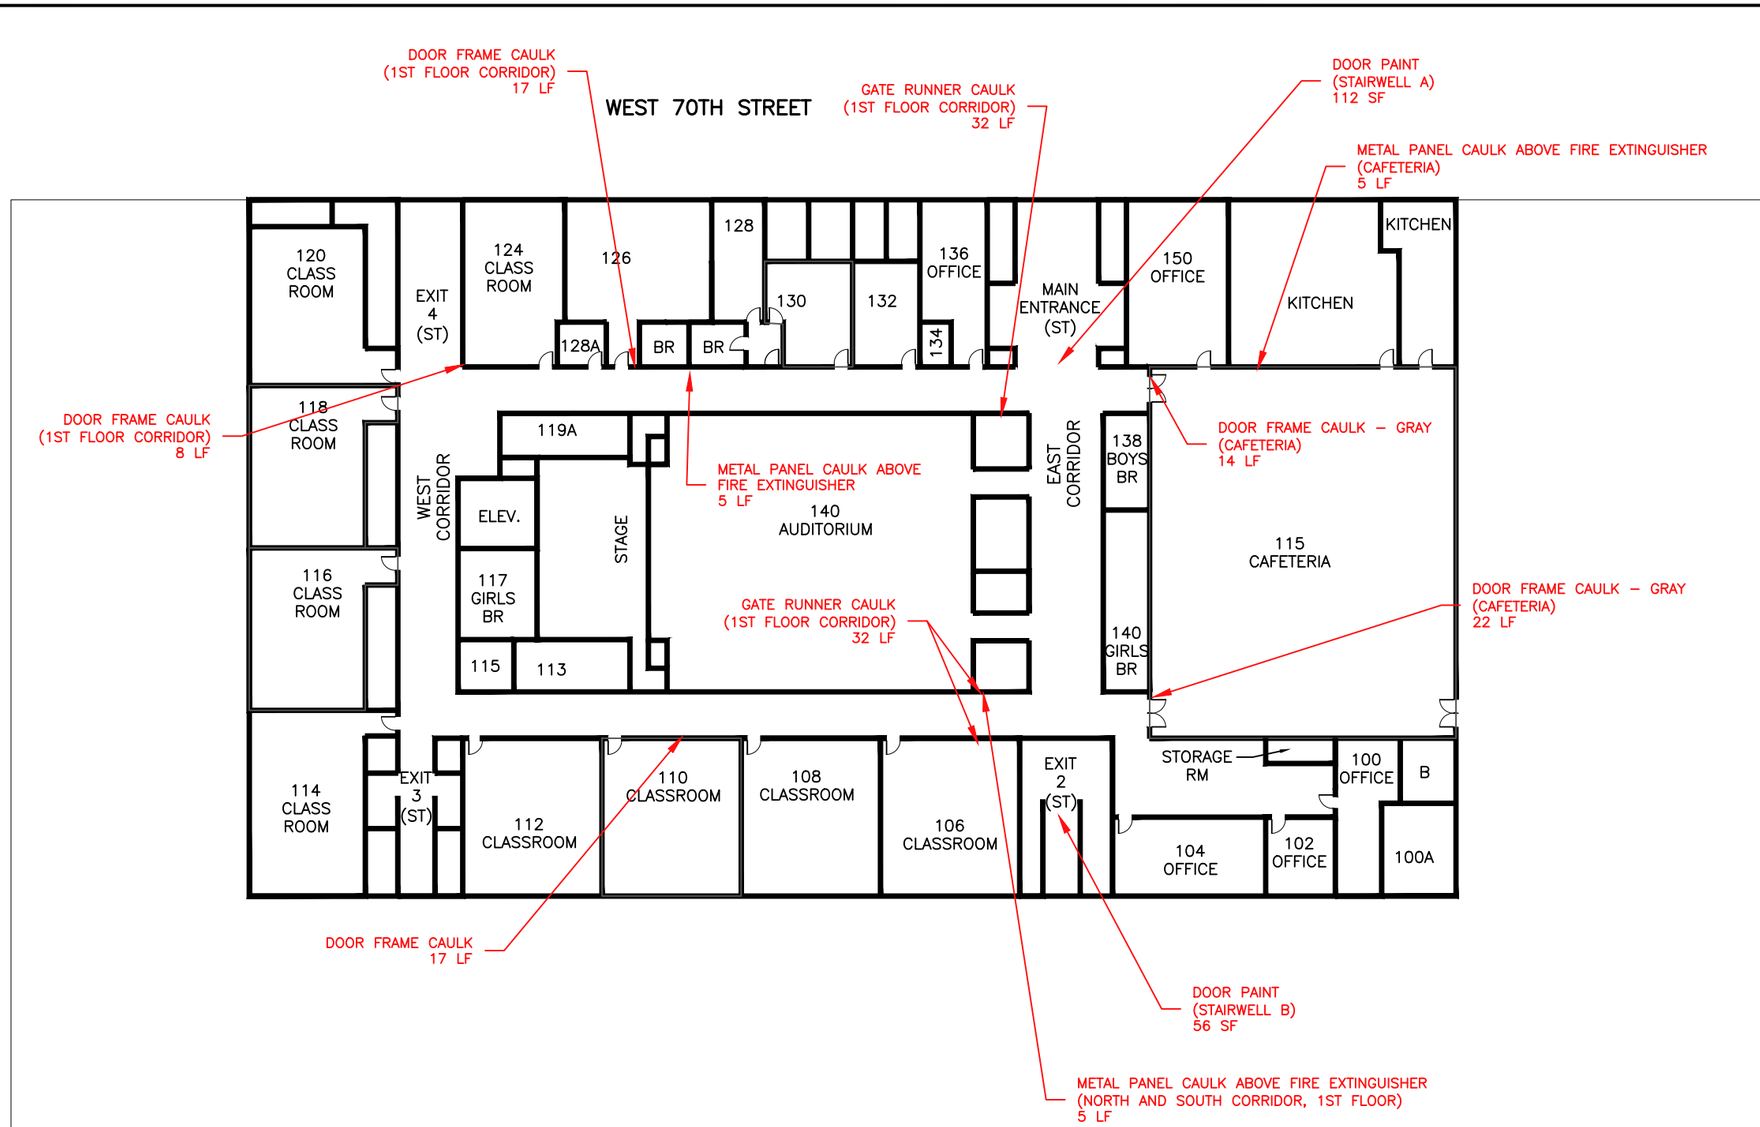
FIGURE
1A

Bulk Material Description	Floor	Room/ Location	Approximate Quantity (linear feet – except where noted)
Blue Exit Doors (Orange undercoating) - PCB Containing Paint	1	Stairwell A (2 doors) and Stairwell B (1 door)	168 SF
Door Frame Caulk	1	Cafeteria	36
Metal Panel Caulk above Fire Extinguisher	1	Cafeteria	5
Door Frame Caulk	1	1st Floor Corridors	42
Gate Runner Caulk	1	1st Floor Corridors	64
Metal Panel Caulk above Fire Extinguisher	1	1st Floor Corridors	10
		Total	325

All identified PCB Remediation Waste materials containing greater than 500 ppm PCBs (caulks and door paint) will be removed utilizing abatement work practices and engineering controls to limit the potential release of PCB dust/debris. Please refer to Tables 4A and 4B, in Appendix A, for a list of identified materials, and Figures 1A through 1G, in Appendix B, for additional details. The work will be performed by a specialty contractor utilizing workers afforded appropriate hazard communication training and under the observation of an appropriately educated and trained third party (field inspector) who will monitor compliance with appropriate removal techniques and confirm thorough removal of identified materials through visual inspection. The contractor shall provide all labor, equipment and materials complete for performance of the work. Work shall generally conform to NYCSCA Specification Section S01900 for Existing Premises Work, and be performed in accordance with this Scope of Work and NYCSCA Specification Section 02082 - PCB-Containing Caulk Removal Work.

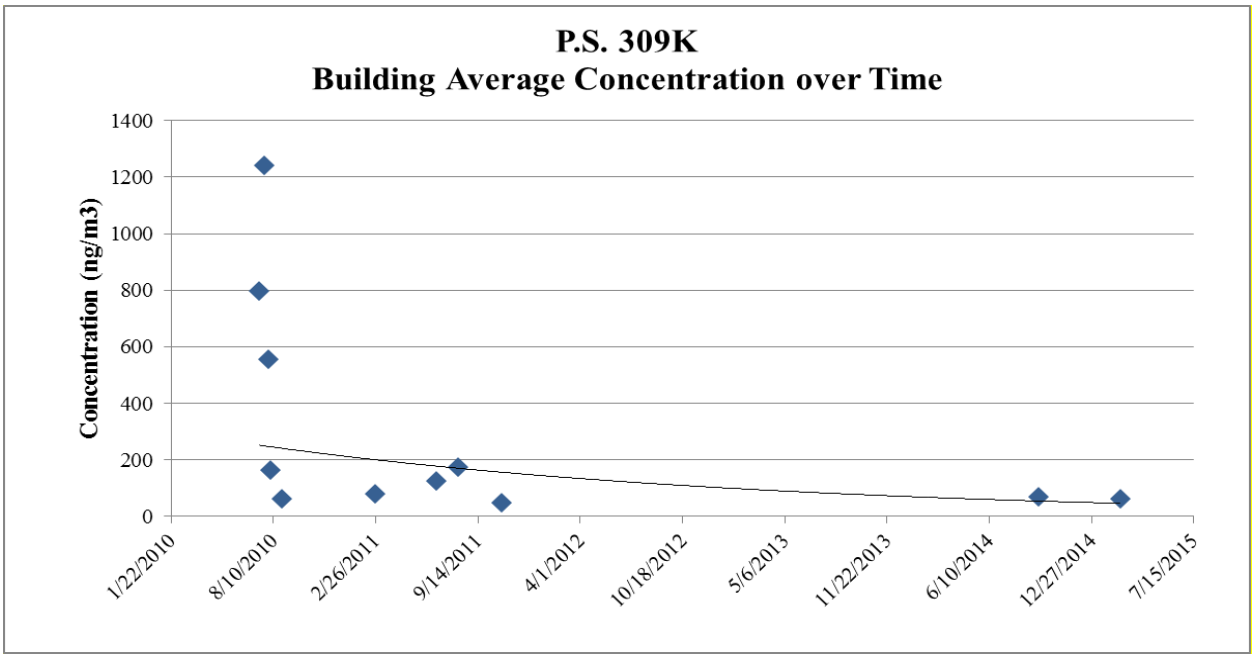
Figure 5.1

Based on the data presented, the potential human exposure to PCBs via dermal absorption, ingestion, and inhalation from the PCB remediation replacement caulk left in place is considered very low.
