Location 33 Hampton House Rd Date 10/31/13

Project / Client Spartan 01 Hampton

Location 660 River Rd, Edgewater Date 11/1/13

Project / Client Daibes Edgewater

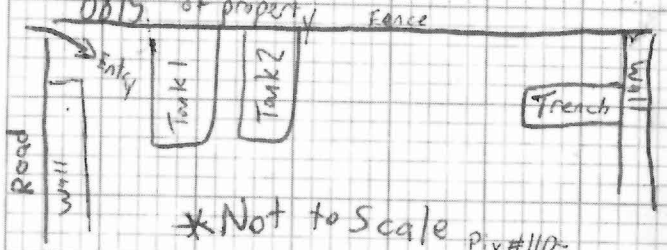
*Not to Scale

110-0814 Unusual trench in corner

0815 of property
