EAST MAMM CREEK PROJECT DRILLING AND CEMENTI NG STUDY

CRESCENT CONSULTING, LLC
REED ENERGY CONSULTI NG, LLC
ROGE, LLC

JUNE 20 , 2011

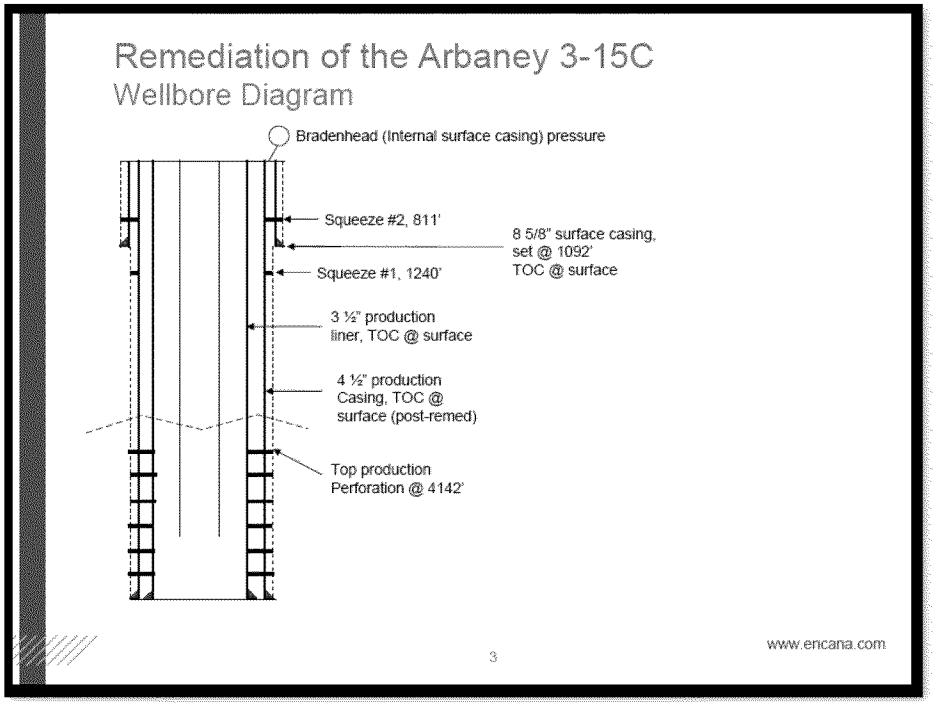
The well exhibited 450 psi Bradenhead pressure within a few days after the production casing cementing operation, and subsequently, gas bubbling was observed in the soil at the surface near this well. Upon further investigation, all of the wells on the pad, with the notable exception of the Magic 10-2, have exhibited elevated Bradenhead pressures, and both Arbaney wells have gas bubbling in the soil outside the surface casing. Additionally, two water wells in the immediate vicinity of the P3 Pad have been impacted with methane gas. The Arbaney 3-15C well was remediated with cement squeeze jobs performed at 1,240 feet and 811 feet. A full-string 3-1/2 inch liner was installed and cemented to surface prior to commencing stimulation operations. This well continues to have Bradenhead pressures trending slowly higher when shut-in. However, the well is currently being vented to mitigate Bradenhead pressure buildup.

Remediation of the Arbaney 3-15C
Wellbore Diagram
Bradenhead (Internal surface casing) pressure
Squeeze #2, 811'
8 5/8" surface casing, set @ 1092' TOC @ surface
Squeeze #1, 1240'
3 ½" production liner, TOC @ surface
4 ½" production Casing, TOC @ surface (post-remed)
Top production Perforation @ 4142'
3
www.encana.com

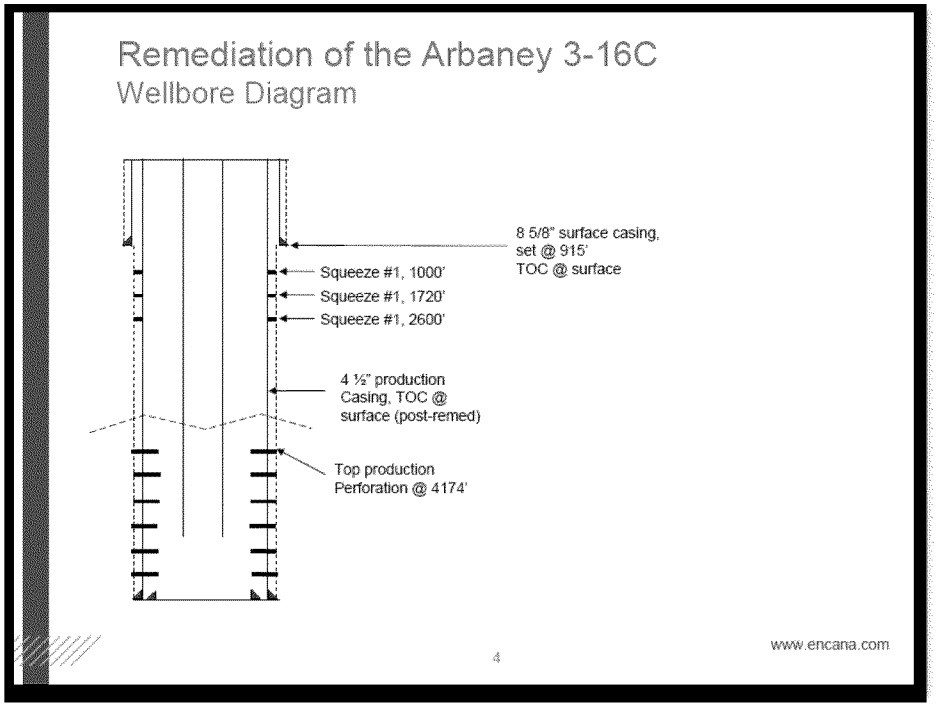
Remediation of the Arbaney 3-16C
Wellbore Diagram
8 5/8" surface casing, set @ 915' TOC @ surface
Squeeze #1, 1000'
Squeeze #1, 1720'
Squeeze #1, 2600'
4 ½" production Casing, TOC @ surface (post-remed)
Top production Perforation @ 4174'
4
www.encana.com

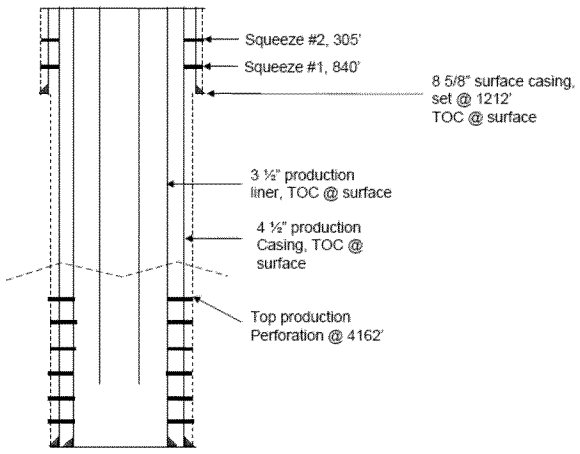
Remediation of the Magic 10-2
Wellbore Diagram

The Magic 10-2 was drilled in early March 2004. The surface casing drilling and cementing operations were uneventful. A FIT was performed at the surface shoe of 1,212 feet, but the data was not found in the well records. The well was drilled in an "underbalanced" mode. On March 8, 2004, the rig noted elevated gas levels in the drilling mud returns at

approximately 3,300 feet. Mud returns, which had been flowing to the pit, were switched to the return lines through the gas buster[1]. This operation is normal practice when gas is observed in the mud system. However, a risk with this procedure is the potential for drill cuttings to plug the return lines, flow lines and chokes. Apparently, on March 9, 2004 some of the drill cuttings plugged the flow lines and choke system, resulting in an unanticipated pressure buildup in the surface equipment and the borehole. This pressure buildup and subsequent pressure release is hereinafter referred to as the "Arbaney Event". With the flow lines and chokes plugged, there was no place for the gas to be released, so pressure built on the annulus between the drill pipe and surface casing, as well as the open hole section below, for a period of not more than four (4) hours.

The remainder of the well was drilled underbalanced without further incident. The production string was run and cemented as planned, however cement was not circulated back to surface. The well had two squeeze jobs performed on the production casing, above the surface casing shoe at depths of 840 feet and 305 feet to mitigate high Bradenhead pressure, which was apparently observed shortly after completion of the primary cement job on the production casing. The cement remediation resulted in a consistent Bradenhead pressure response of less than 20 psi to date. A 3-1/2 inch full-string production liner was installed and cemented back to surface prior to commencing stimulation operations.
