EAST MAMM CREEK PROJECT DRILLING AND CEMENTI NG STUDY

CRESCENT CONSULTING, LLC
REED ENERGY CONSULTI NG, LLC
ROGE, LLC

JUNE 20 , 2011

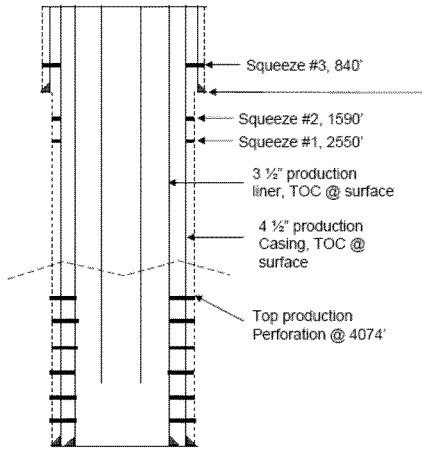
Remediation of the Magic 10-1
Wellbore Diagram

The Magic 10-1 well was drilled in late January 2004. Drilling of the surface hole and the surface casing cement job were uneventful, with surface casing set at a depth of 860 feet. A FIT was performed to an equivalent mud weight of 11.5 ppg. After drilling out of the surface casing, a number of substantial gas flows were observed, starting at 3,742 feet and continuing throughout the well. This well also utilized the LCA mud methodology, and a 10 foot to15 foot gas flare was reported during the drilling process (flaring is used as a surface safety control procedure during a gas flow). This indicates a slightly underbalanced condition (condition in which mud weight is less than formation pressure). The mud weight used to finish the hole was 13.3 ppg. The production string was run and cemented to surface without incident; however, the cement weights were 13.3 ppg on the lead and 13.4 ppg on the tail. Industry best practices promote a cement density of +/- 1 ppg greater than the final mud weight.

In the EMCPA, it is not unusual to use a cement density of 1/2 ppg to 3/4 ppg greater than the final mud weight, to avoid lost circulation. The resulting potential for gas flow increases as the density of the cement approaches the density of the drilling mud. A CBL was run and showed very poor to no bond in the upper 1/3 of the hole. It was not standard practice at the time to monitor Bradenhead pressure, and therefore, it is unknown if Bradenhead pressure was present immediately after the cementing process. It is unclear as to when Bradenhead pressure was first noted. However, the well was remediated in October 2004 to mitigate high Bradenhead pressures. The remediation process was similar to the other P3 Pad wells, in that logs were run to locate gas flows and optimize depths for squeeze cementing. Multiple cement squeeze jobs were performed at 2,250 feet, 1,590 feet and 840 feet, ultimately resulting in isolation of gas-bearing zones and elimination of Bradenhead pressure. A 3-1/2 inch full-string production liner was installed in May 2004 and cemented back to surface prior to commencing stimulation operations.
