EAST MAMM CREEK PROJECT DRILLING AND CEMENTI NG STUDY

CRESCENT CONSULTING, LLC
REED ENERGY CONSULTI NG, LLC
ROGE, LLC

JUNE 20 , 2011

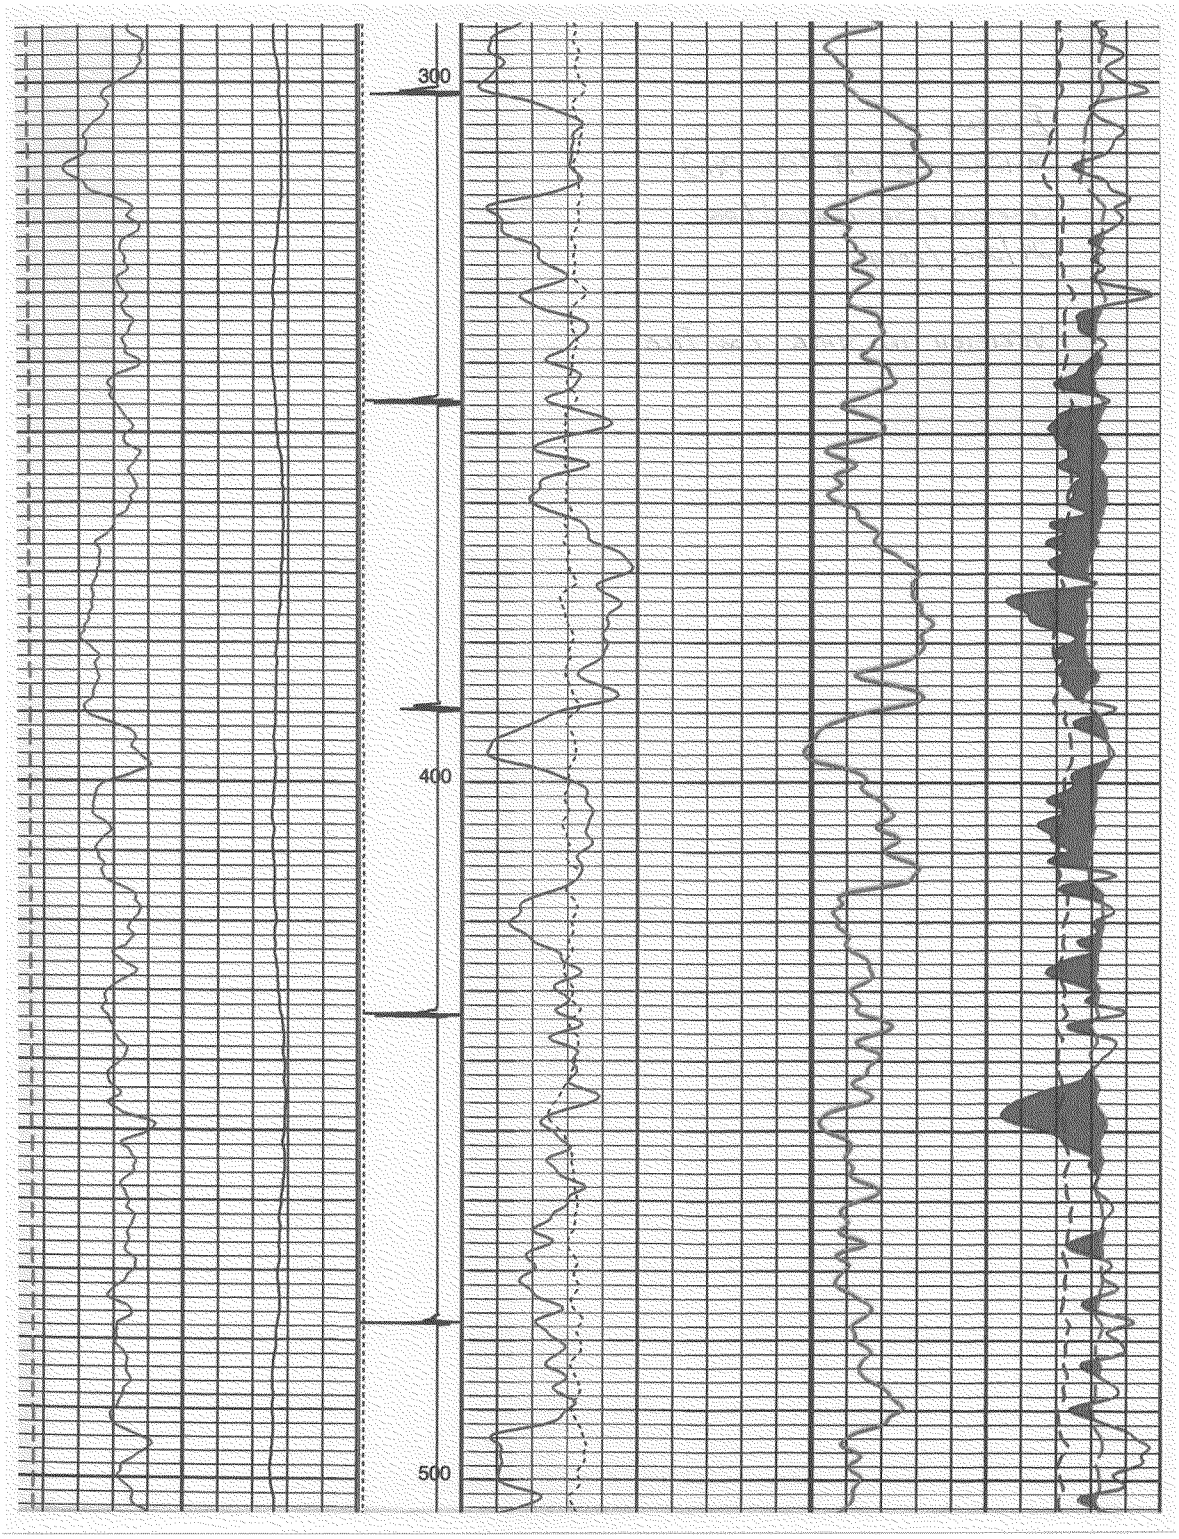
The issues of shallow gas are illustrated by Figure 3 and Figure 4 in Appendix A, showing an example section of RST log and a Triple Combo log section. These logs indicate the occurrence of possible shallow gas zones starting at approximately 60 feet below the surface.

Figure 3 – Example section of RST log showing potential presence of hydrocarbon (shaded intervals) in the second track at shallow depth

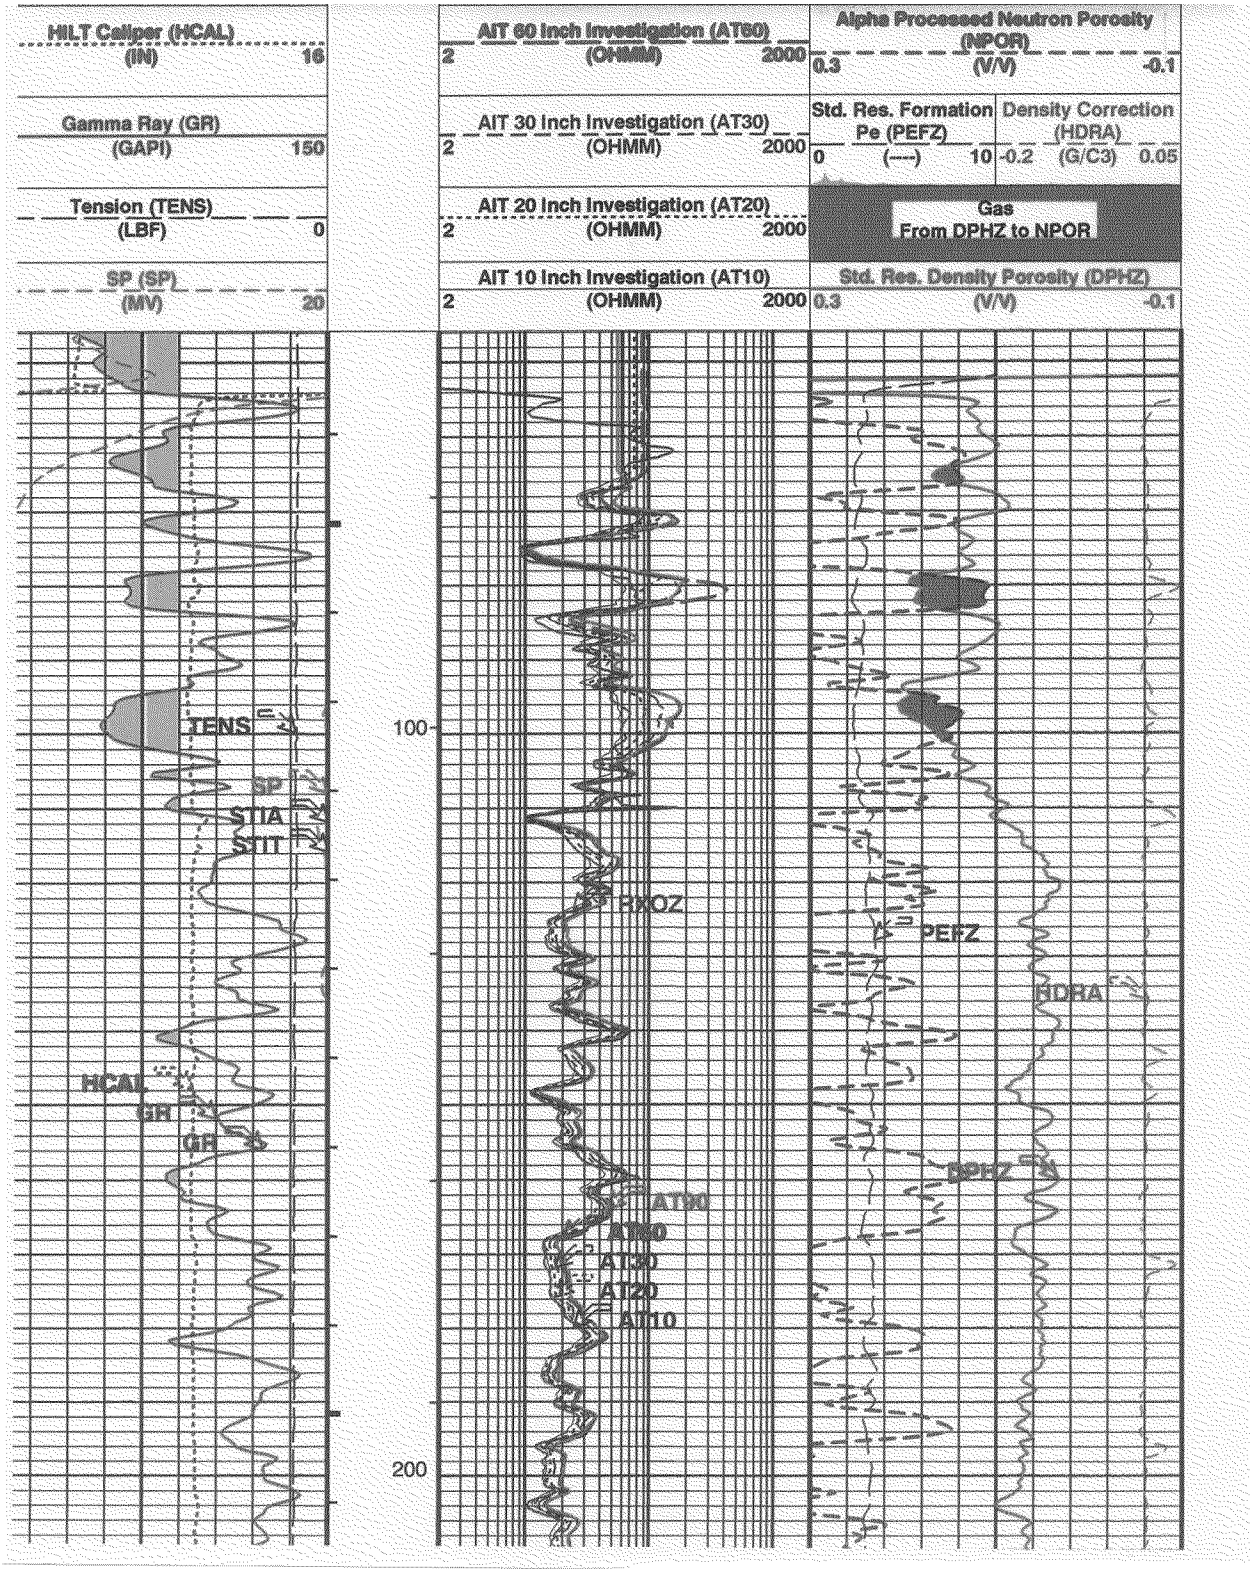
Figure 4 – Example triple combo log section indicating potential shallow gas zones (shaded intervals)

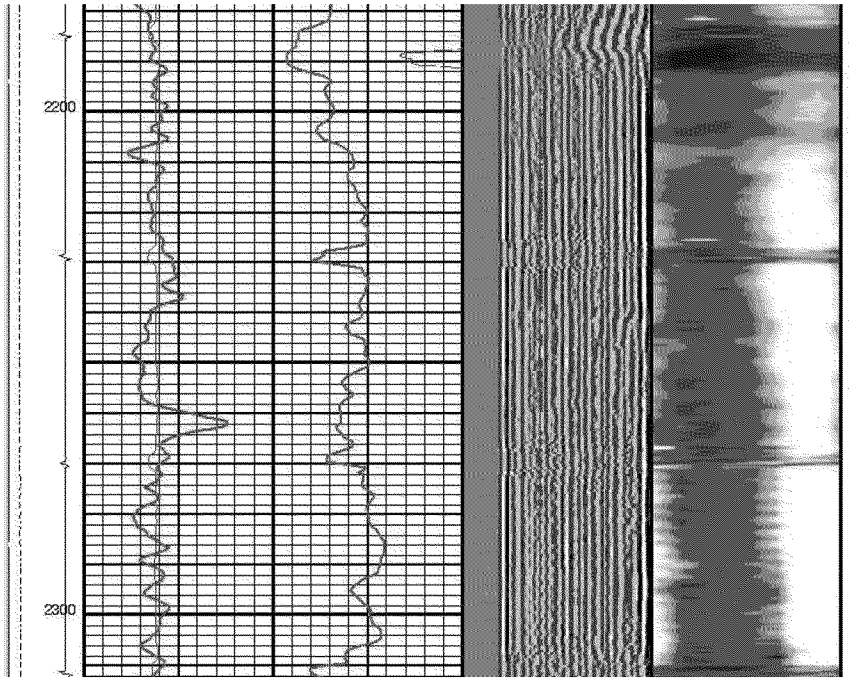
Figure 5 – Example log section of Cement Bond Log (CBL) before cement squeeze job

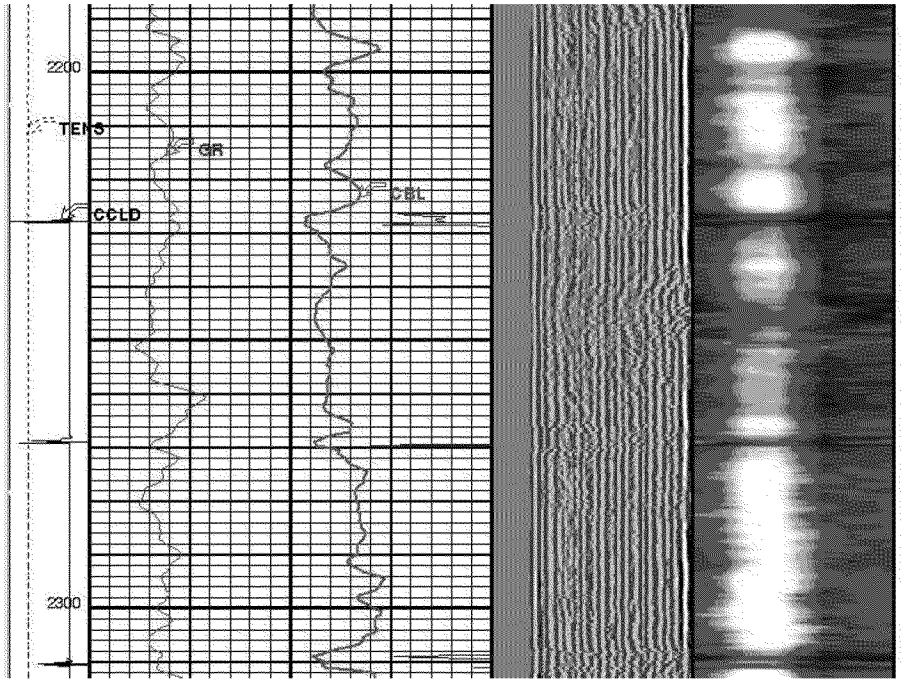
Figure 6 – Example log section of CBL after cement squeeze job

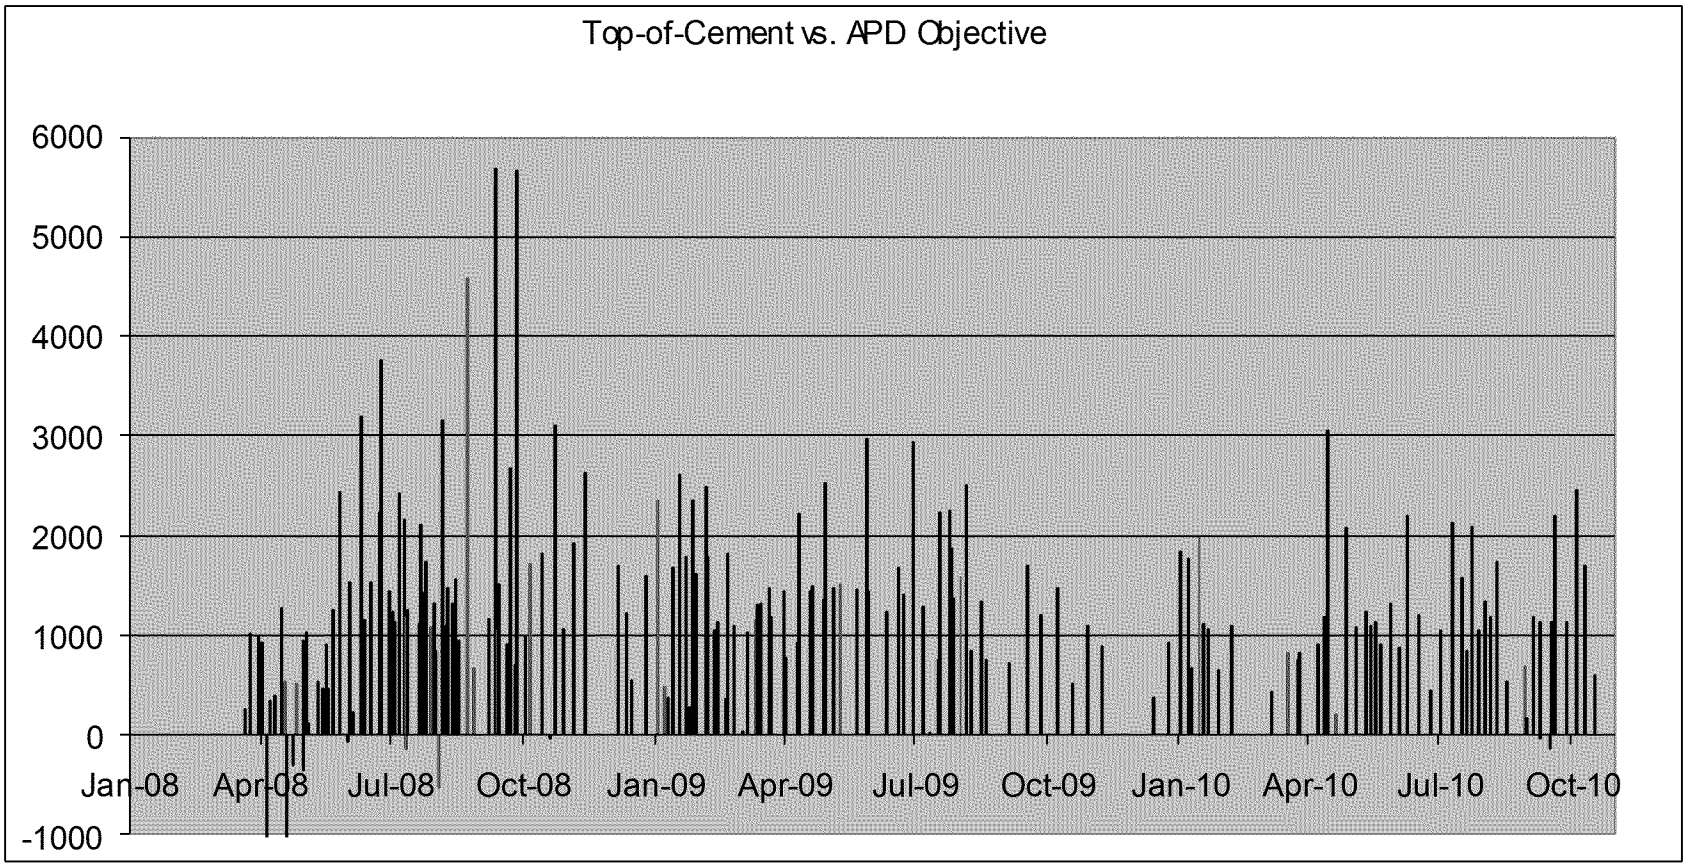
rarely missed. However, Encana's internal standard, which exceeds both Federal and State requirements by several hundred feet, is often missed on the low side. This data is presented in Figure 8 and Figure 9 in Appendix A, which show charts generated from Schlumberger data of Top of Cement vs. APD Objective.

Figure 8 – Schlumberger chart showing the progression of top of cement compared to APD values from 2008 through 2010 for all EnCana wells in Piceance Basin. The y-axis represents the height of cement above the State-required TOC in feet.

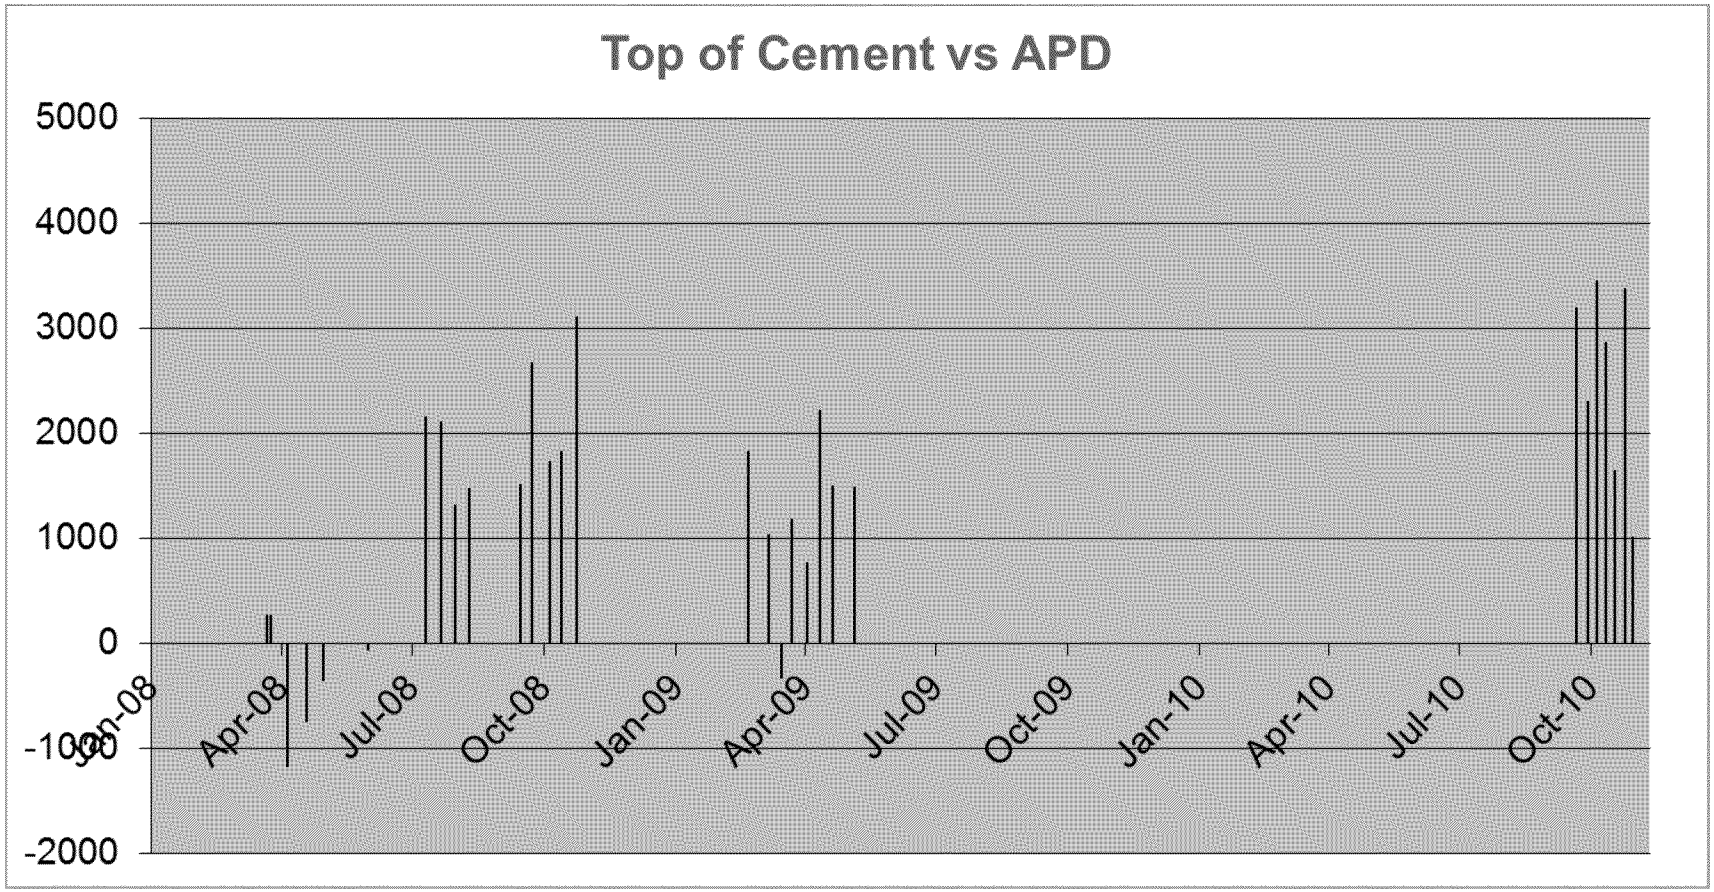
Figure 9 – Schlumberger chart showing the progression of top of cement compared to APD values from 2008 to 2010 on study area wells only. The y-axis represents the height of cement above the State-required TOC in feet.

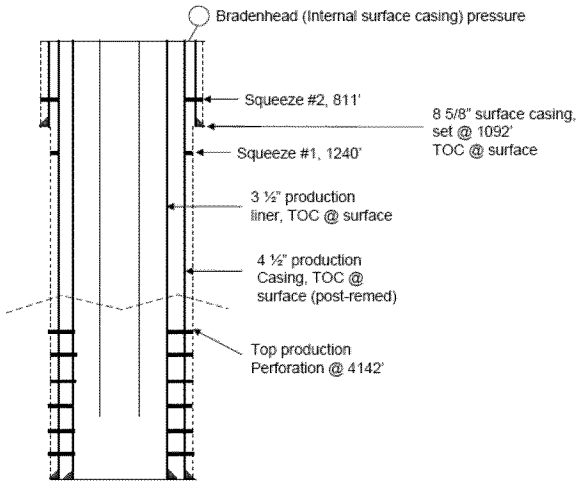
Remediation of the Arbaney 3-15C
Wellbore Diagram

The Arbaney 3-15C well was drilled in March and April of 2004. The surface drilling and cementing operations were uneventful. The cement job went as planned, with cement circulated to surface and a surface casing shoe depth of 1,092 feet. A FIT was performed at an equivalent mud weight of 13.0 ppg. The production hole was marred by a driller "crowning" the blocks with the bit positioned in the potential gas zones at a depth of 4,175 feet. The damage to the rig forced a temporary abandonment procedure which included setting a drillable bridge plug at 1,032 feet. Upon resumption of drilling operations five (5) days later, the mud weight was raised to 12.5 ppg and there was no report of well control difficulties when the temporary plug was drilled out. Upon reaching TD, the well had a number of bridges (sloughed formation) to drill out prior to logging. The production casing was run and cemented without difficulty, returning 30 Bbls of cement to surface.

The well exhibited 450 psi Bradenhead pressure within a few days after the production casing cementing operation, and subsequently, gas bubbling was observed in the soil at the surface near this well. Upon further investigation, all of the wells on the pad, with the notable exception of the Magic 10-2, have exhibited elevated Bradenhead pressures, and both Arbaney wells have gas bubbling in the soil outside the surface casing. Additionally, two water wells in the immediate vicinity of the P3 Pad have been impacted with methane gas. The Arbaney 3-15C well was remediated with cement squeeze jobs performed at 1,240 feet and 811 feet. A full-string 3-1/2 inch liner was installed and cemented to surface prior to commencing stimulation operations. This well continues to have Bradenhead pressures trending slowly higher when shut-in. However, the well is currently being vented to mitigate Bradenhead pressure buildup.

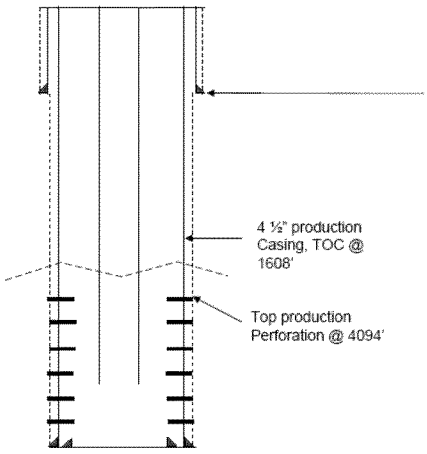
Magic 10-1A
Wellbore Diagram

- No bradenhead pressure observed
- No remediation performed

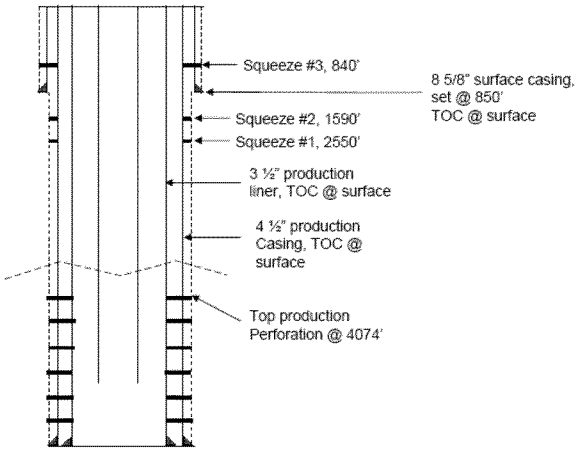
Remediation of the Magic 10-1
Wellbore Diagram

The Magic 10-1 well was drilled in late January 2004. Drilling of the surface hole and the surface casing cement job were uneventful, with surface casing set at a depth of 860 feet. A FIT was performed to an equivalent mud weight of 11.5 ppg. After drilling out of the surface casing, a number of substantial gas flows were observed, starting at 3,742 feet and continuing throughout the well. This well also utilized the LCA mud methodology, and a 10 foot to15 foot gas flare was reported during the drilling process (flaring is used as a surface safety control procedure during a gas flow). This indicates a slightly underbalanced condition (condition in which mud weight is less than formation pressure). The mud weight used to finish the hole was 13.3 ppg. The production string was run and cemented to surface without incident; however, the cement weights were 13.3 ppg on the lead and 13.4 ppg on the tail. Industry best practices promote a cement density of +/- 1 ppg greater than the final mud weight.

In the EMCPA, it is not unusual to use a cement density of 1/2 ppg to 3/4 ppg greater than the final mud weight, to avoid lost circulation. The resulting potential for gas flow increases as the density of the cement approaches the density of the drilling mud. A CBL was run and showed very poor to no bond in the upper 1/3 of the hole. It was not standard practice at the time to monitor Bradenhead pressure, and therefore, it is unknown if Bradenhead pressure was present immediately after the cementing process. It is unclear as to when Bradenhead pressure was first noted. However, the well was remediated in October 2004 to mitigate high Bradenhead pressures. The remediation process was similar to the other P3 Pad wells, in that logs were run to locate gas flows and optimize depths for squeeze cementing. Multiple cement squeeze jobs were performed at 2,250 feet, 1,590 feet and 840 feet, ultimately resulting in isolation of gas-bearing zones and elimination of Bradenhead pressure. A 3-1/2 inch full-string production liner was installed in May 2004 and cemented back to surface prior to commencing stimulation operations.

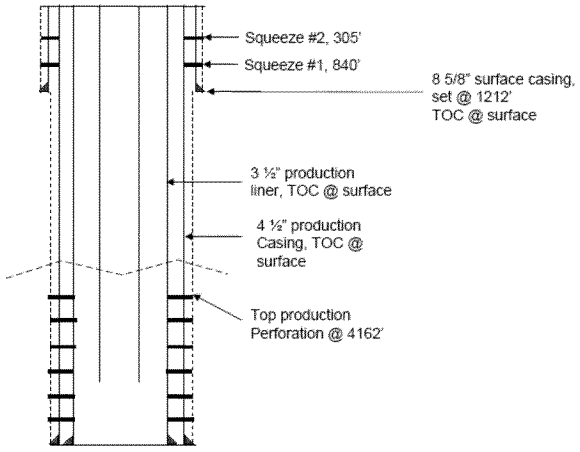
Remediation of the Magic 10-2
Wellbore Diagram

The Magic 10-2 was drilled in early March 2004. The surface casing drilling and cementing operations were uneventful. A FIT was performed at the surface shoe of 1,212 feet, but the data was not found in the well records. The well was drilled in an "underbalanced" mode. On March 8, 2004, the rig noted elevated gas levels in the drilling mud returns at

approximately 3,300 feet. Mud returns, which had been flowing to the pit, were switched to the return lines through the gas buster[1]. This operation is normal practice when gas is observed in the mud system. However, a risk with this procedure is the potential for drill cuttings to plug the return lines, flow lines and chokes. Apparently, on March 9, 2004 some of the drill cuttings plugged the flow lines and choke system, resulting in an unanticipated pressure buildup in the surface equipment and the borehole. This pressure buildup and subsequent pressure release is hereinafter referred to as the "Arbaney Event". With the flow lines and chokes plugged, there was no place for the gas to be released, so pressure built on the annulus between the drill pipe and surface casing, as well as the open hole section below, for a period of not more than four (4) hours.

The remainder of the well was drilled underbalanced without further incident. The production string was run and cemented as planned, however cement was not circulated back to surface. The well had two squeeze jobs performed on the production casing, above the surface casing shoe at depths of 840 feet and 305 feet to mitigate high Bradenhead pressure, which was apparently observed shortly after completion of the primary cement job on the production casing. The cement remediation resulted in a consistent Bradenhead pressure response of less than 20 psi to date. A 3-1/2 inch full-string production liner was installed and cemented back to surface prior to commencing stimulation operations.

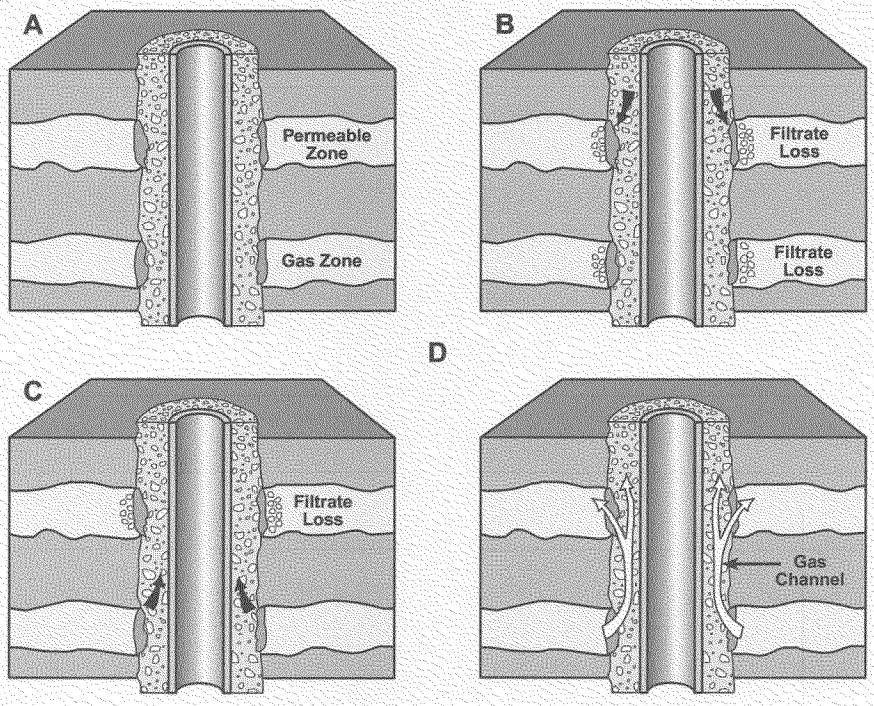
Figure 1: Gas channel migration: Gas migration creates permanent channels in cement columns, decreasing cement strength and contributing to continuing gas-flow problems. The most widely accepted explanation for short-term migration is the cement column's inability to maintain overbalance pressure. This pressure loss depnds on the cement's development of static gel stength, transition time and hydration volume reduction. There are 2 suspected causes of long-term migration: inadequate drilling fluid displacement and cement debonding. Inadequately displaced drilling fluid can prevent good bond formation between the pipe and cement and/or the cement and the formation. Incomplete displacement or excessive filter-cake buildup can create drilling fluid channels in the cement. Over time, gas flow causes the drilling fluid and cake to dehydrate and shrink, resulting in a highly permeable pathway for gas.

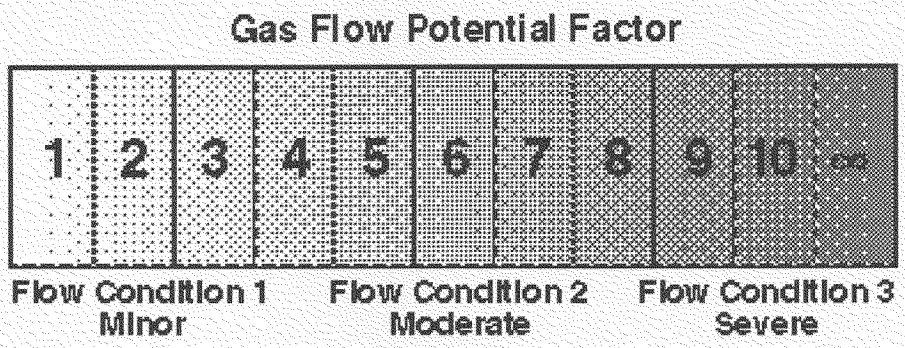
Figure 2: The gas-flow potential factor (GFP) is the estimated amount of gas flow that can be expected from a formation. Operators can use this factor to help determine the most effective cementing system for controlling gas migration. The system should produce effective control at the least expense without producing technological "overkill". The GFP is proportional to the product of the maximum pressure loss and the overbalance pressure.

The gas-flow potential factor (GFP) is the estimated amount of gas flow that can be expected from a formation (Figure 2). Operators can use this factor to help determine the most effective cementing system for controlling gas migration. The system should produce effective control at the least expense to the customer without producing technological "overkill." The following equation can be used to determine the gas-flow potential factor:

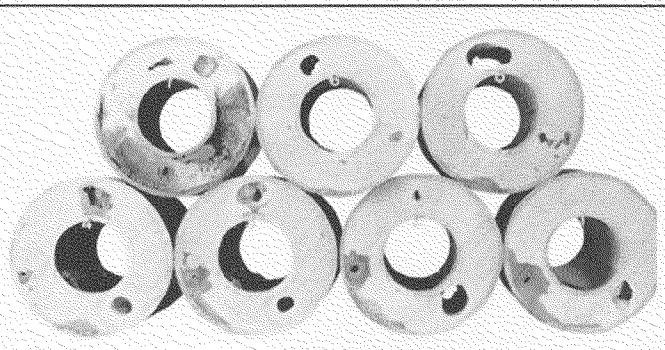
Figure 3: Test cores of cement subjected to gas flow of 6 liter/min before the slurry achieved adequate gel strength. Controling gas flow depends on the severity of the problem. For small gas-flow potentials, fluid-loss control may be sufficient. For moderate GFPs, exceptional fluid-loss control techniques are called for. In severe cases, especially high-temperature wells, fluid-loss control additives, job modifications and delayed gelling agents alone are not enough. Highly compressible cements are needed in these situations.
