EAST MAMM CREEK PROJECT DRILLING AND CEMENTI NG STUDY

CRESCENT CONSULTING, LLC
REED ENERGY CONSULTI NG, LLC
ROGE, LLC

JUNE 20 , 2011

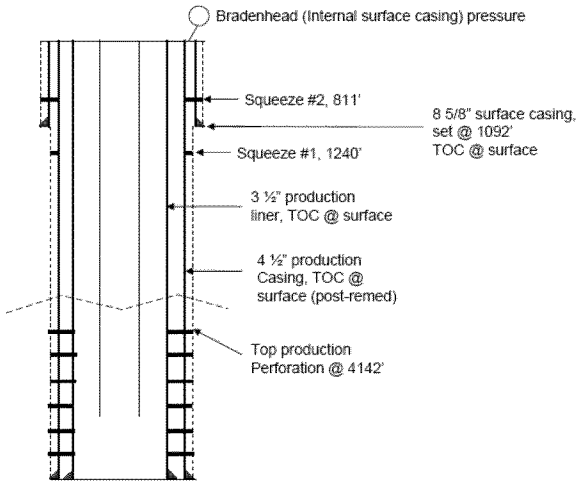
Remediation of the Arbaney 3-15C
Wellbore Diagram

The Arbaney 3-15C well was drilled in March and April of 2004. The surface drilling and cementing operations were uneventful. The cement job went as planned, with cement circulated to surface and a surface casing shoe depth of 1,092 feet. A FIT was performed at an equivalent mud weight of 13.0 ppg. The production hole was marred by a driller "crowning" the blocks with the bit positioned in the potential gas zones at a depth of 4,175 feet. The damage to the rig forced a temporary abandonment procedure which included setting a drillable bridge plug at 1,032 feet. Upon resumption of drilling operations five (5) days later, the mud weight was raised to 12.5 ppg and there was no report of well control difficulties when the temporary plug was drilled out. Upon reaching TD, the well had a number of bridges (sloughed formation) to drill out prior to logging. The production casing was run and cemented without difficulty, returning 30 Bbls of cement to surface.

The well exhibited 450 psi Bradenhead pressure within a few days after the production casing cementing operation, and subsequently, gas bubbling was observed in the soil at the surface near this well. Upon further investigation, all of the wells on the pad, with the notable exception of the Magic 10-2, have exhibited elevated Bradenhead pressures, and both Arbaney wells have gas bubbling in the soil outside the surface casing. Additionally, two water wells in the immediate vicinity of the P3 Pad have been impacted with methane gas. The Arbaney 3-15C well was remediated with cement squeeze jobs performed at 1,240 feet and 811 feet. A full-string 3-1/2 inch liner was installed and cemented to surface prior to commencing stimulation operations. This well continues to have Bradenhead pressures trending slowly higher when shut-in. However, the well is currently being vented to mitigate Bradenhead pressure buildup.

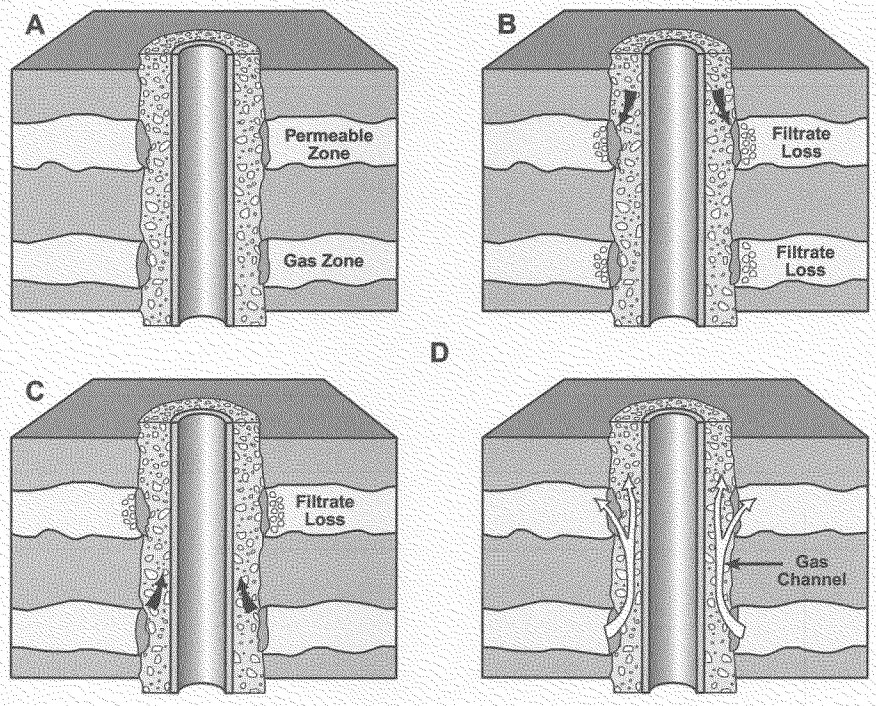
Figure 1: Gas channel migration: Gas migration creates permanent channels in cement columns, decreasing cement strength and contributing to continuing gas-flow problems. The most widely accepted explanation for short-term migration is the cement column's inability to maintain overbalance pressure. This pressure loss depnds on the cement's development of static gel stength, transition time and hydration volume reduction. There are 2 suspected causes of long-term migration: inadequate drilling fluid displacement and cement debonding. Inadequately displaced drilling fluid can prevent good bond formation between the pipe and cement and/or the cement and the formation. Incomplete displacement or excessive filter-cake buildup can create drilling fluid channels in the cement. Over time, gas flow causes the drilling fluid and cake to dehydrate and shrink, resulting in a highly permeable pathway for gas.

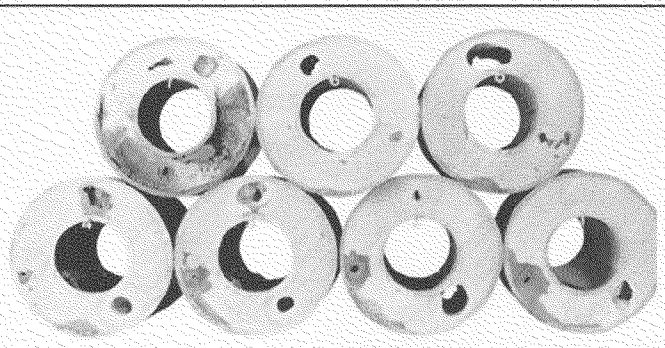
Figure 3: Test cores of cement subjected to gas flow of 6 liter/min before the slurry achieved adequate gel strength. Controling gas flow depends on the severity of the problem. For small gas-flow potentials, fluid-loss control may be sufficient. For moderate GFPs, exceptional fluid-loss control techniques are called for. In severe cases, especially high-temperature wells, fluid-loss control additives, job modifications and delayed gelling agents alone are not enough. Highly compressible cements are needed in these situations.
