EAST MAMM CREEK PROJECT DRILLING AND CEMENTI NG STUDY

CRESCENT CONSULTING, LLC
REED ENERGY CONSULTI NG, LLC
ROGE, LLC

JUNE 20 , 2011

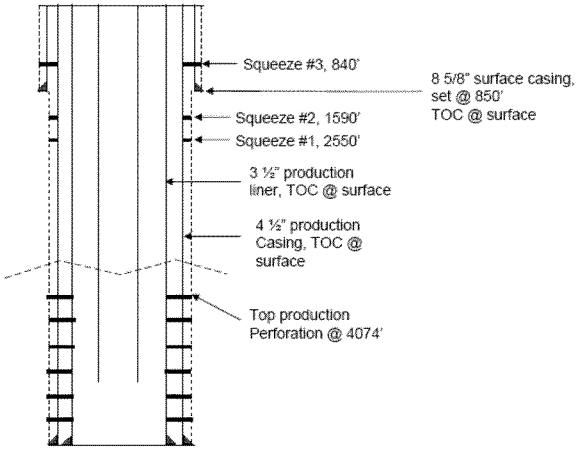
Remediation of the Magic 10-2
Wellbore Diagram

The Magic 10-2 was drilled in early March 2004. The surface casing drilling and cementing operations were uneventful. A FIT was performed at the surface shoe of 1,212 feet, but the data was not found in the well records. The well was drilled in an "underbalanced" mode. On March 8, 2004, the rig noted elevated gas levels in the drilling mud returns at

approximately 3,300 feet. Mud returns, which had been flowing to the pit, were switched to the return lines through the gas buster[1]. This operation is normal practice when gas is observed in the mud system. However, a risk with this procedure is the potential for drill cuttings to plug the return lines, flow lines and chokes. Apparently, on March 9, 2004 some of the drill cuttings plugged the flow lines and choke system, resulting in an unanticipated pressure buildup in the surface equipment and the borehole. This pressure buildup and subsequent pressure release is hereinafter referred to as the "Arbaney Event". With the flow lines and chokes plugged, there was no place for the gas to be released, so pressure built on the annulus between the drill pipe and surface casing, as well as the open hole section below, for a period of not more than four (4) hours.

The remainder of the well was drilled underbalanced without further incident. The production string was run and cemented as planned, however cement was not circulated back to surface. The well had two squeeze jobs performed on the production casing, above the surface casing shoe at depths of 840 feet and 305 feet to mitigate high Bradenhead pressure, which was apparently observed shortly after completion of the primary cement job on the production casing. The cement remediation resulted in a consistent Bradenhead pressure response of less than 20 psi to date. A 3-1/2 inch full-string production liner was installed and cemented back to surface prior to commencing stimulation operations.
