Subject: September 18, 2019, EPA Inspection

| **Subj:** | Inspection Report<br>Clean Water Act - National Pollutant Discharge Elimination System ("NPDES")<br>Hull WPCF |

A. *Facility Name:* Hull WPCF

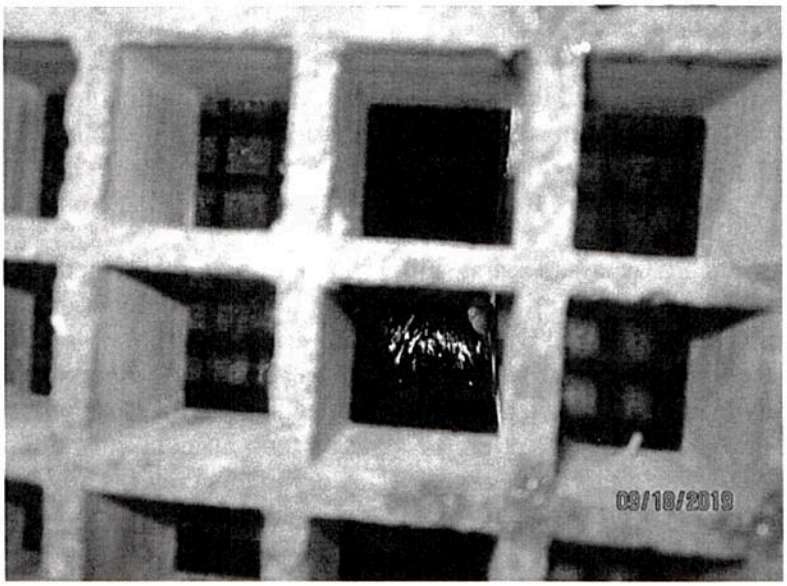
The site tour began in the headworks in the basement level of the treatment plant. The staff showed us the Parshall flume, which is covered with rubber mats to help control odors [Photo 1 and 2]. The facility explained that it relies on "strap-on" flow meters to measure influent and effluent flow at the facility via readings through the pipes, rather than the Parshall flume. Dimensions of the Parshall flume would be needed to use it for measuring flow during the field exercise. The facility explained that it uses another flow meter on the influent line between the primary distribution box and the aerators to cross-check the influent strap-on meter. Pumps and electrical control boxes are in the subbasement. The operators pointed out the influent and

Photo 1: Parshall flume at headworks

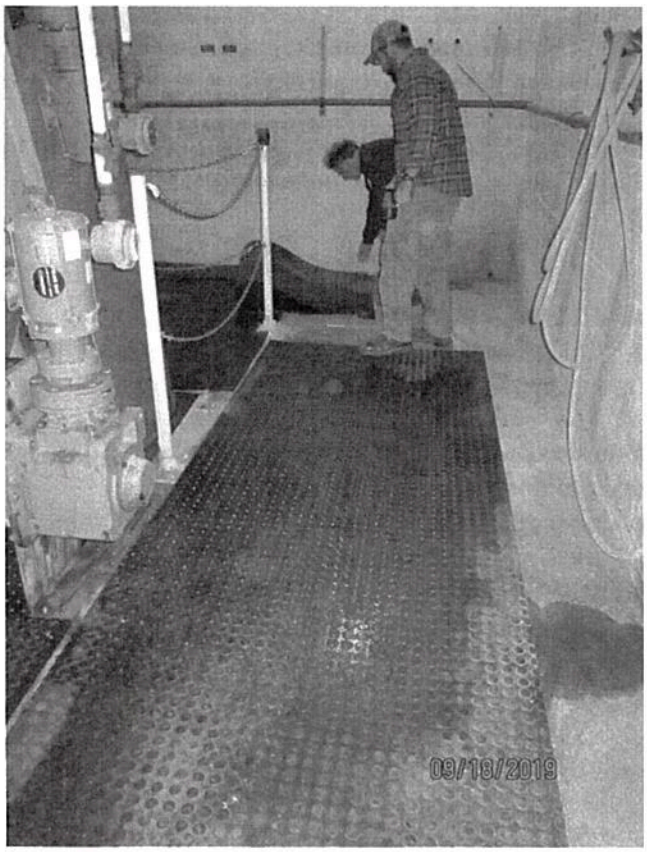
Photo 2: Rubber mat over Parshall flume

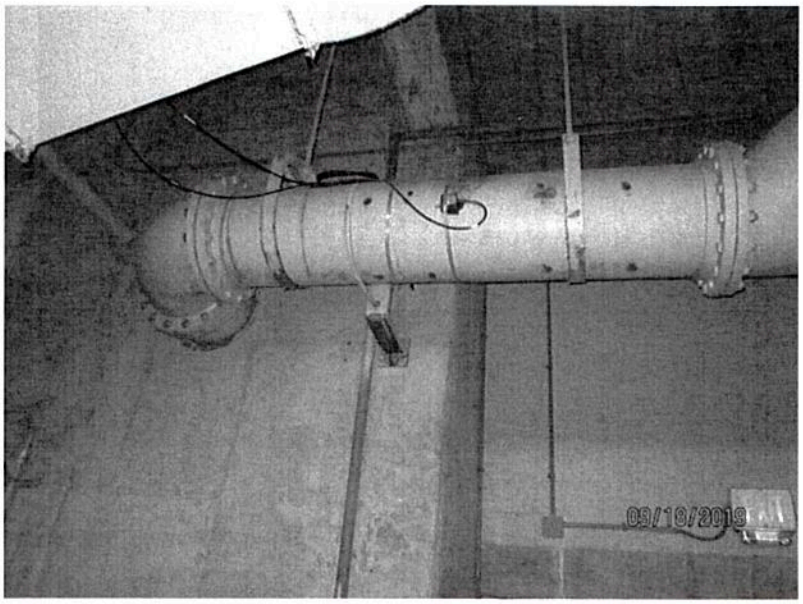
effluent strap-on flow meters [Photo 3] and indicated that while only 1 of 5 available influent pumps are needed during dry weather, all 5 may be needed to handle wet weather flow. The facility also described an influent headworks project that, among other things, would move critical electrical equipment to a higher level to protect against flooding.

Photo 3: Strap-on meters

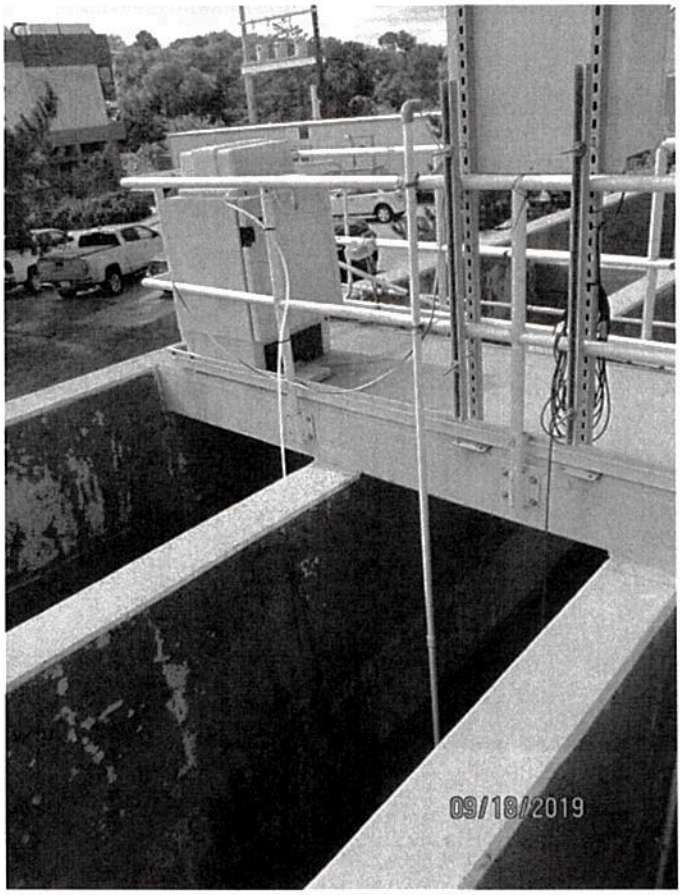
We were informed that primary clarifiers are bypassed at the splitter box and flow is diverted directly to the aeration tanks. According to the Mr. Varjabedian, this primary clarifier bypass has been in place since 2016 and the facility operates well with this configuration. The primary set of aeration tanks use diffused air. A second set of tanks that were not serviceable during a previous inspection by EPA are now reportedly available if needed and rely on mechanical mixers [Photos 5 and 6]. The operators pointed out the optical flow meter on the aeration tank influent line that they had referenced as a check of the strap-on meters, but acknowledged that this meter is not currently working properly.

Photo 5 and 6: Aeration tanks
