Draft
Site Characterization and Cleanup Action Summary Report for Building 84 PCB Mezzanine Site
Investigation Area D1.3
Eastern Early Transfer Parcel

March 2010

Subject: Draft Site Characterization and Cleanup Action Summary Report for Building 84 PCB Mezzanine Site, Investigation Area D1.3, Eastern Early Transfer Parcel, Mare Island, Vallejo, California

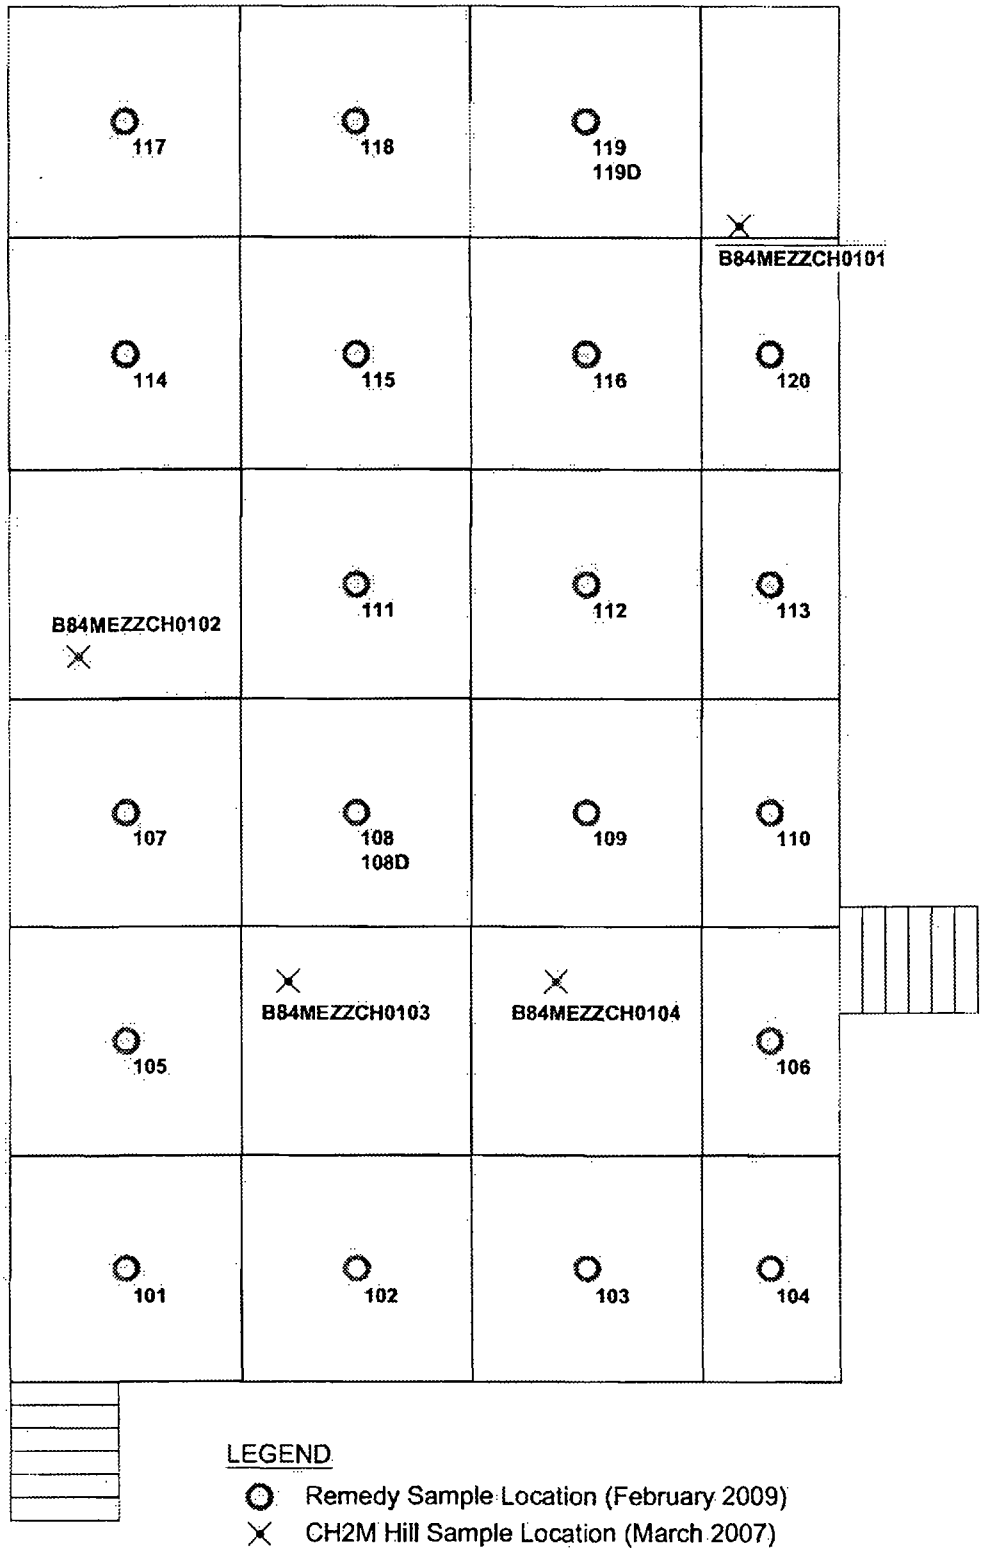
FIGURE 3
LOCATION OF FEBRUARY 5, 2009 CONCRETE CHIP SAMPLES, BUILDING 84 MEZZANINE
Lennar Mare Island, Vallejo, California

Based on the results of the February 2009 sampling, the cleanup plan recommended that the entire floor of the Building 84 Mezzanine Site be scarified to a depth of 0.25 inches. After removal of the mezzanine floor surface, eight 9-point composite samples were collected. Three indoor air samples were collected once the results of the concrete chip verification samples were less than the 0.22 mg/kg cleanup goal. The scope of work activities were completed between September 2009 and January 2010.
