Subject: Polychlorinated Biphenyl Site Building 688 UL#01 in Investigation Area C2, where No Further Action Is Required under the United States Environmental Protection Agency Consent Agreement and Final Order

TABLE 1
Sample Results for PCB Site Building 688 UL#01
PCB Sites, Lennar Mare Island, Vallejo, California

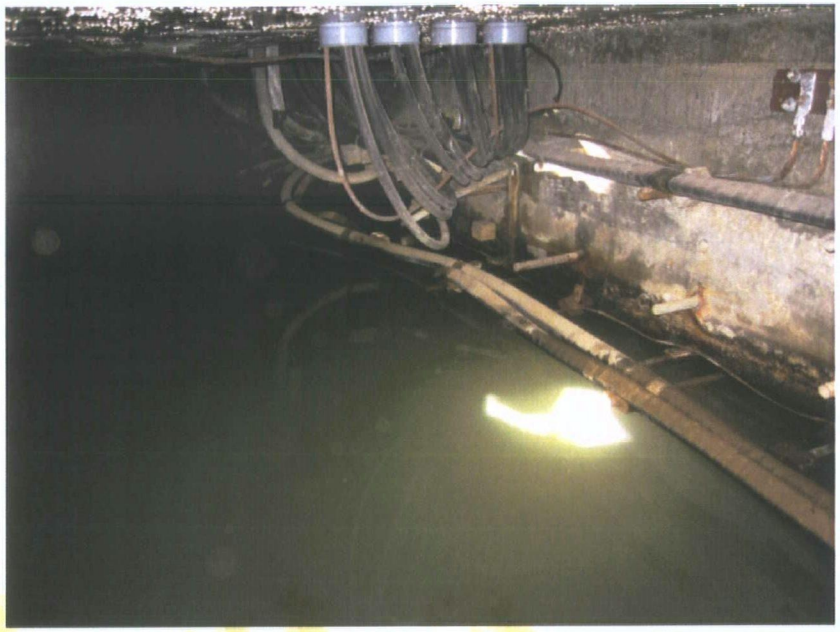
Photograph 7: Electrical manhole at southwest end of transformer pad, view looking northwest towards electrical manhole at northwest end of transformer pad.
