United States Environmental Protection Agency (EPA)
Region 2
290 Broadway
New York, NY 10007-1866

# Underground Storage Tank (UST) Inspection Form

INSPECTOR NAME(S): Luis Diaz, Bill Hahn DATE: 3/25/13

Facility Name: US Petroleum #ST 329

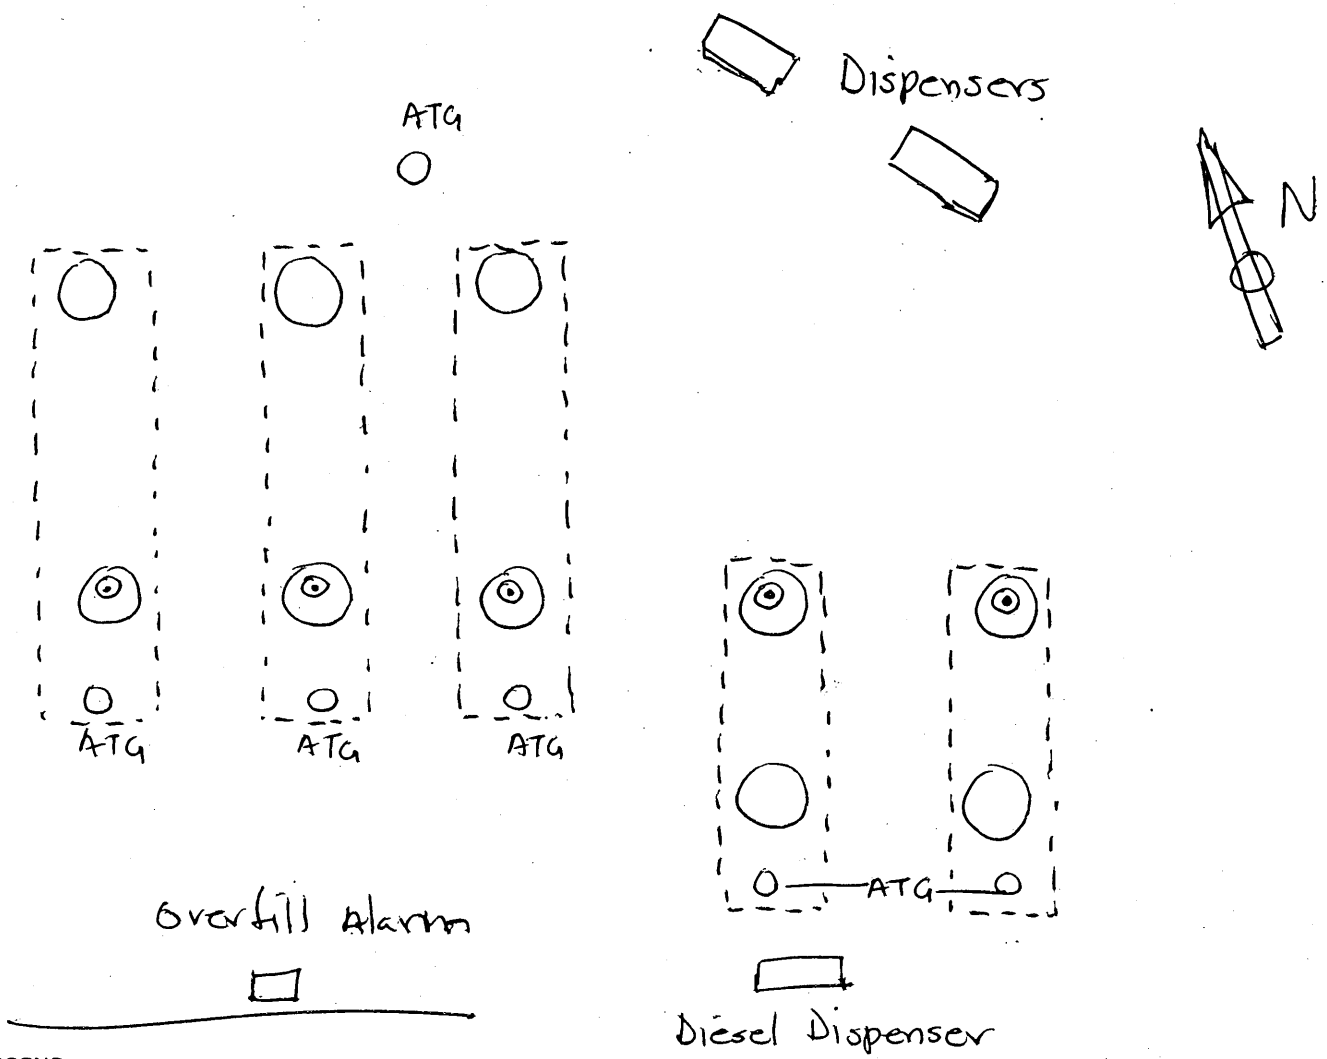
## Facility Diagram

(4) The sump covers to Tanks 1-3 could not be removed during the inspection

could not open sump covers. Covers required special tool which was not available on-site.
