Federal Office Building No. 8
Building Renovation for General Services Administration
Washington, DC

Building Survey Report – Environmental Hazards

May 16, 2003

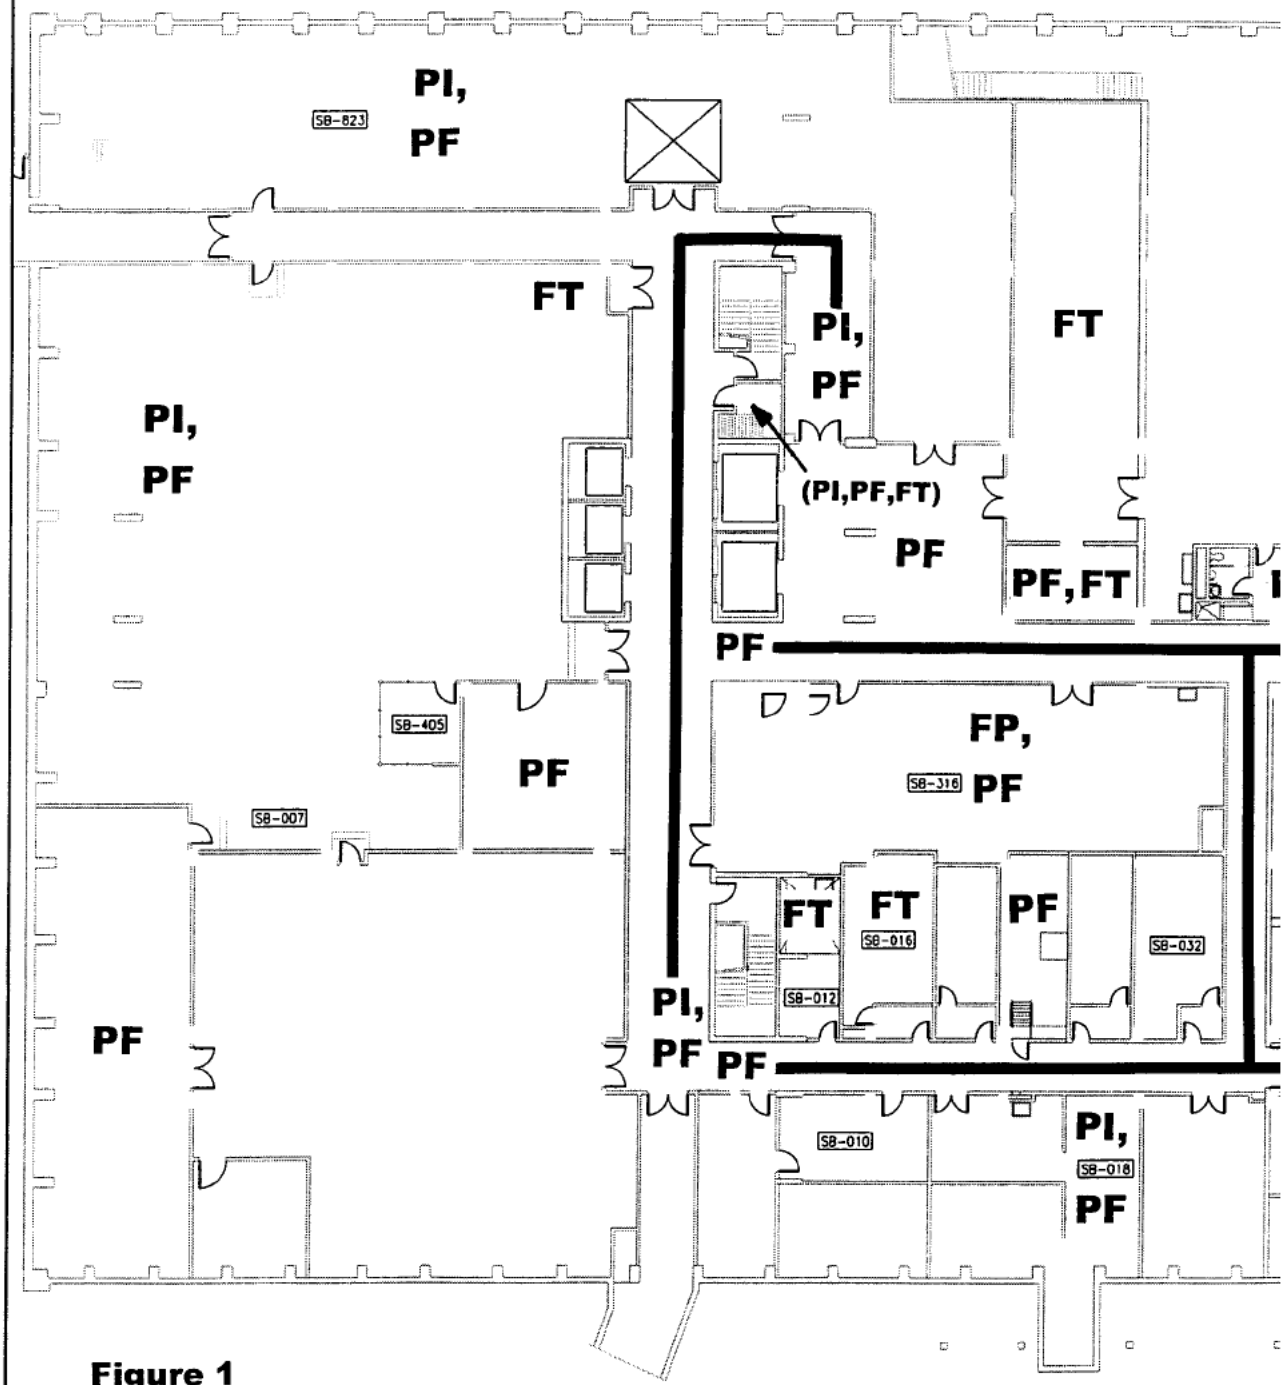
Figure 1

PI: Pipe Insulation = 2,000 LF

PF: Pipe Fittings = 600 Each

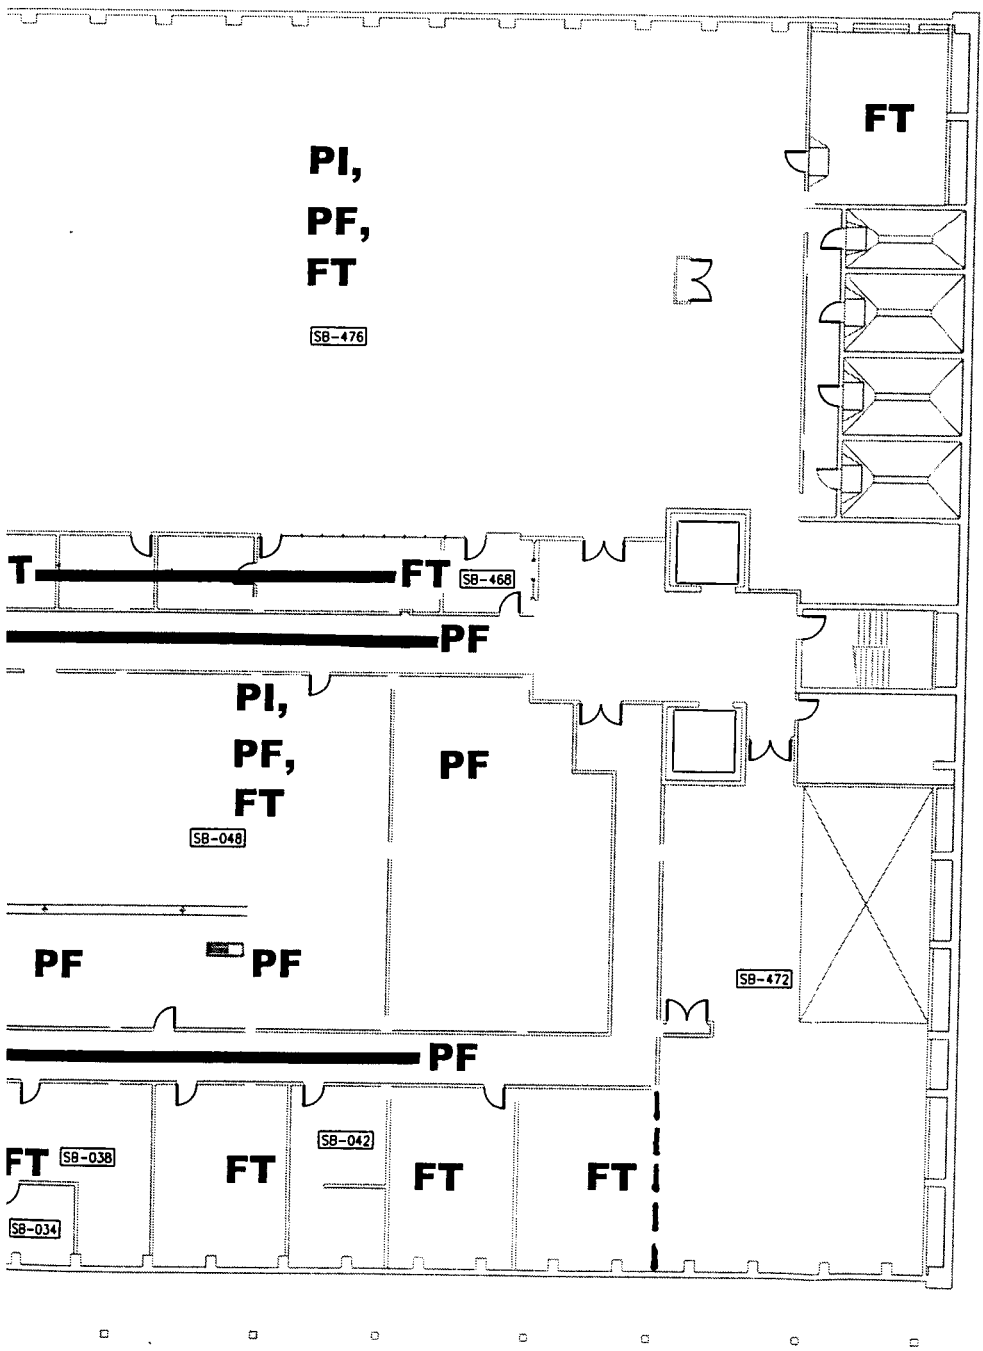
1 SUB-BASEMENT FLOOR PLAN - EXISTING

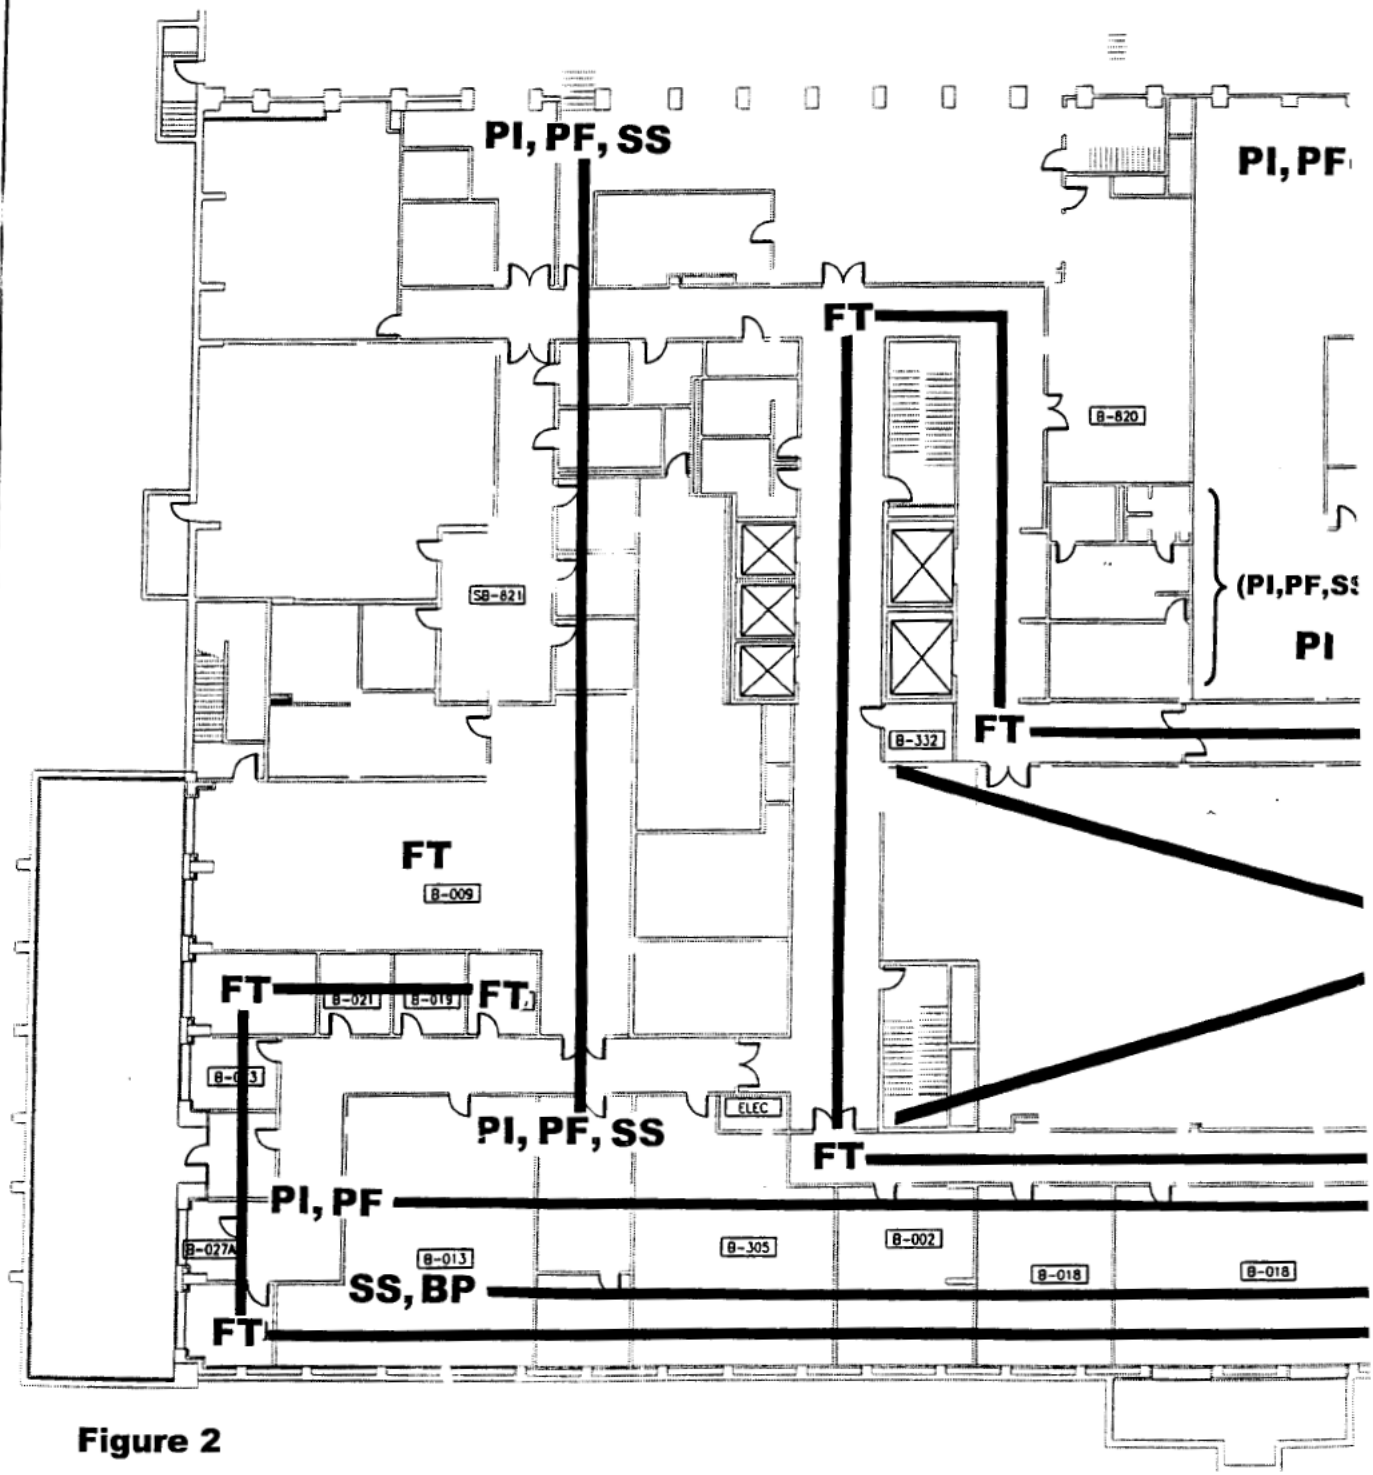
Figure 2

Pipe Insulation = 5,000 LF
Transite
Benchtops = 50 SF
Cabinet Fire Coating = 1,000 SF
Rope Gasket = 30 LF

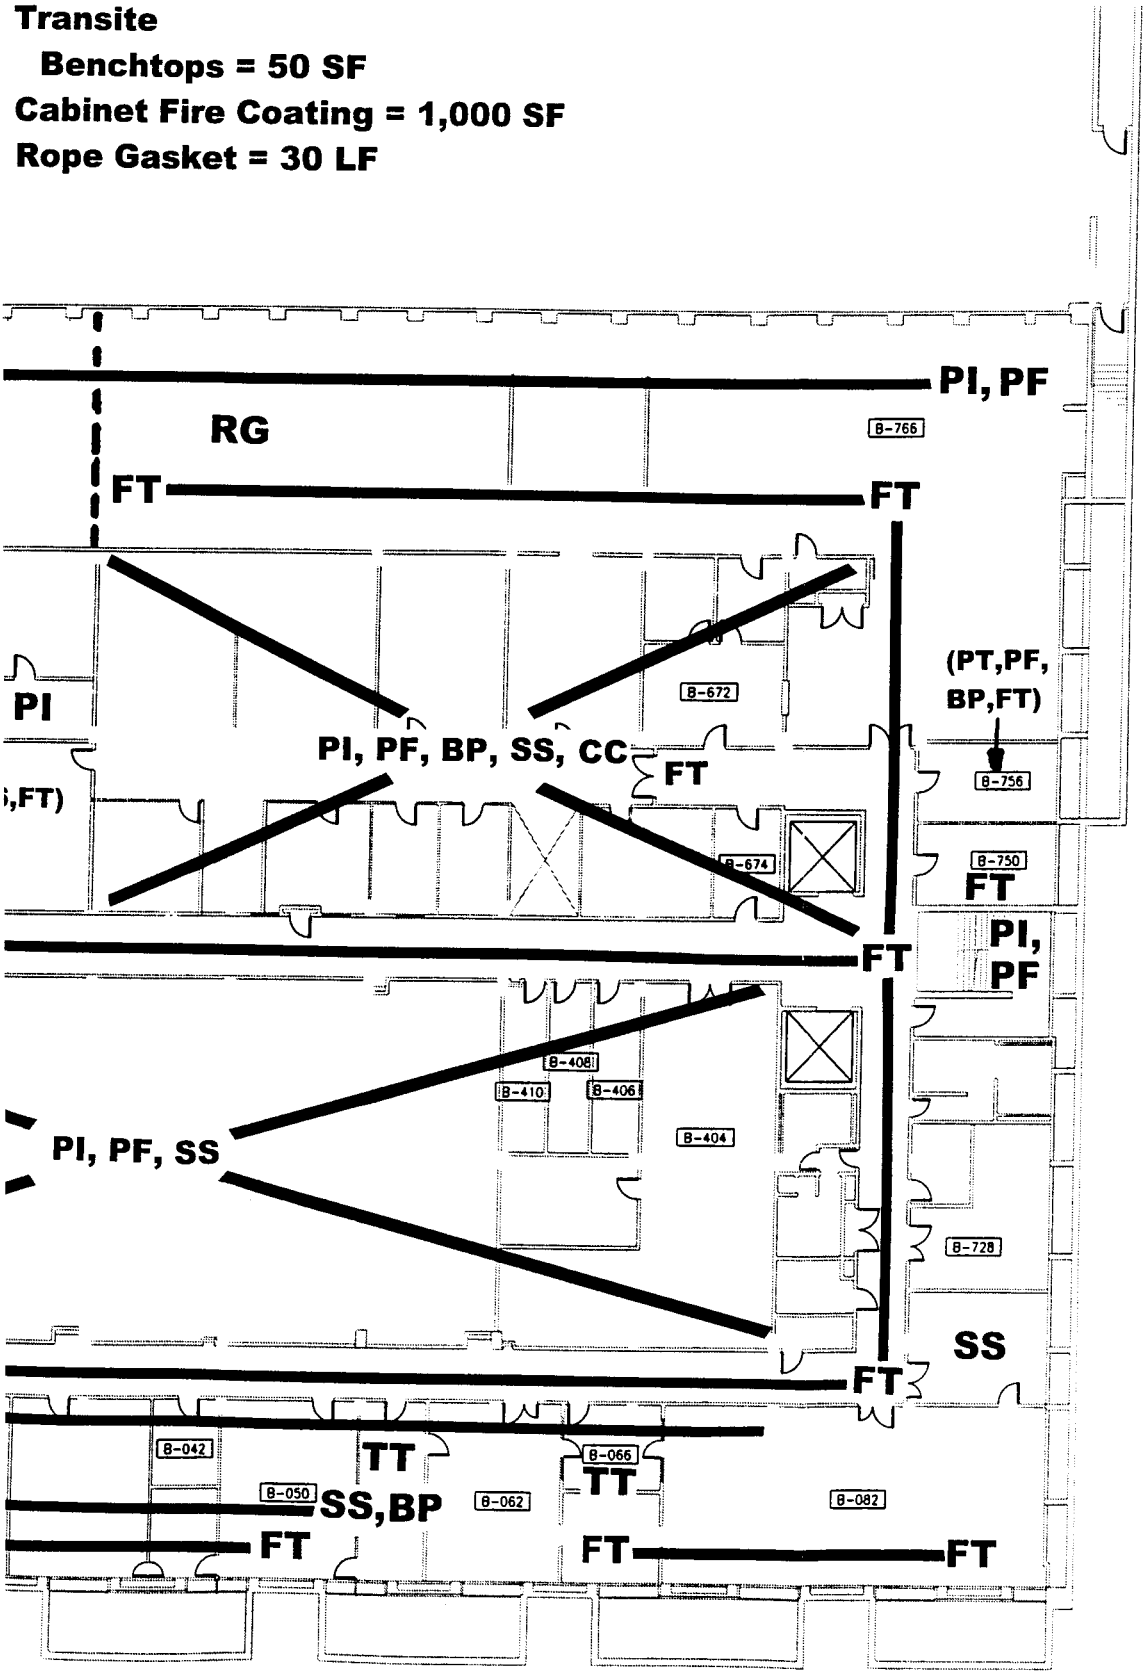
1 BASEMENT EXISTING PLAN

FP: Sprayed-on Fire Proofing = 500 SF

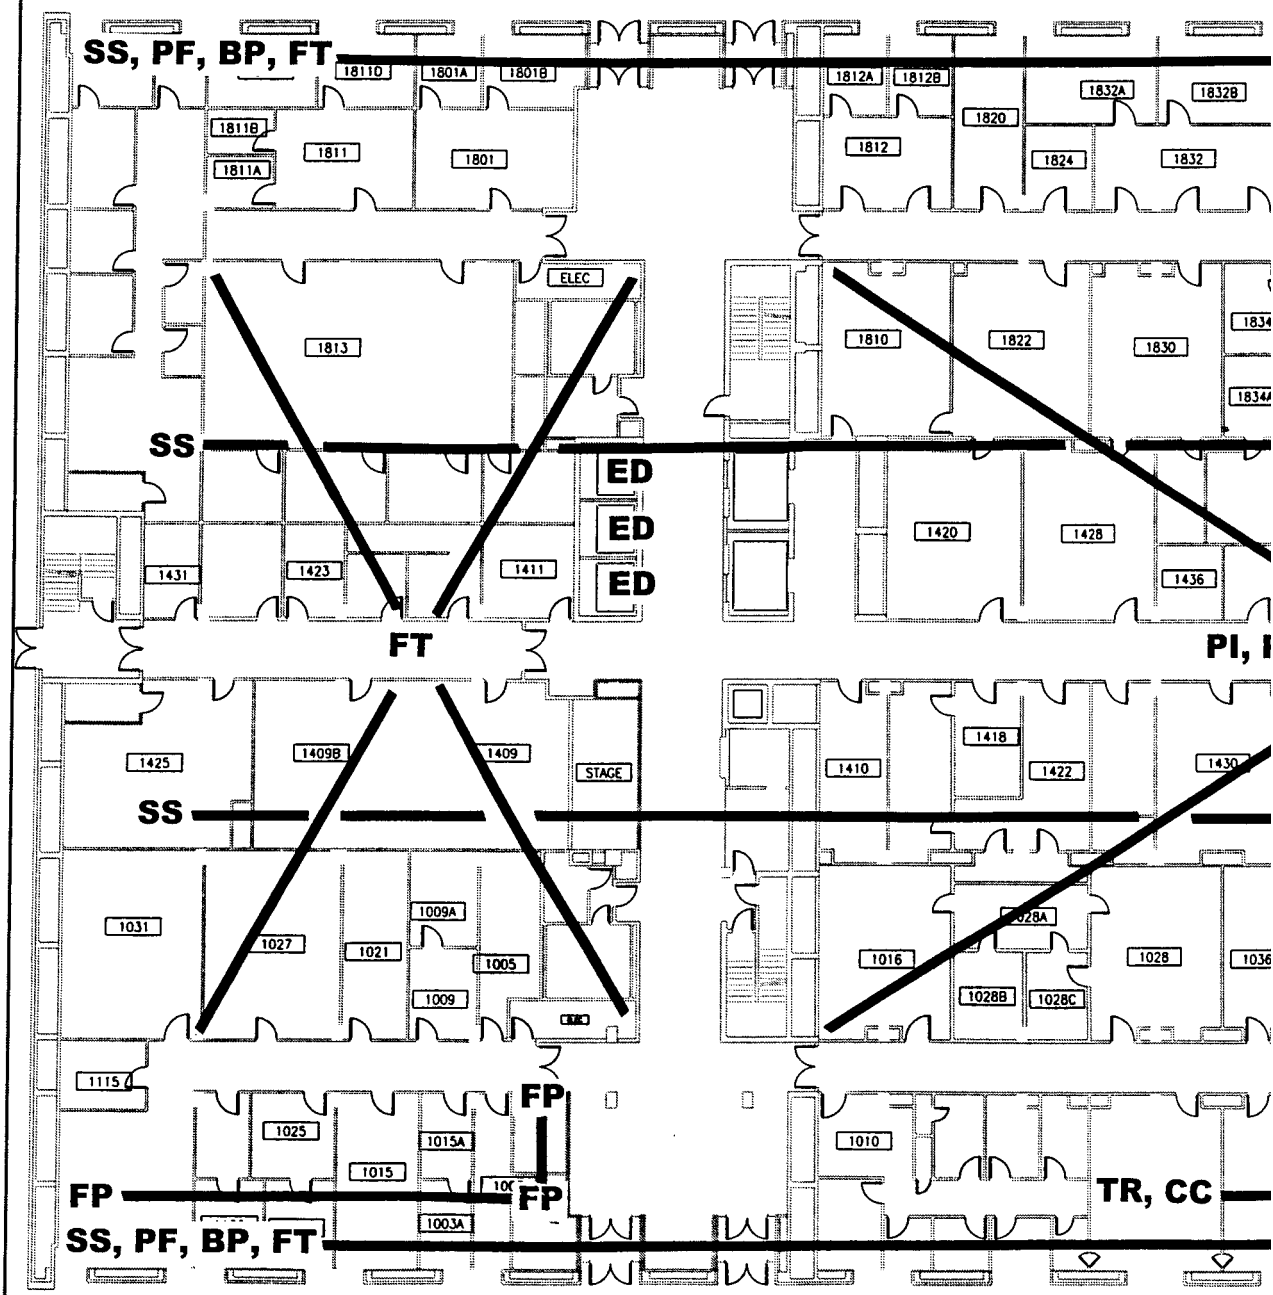
Figure 3

e Insulation = 800 LF
ansite
ume Hoods = 6,000 SF
enchtops = 10,000 SF
binet Fire Coating = 15,000 SF
evator Doors = 100 SF

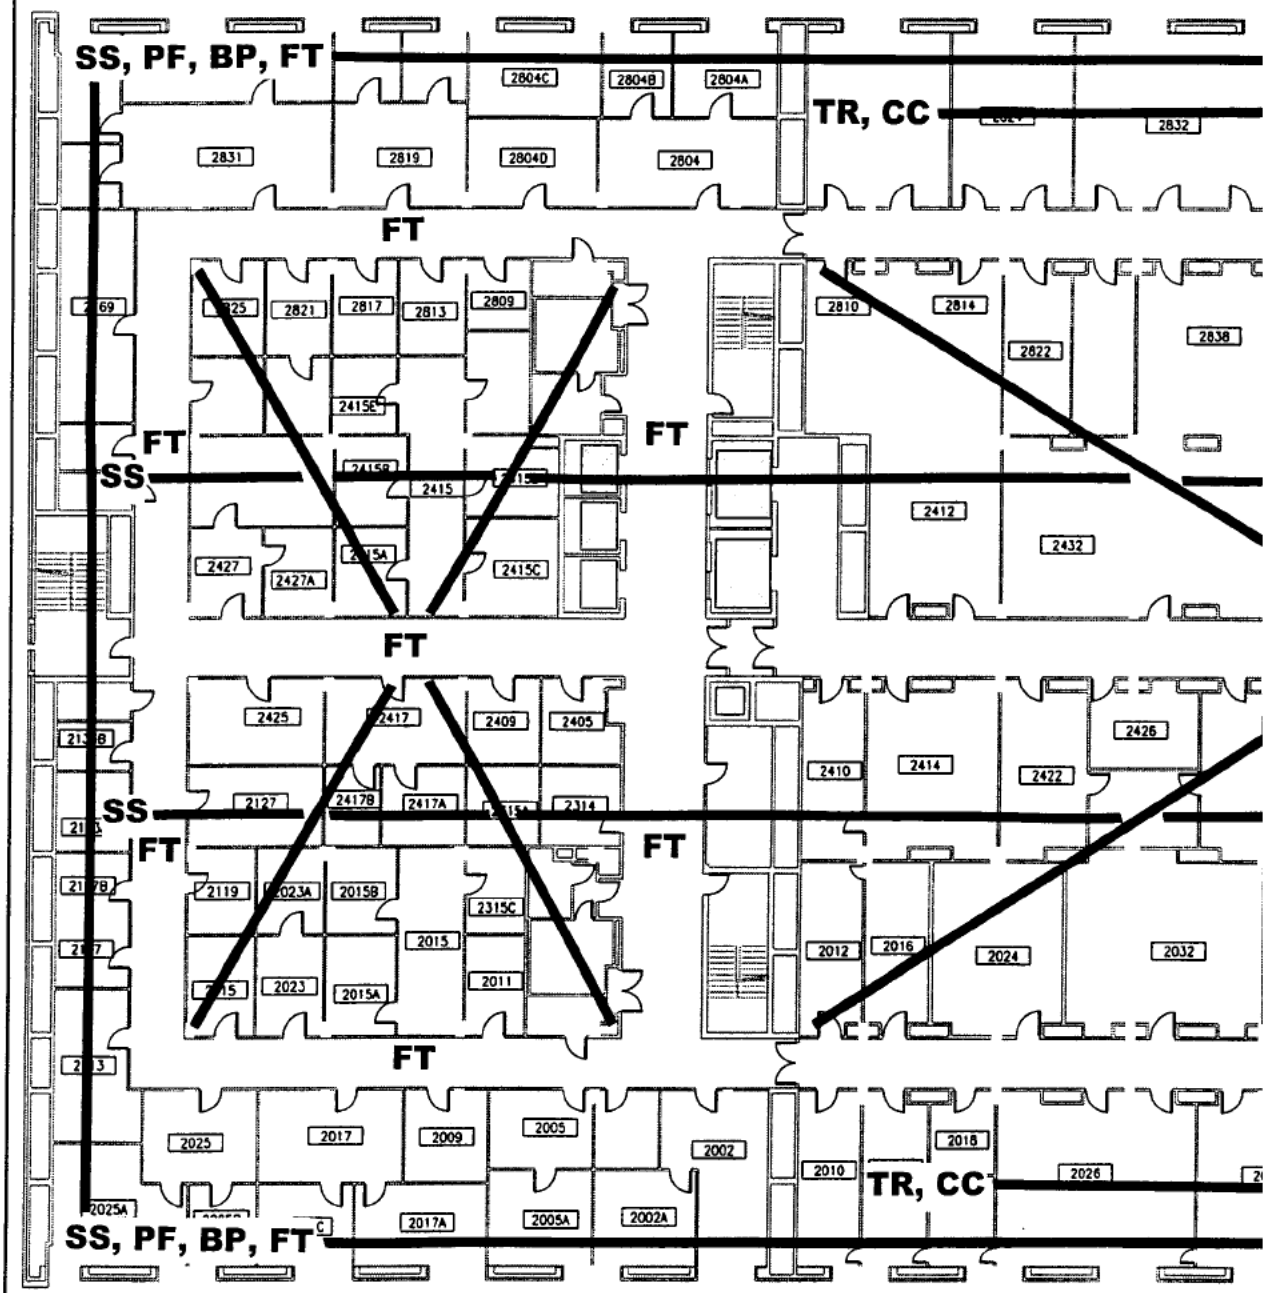
Figure 4

e Insulation = 800 LF
ansite
ume Hoods = 2,500 SF
enchtops = 6,000 SF
binet Fire Coating = 10,000 SF

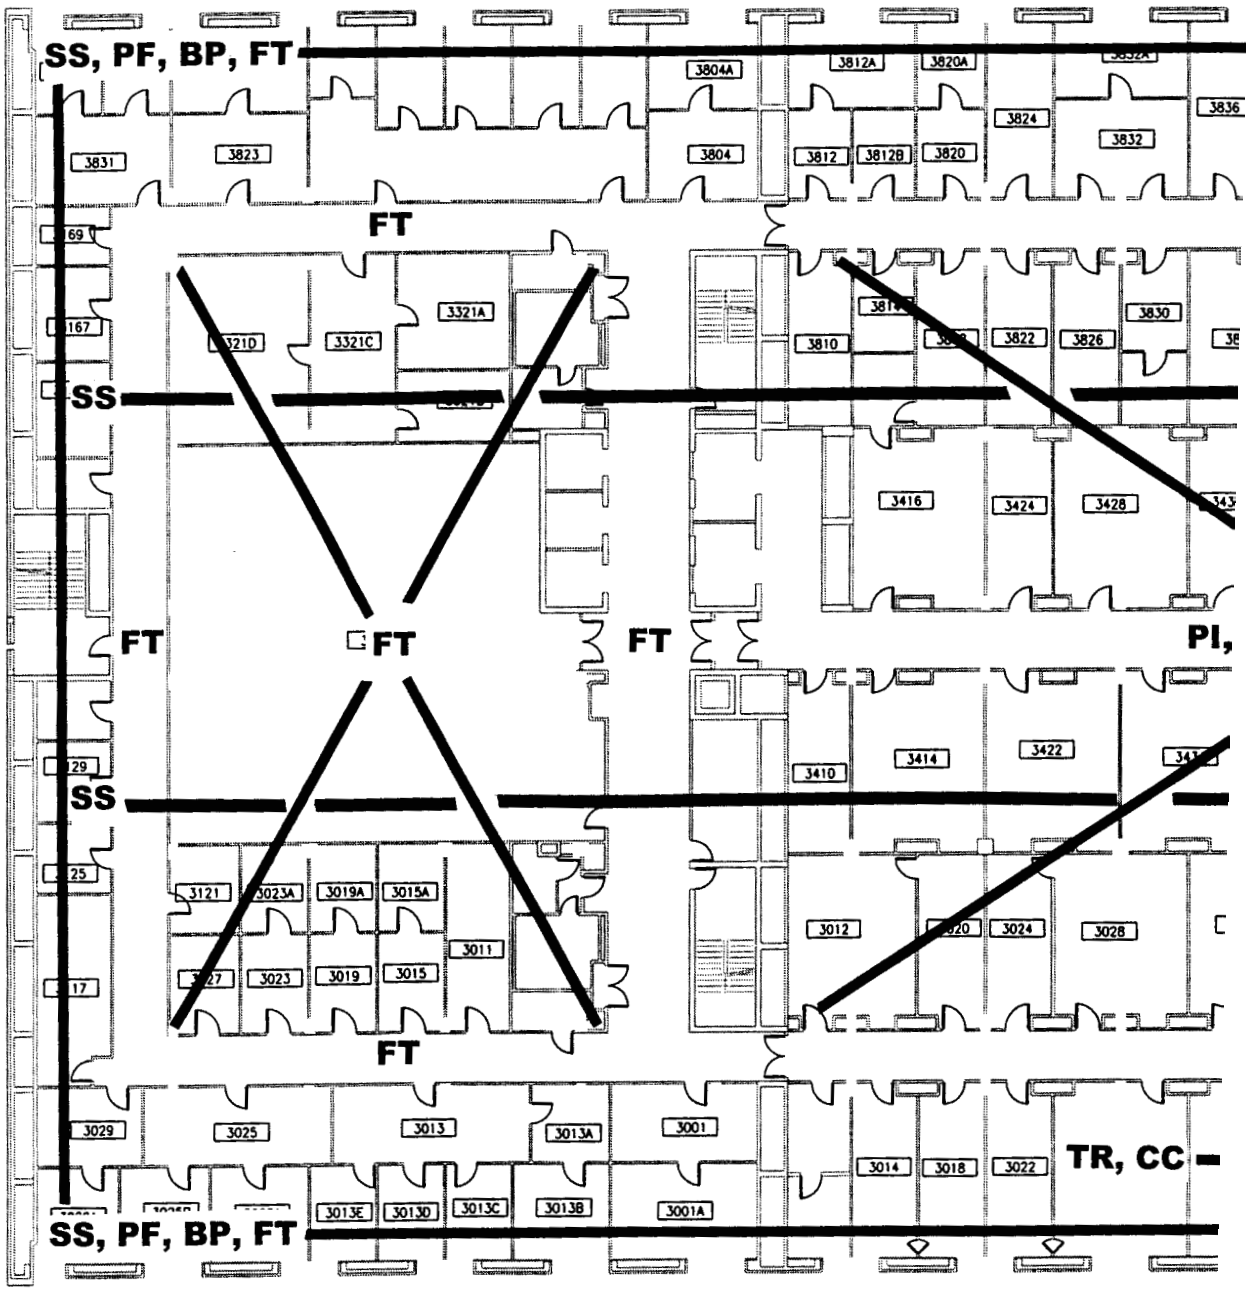
Figure 5

pe Insulation = 950 LF
ransite
Fume Hoods = 3,700 SF
Benchtops = 13,200 SF
abinet Fire Coating = 14,000 SF

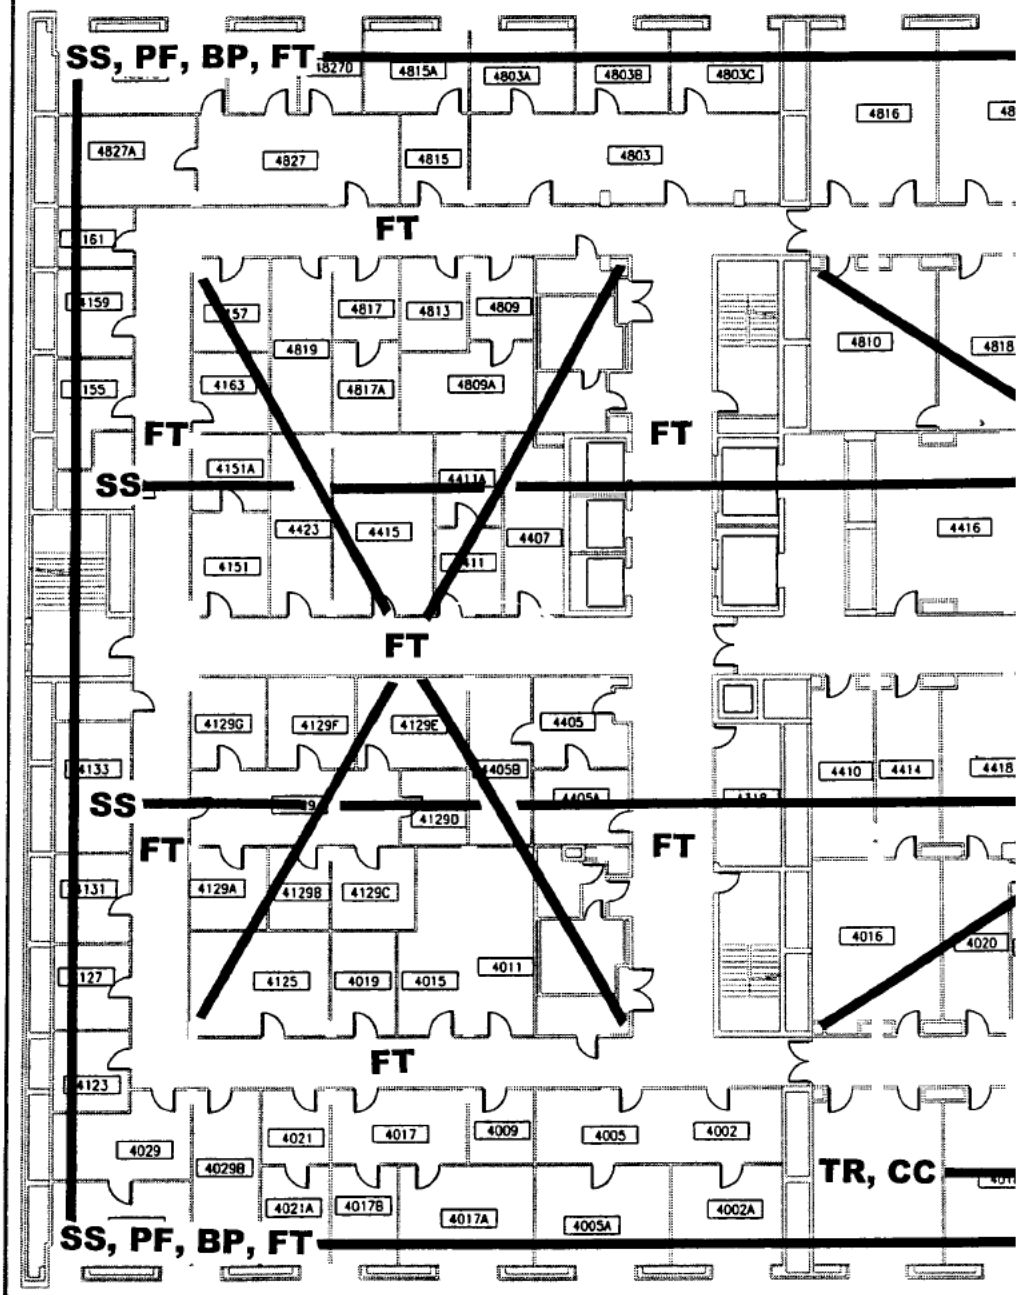
Figure 6

Benchtops = 8,700 SF

CC: Cabinet Fire Coating = 16,000 SF

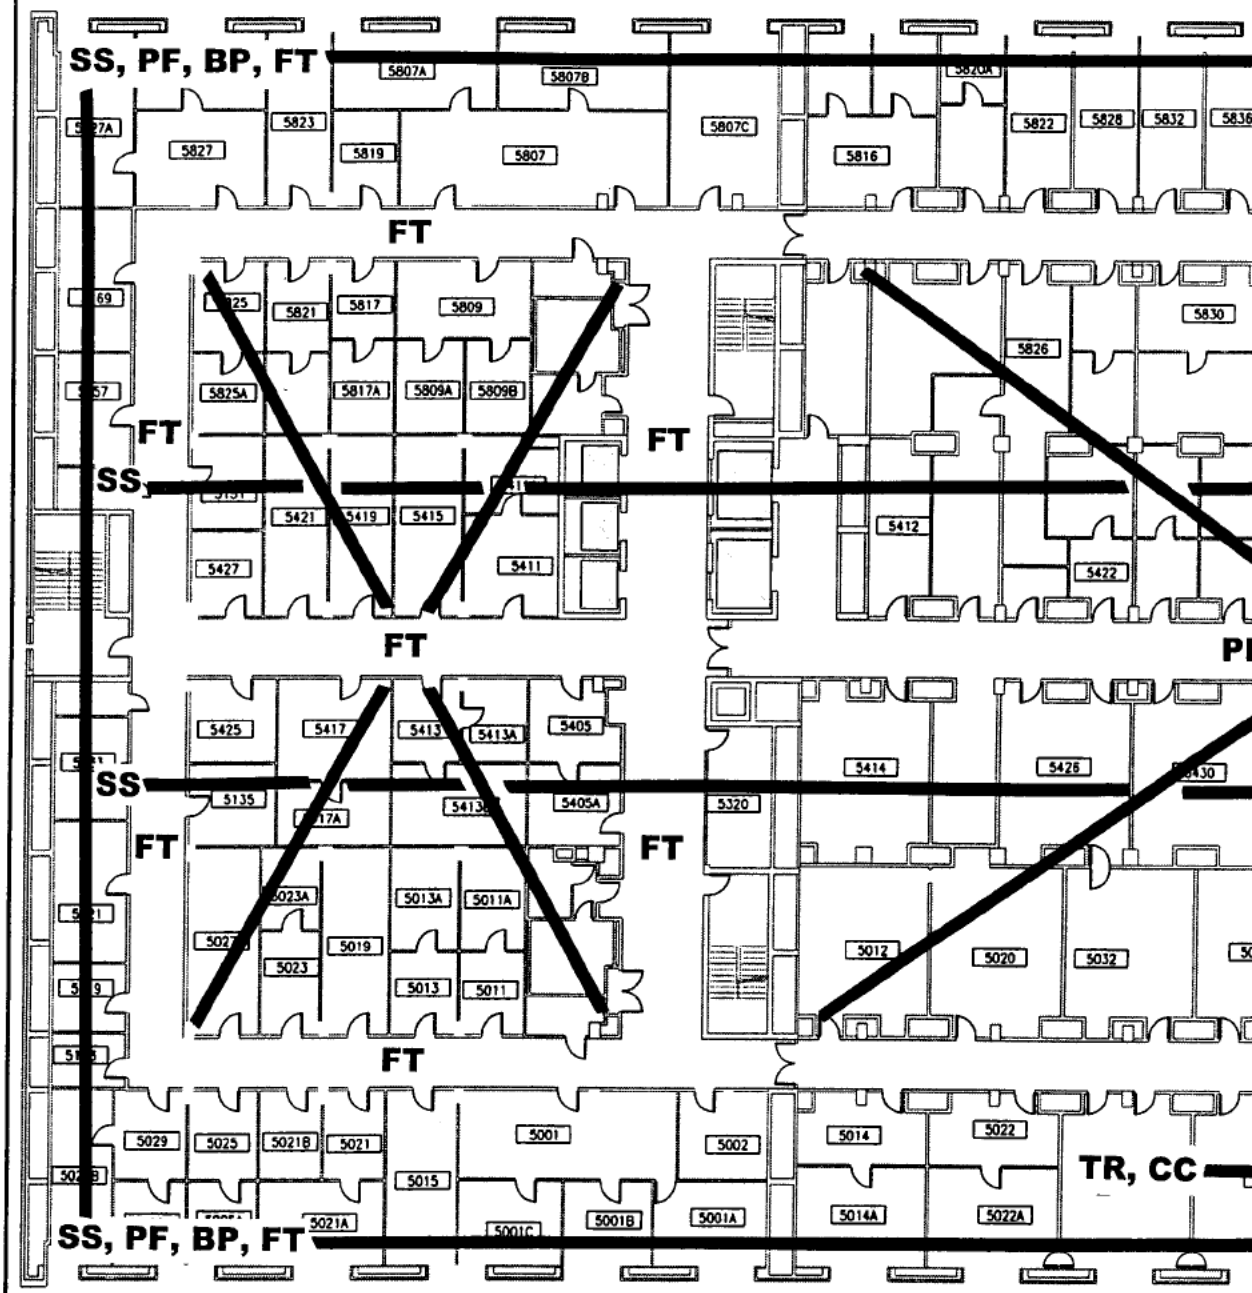
Figure 7

ipe Insulation = 1,300 LF
Transite
Fume Hoods = 2,200 SF
Benchtops = 5,500 SF
Cabinet Fire Coating = 4,000 SF

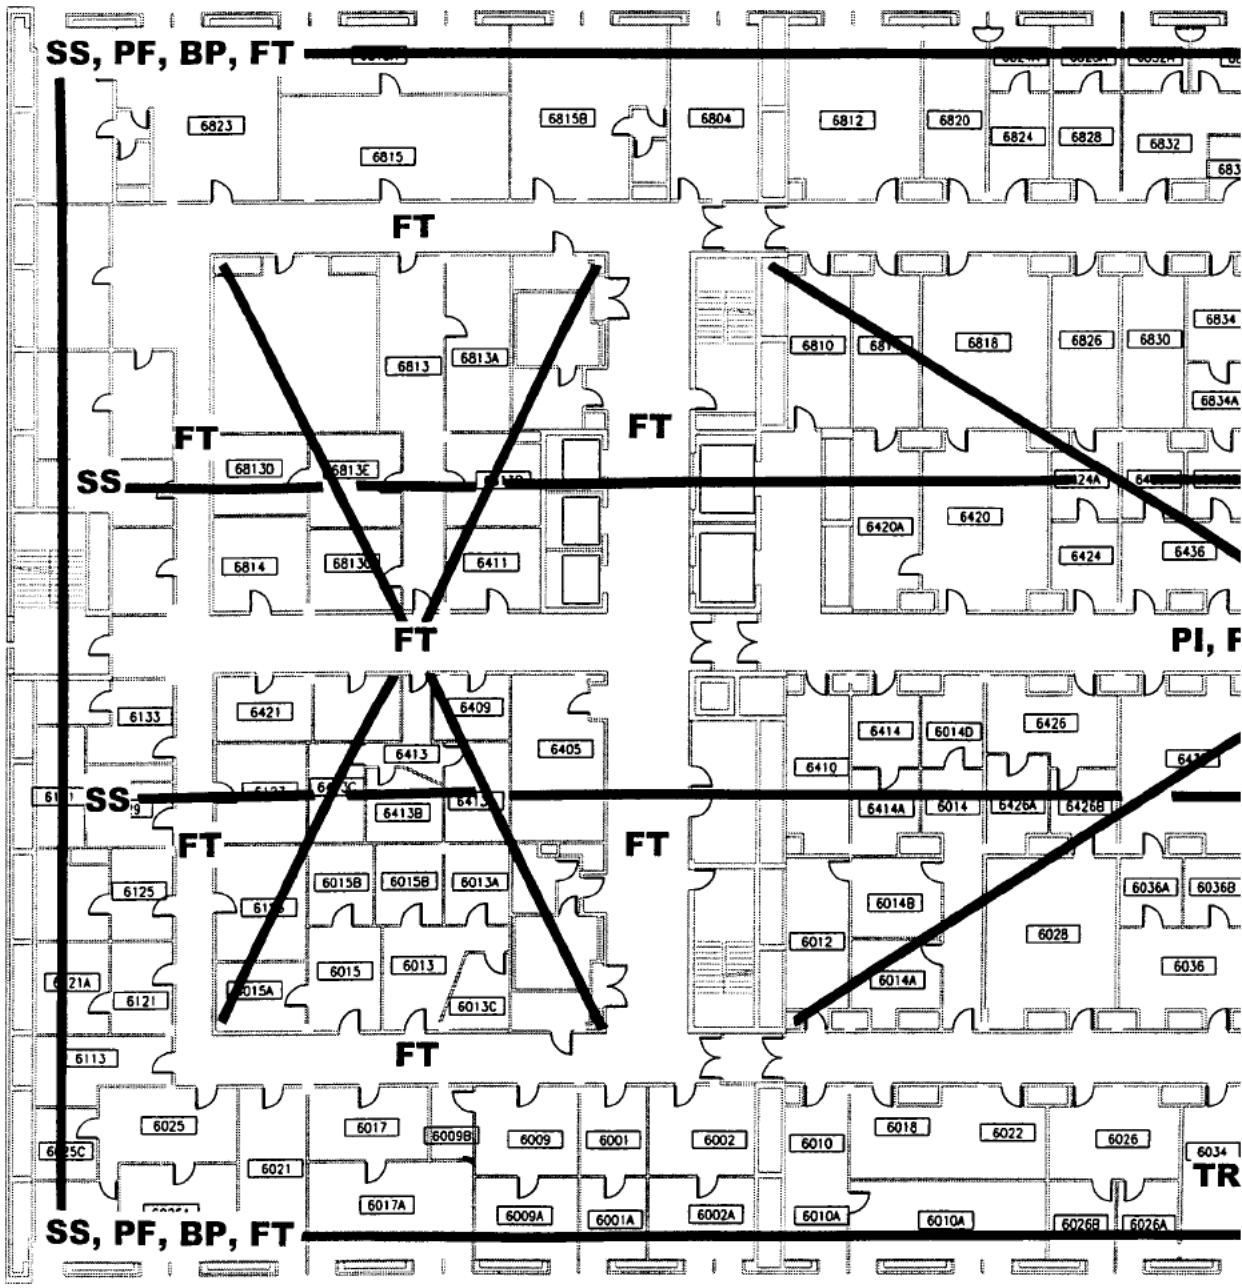
Figure 8

ipe Insulation = 150 LF
'ransite
Fume Hoods = 2,200 SF
Benchtops = 5,300 SF
:abinet Fire Coating = 2,700 SF

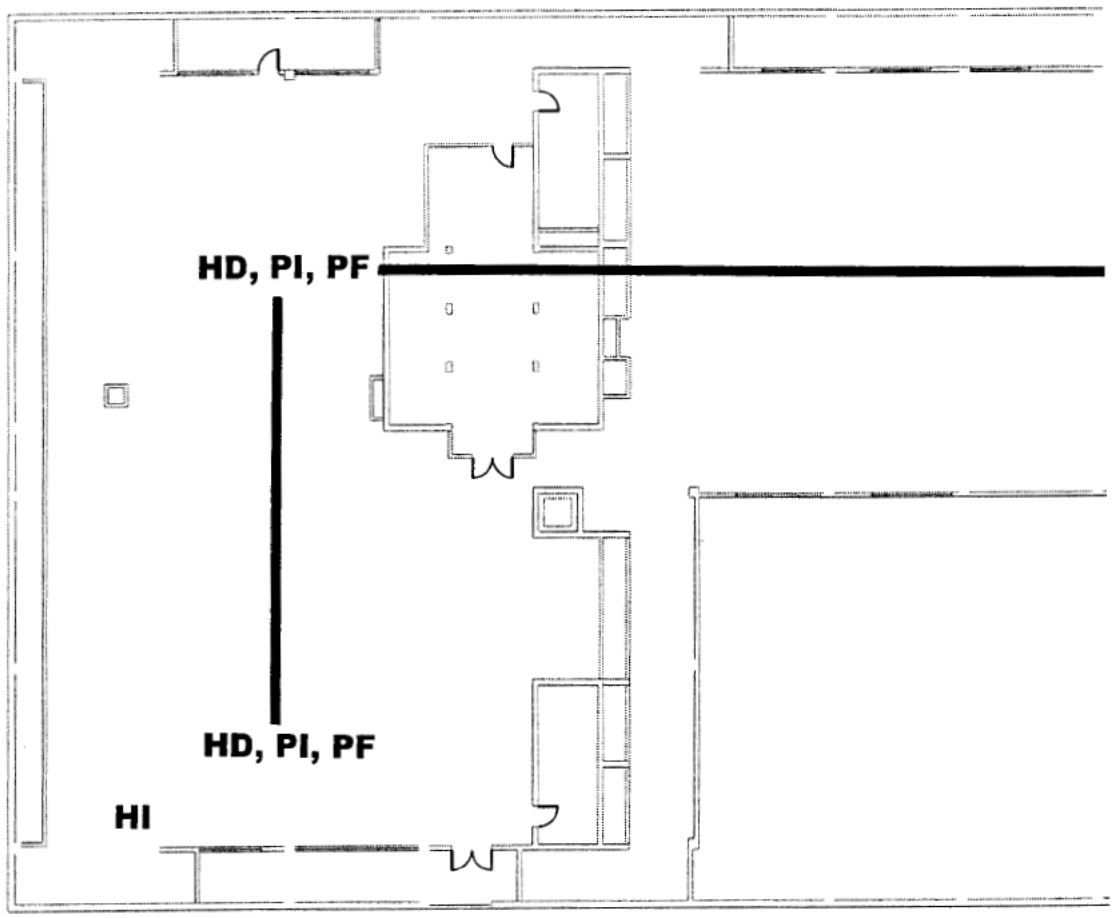
Figure 9

HD: Air Handling Duct Insulation = 36,000 SF

HI: Fume Hood Insulation = 450 Square Feet

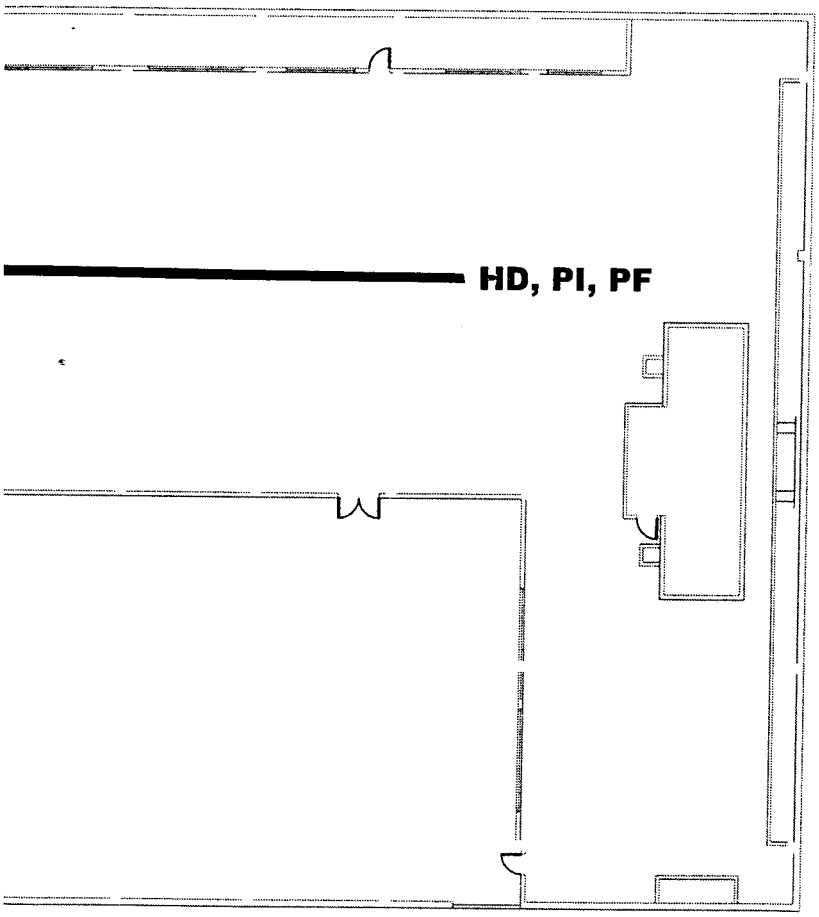
1 PENTHOUSE FLOOR PLAN - EXISTING
