RE: COLUMBUS SCRAP CORP.
FRANKLIN COUNTY, OHIO
OHD131884348
PRELIMINARY ASSESSMENT

PRELIMINARY ASSESSMENT
COLUMBUS SCRAP CORPORATION
FRANKLIN COUNTY, OHIO
USEPA ID# OHD131884348

JANUARY 30, 1992

Site: Columbus Scrap Corporation
580 Furnace Street
Franklin County, Ohio

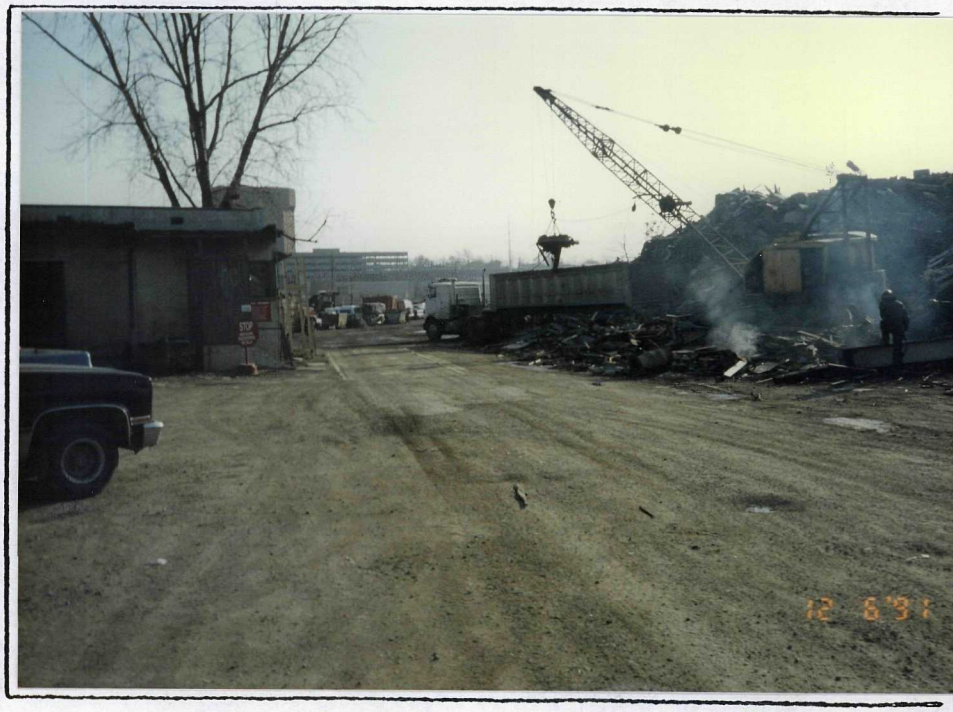
EXHIBIT NO: 5 3

OBJECT: OFFICE ON LEFT, SCALE IN CENTER

REMARKS: CRANE / CUTTING AREA ON RIGHT

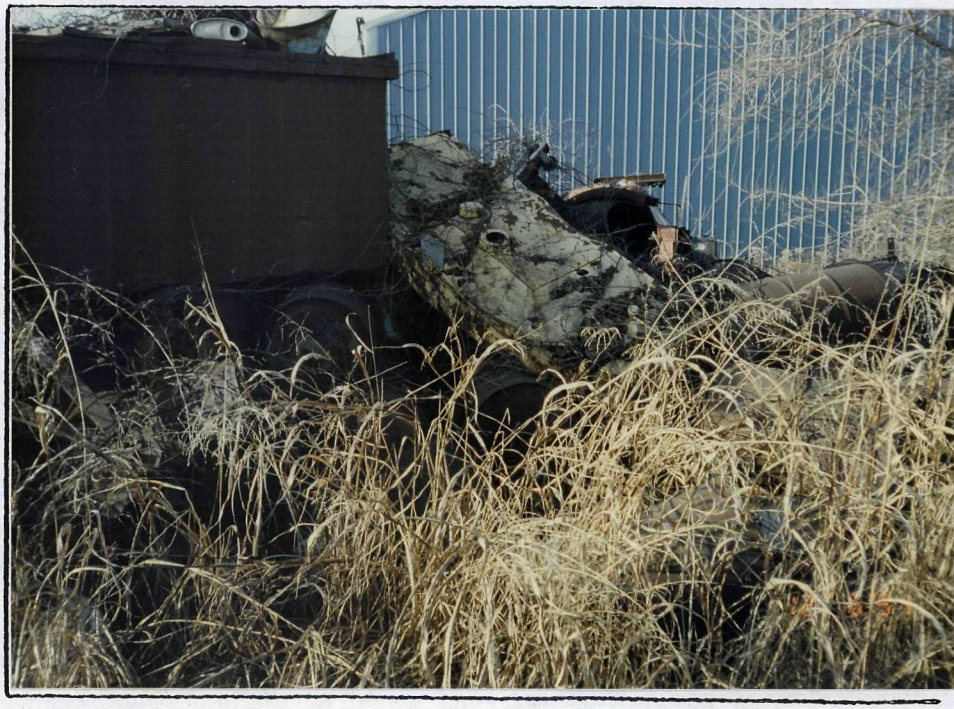
EXHIBIT NO: 9 3

SCRAP PILE
