ENVIRONMENTAL PROTECTION AGENCY STATE OF ILLINOIS

INSPECTION REPORT - SITE INVENTORY NO. 2970501
(11)

Lockport / Wasteland #2 Letter Sent (Yes or No) N
(Location) (Responsible Party) (26)

Lockport / Wasteland #2

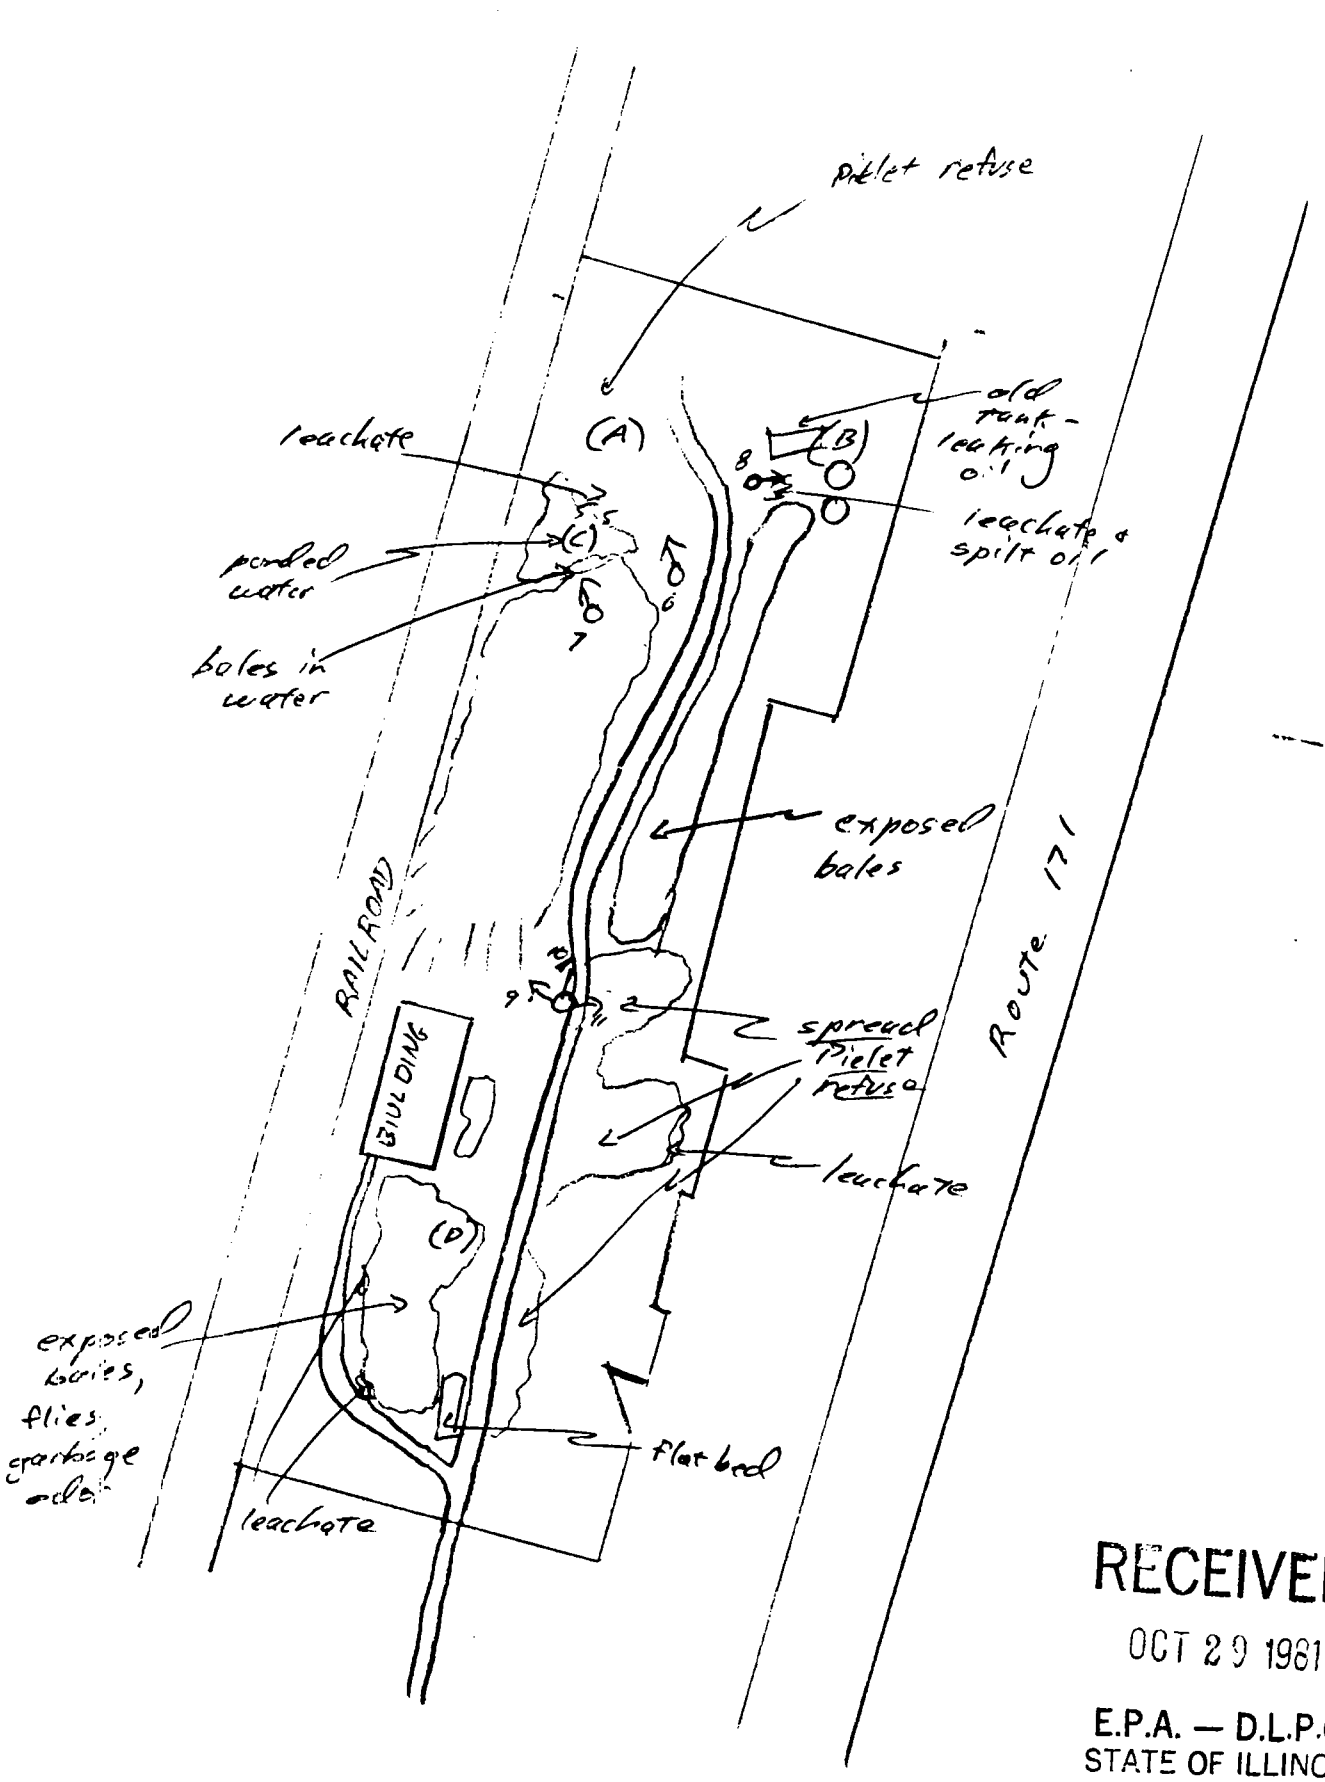
DIAGRAM: SEE ACCOMPANYING DIAGRAM

GENERAL REMARKS: This inspection revealed that the cardboard re-baleing operation is still active, and that no remedial actions, ie. removal of openly dumped refuse, have taken place. It does appear that additional Pielet refuse may have been dumped and spread around (A). Leachate was seen in several spots throughout the site, and oil remains on the ground near the old tank at (B). Bales remain in contact with ponded water at (C); leachate was also observed to be seeping into this water. More bales have been added at (D), numerous flies and a rank garbage odor were noted here.
