ENVIRONMENTAL PROTECTION AGENCY STATE OF ILLINOIS

OBSERVATION REPORT - SITE INVENTORY NO. 19705002
(11) (18)

SUBJECT: LPC #19705002 - Will Co. - Lockport/Wasteland

LOCKPORT / WASTELAND

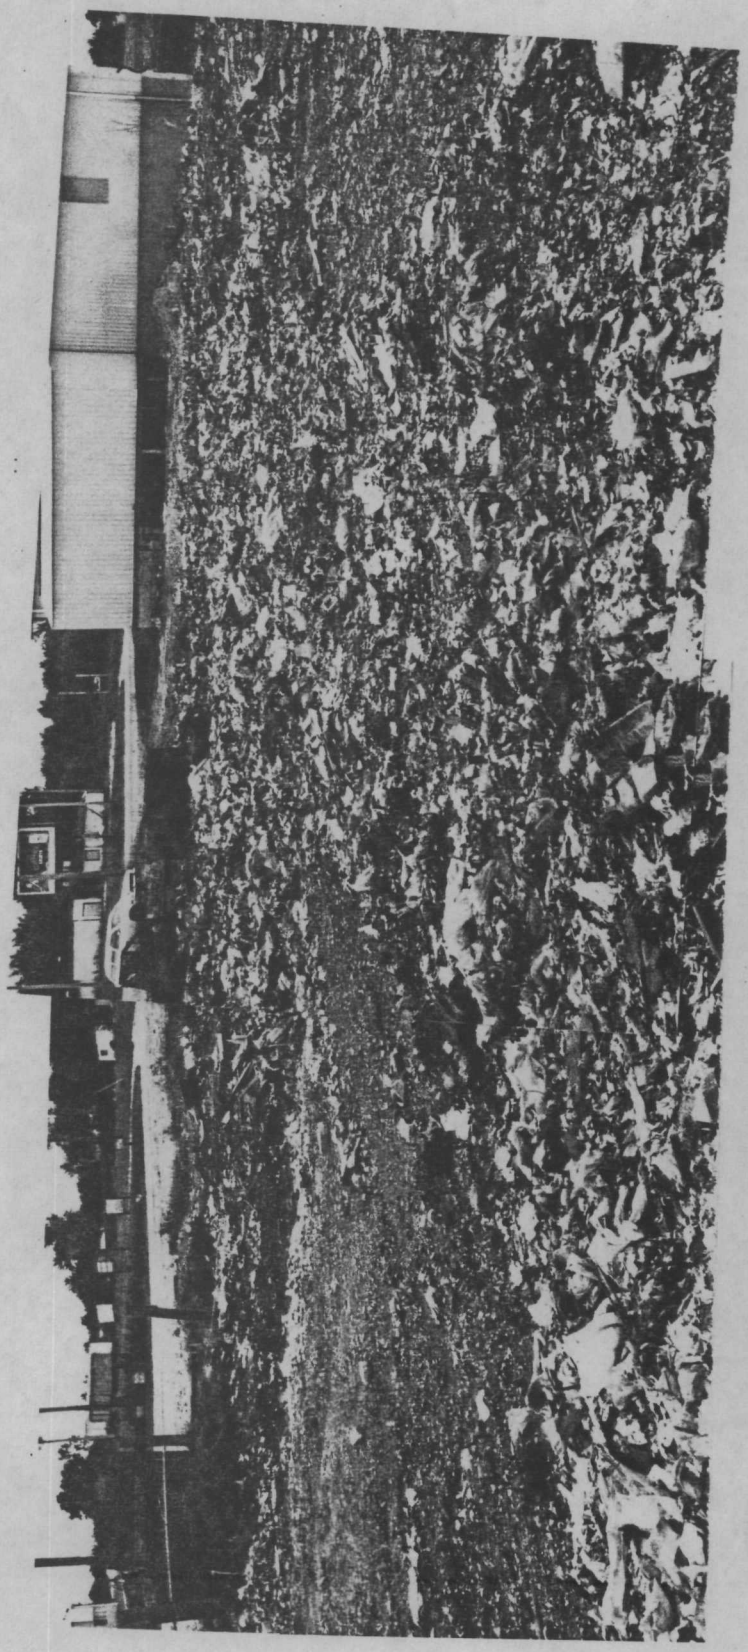
Comments: Photograph taken toward the southeast from the north portion of the landfill.

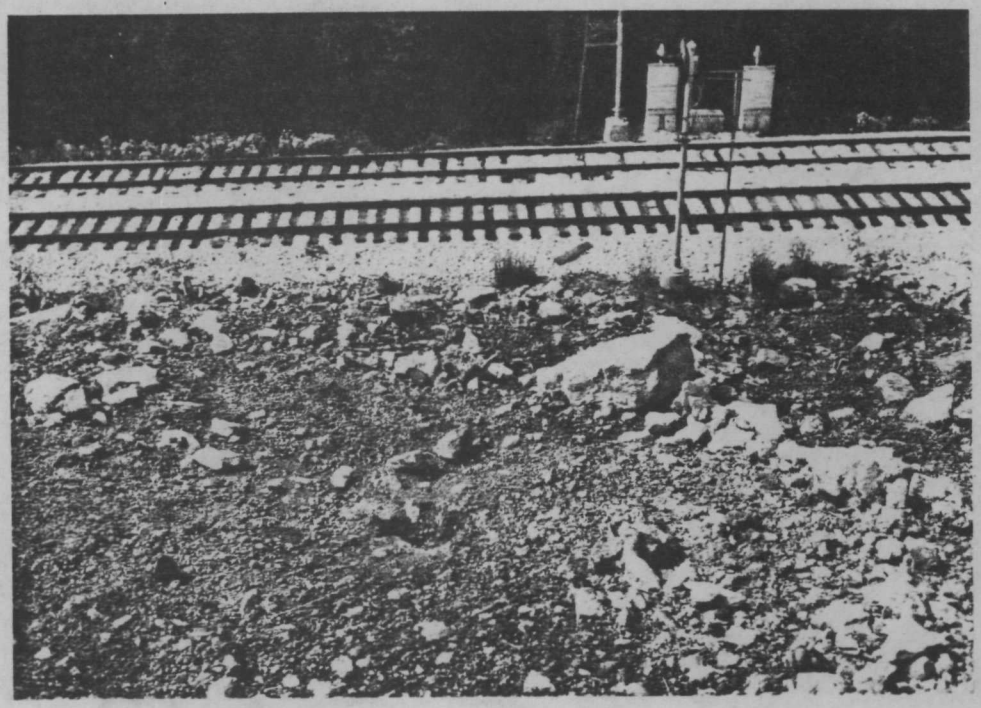
Comments: Photograph taken toward the west from the north portion of the Landfill

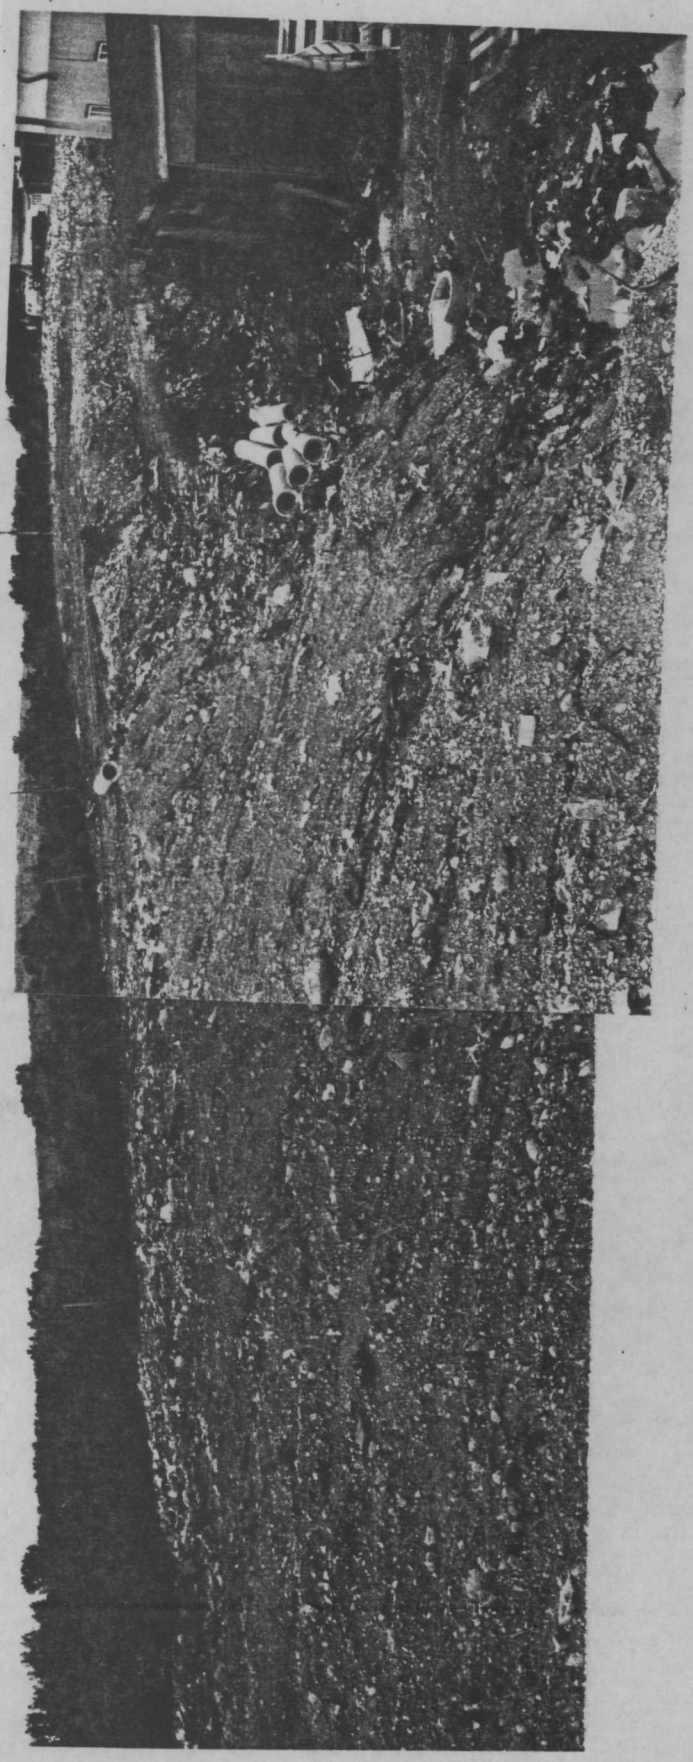
Comments: Photograph taken toward the North from the central portion of the Landfill.

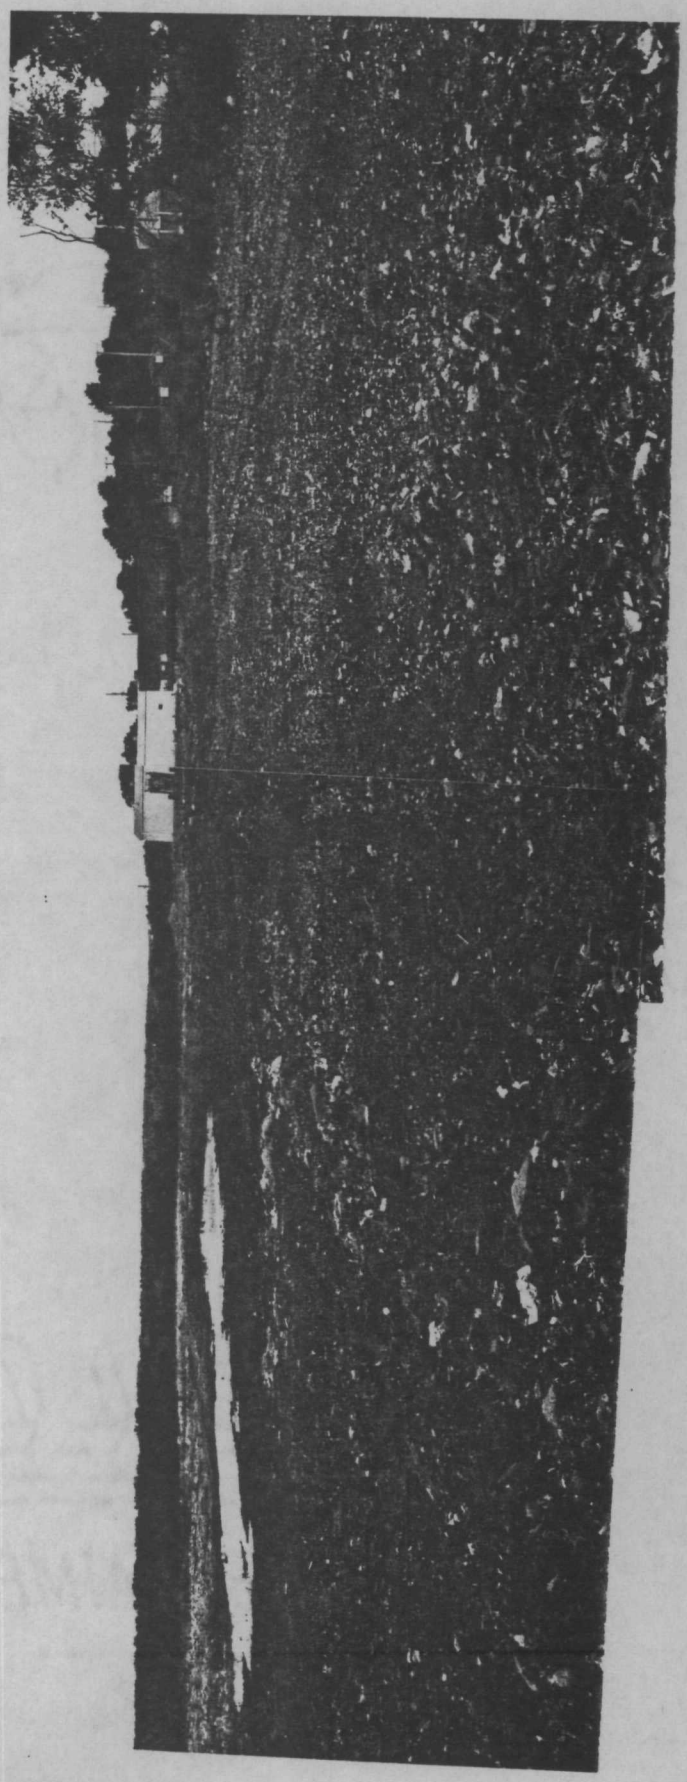
Comments: Photograph taken toward the north from the south portion of the Landfill

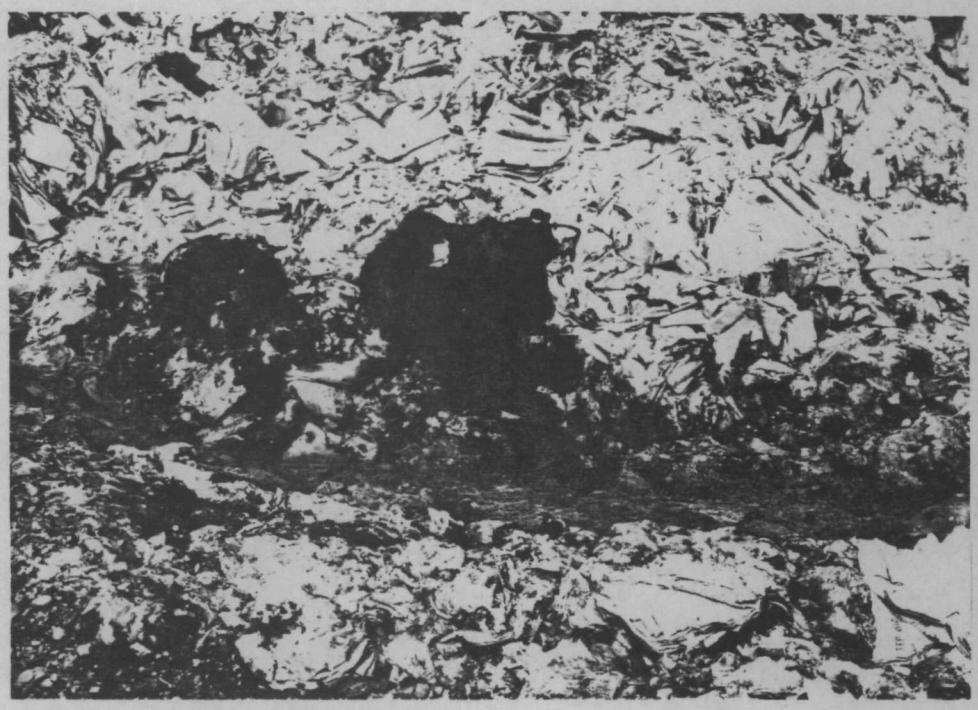
Comments: Photograph taken toward the North from the south end of the site

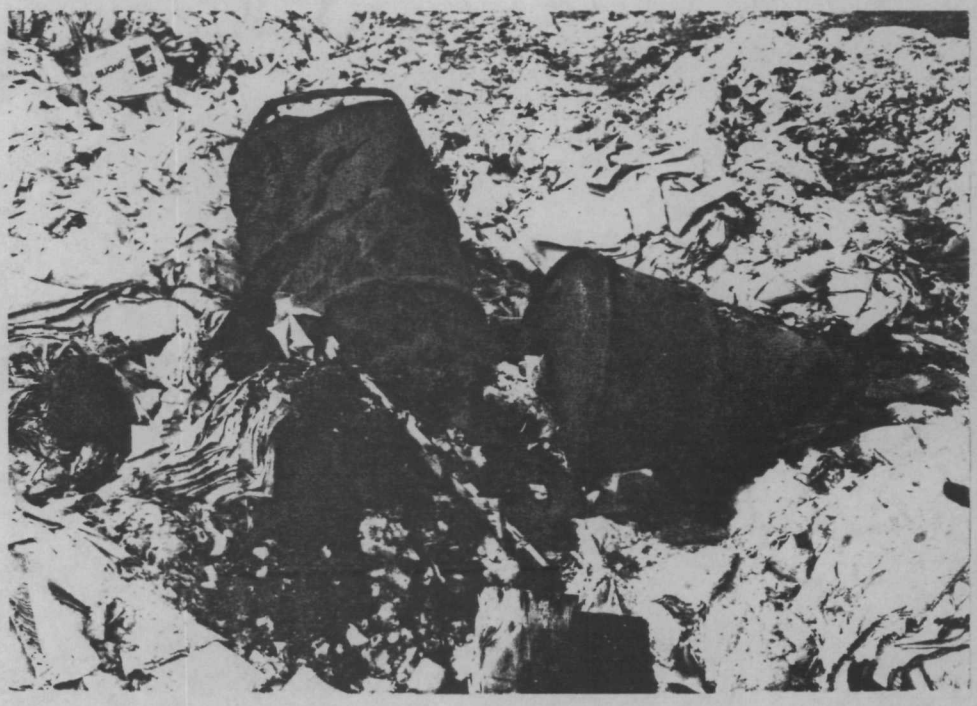
Comments: Photograph taken toward the North from the south end of the site.
