CWA COMPLIANCE EVALUATION INSPECTION REPORT
U.S. ENVIRONMENTAL PROTECTION AGENCY, REGION 5

Purpose:
Compliance Evaluation Inspection

Facility:
Ex. 6 (Personal Privacy) [redacted] Farms, Ltd.
Ex. 6 (Personal Privacy) [redacted]

Date of Inspection:
September 28, 2016

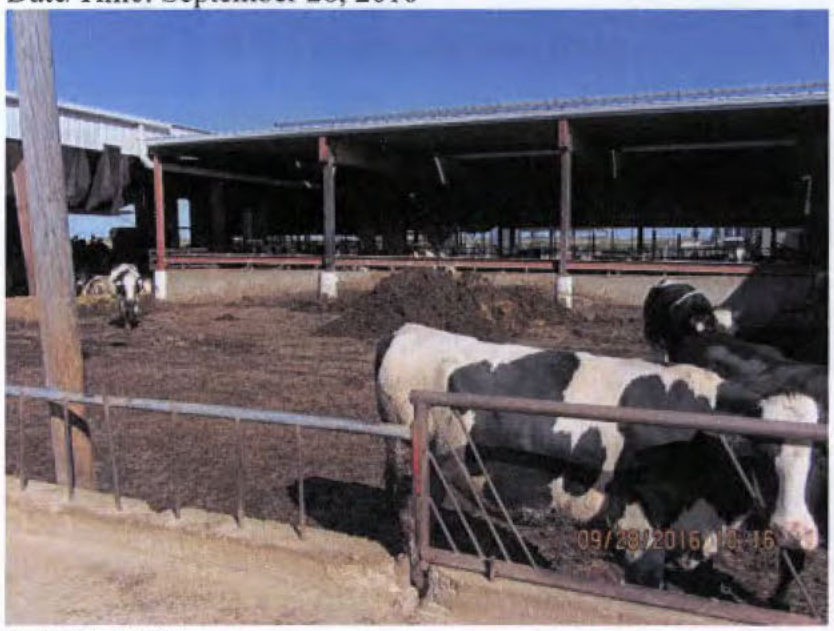
1: IMG_0103
Description: Open alley along the freestall barn has concrete curbing to prevent manure and process wastewater from leaving the pen. Commodities building in back has all commodities under roof.
Location: South of the Milking Parlor and freestall barn
Camera Direction: West
Date/Time: September 28, 2016

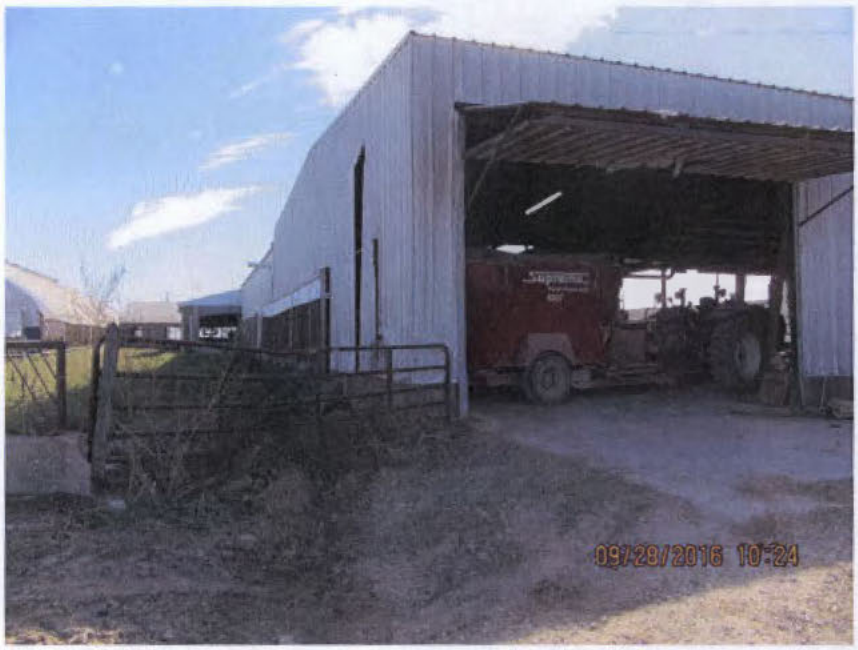
13: IMG_0115
Description: Feed mixer kept in barn. There was formerly an outdoor pen to the left of this barn. The pen has been decommissioned.
Location: West side of facility
Camera Direction: East
Date/Time: September 28, 2016
