PRELIMINARY ASSESSMENT
SMITTY'S SALVAGE AND SUPLY
BROWN COUNTY, WISCONSIN

August 19, 2002

WISCONSIN DEPARTMENT OF NATURAL RESOURCES
NORTHEAST REGION

Site: Smitty's Salvage & Supply
2325 Main Street
Brown County, Wisconsin

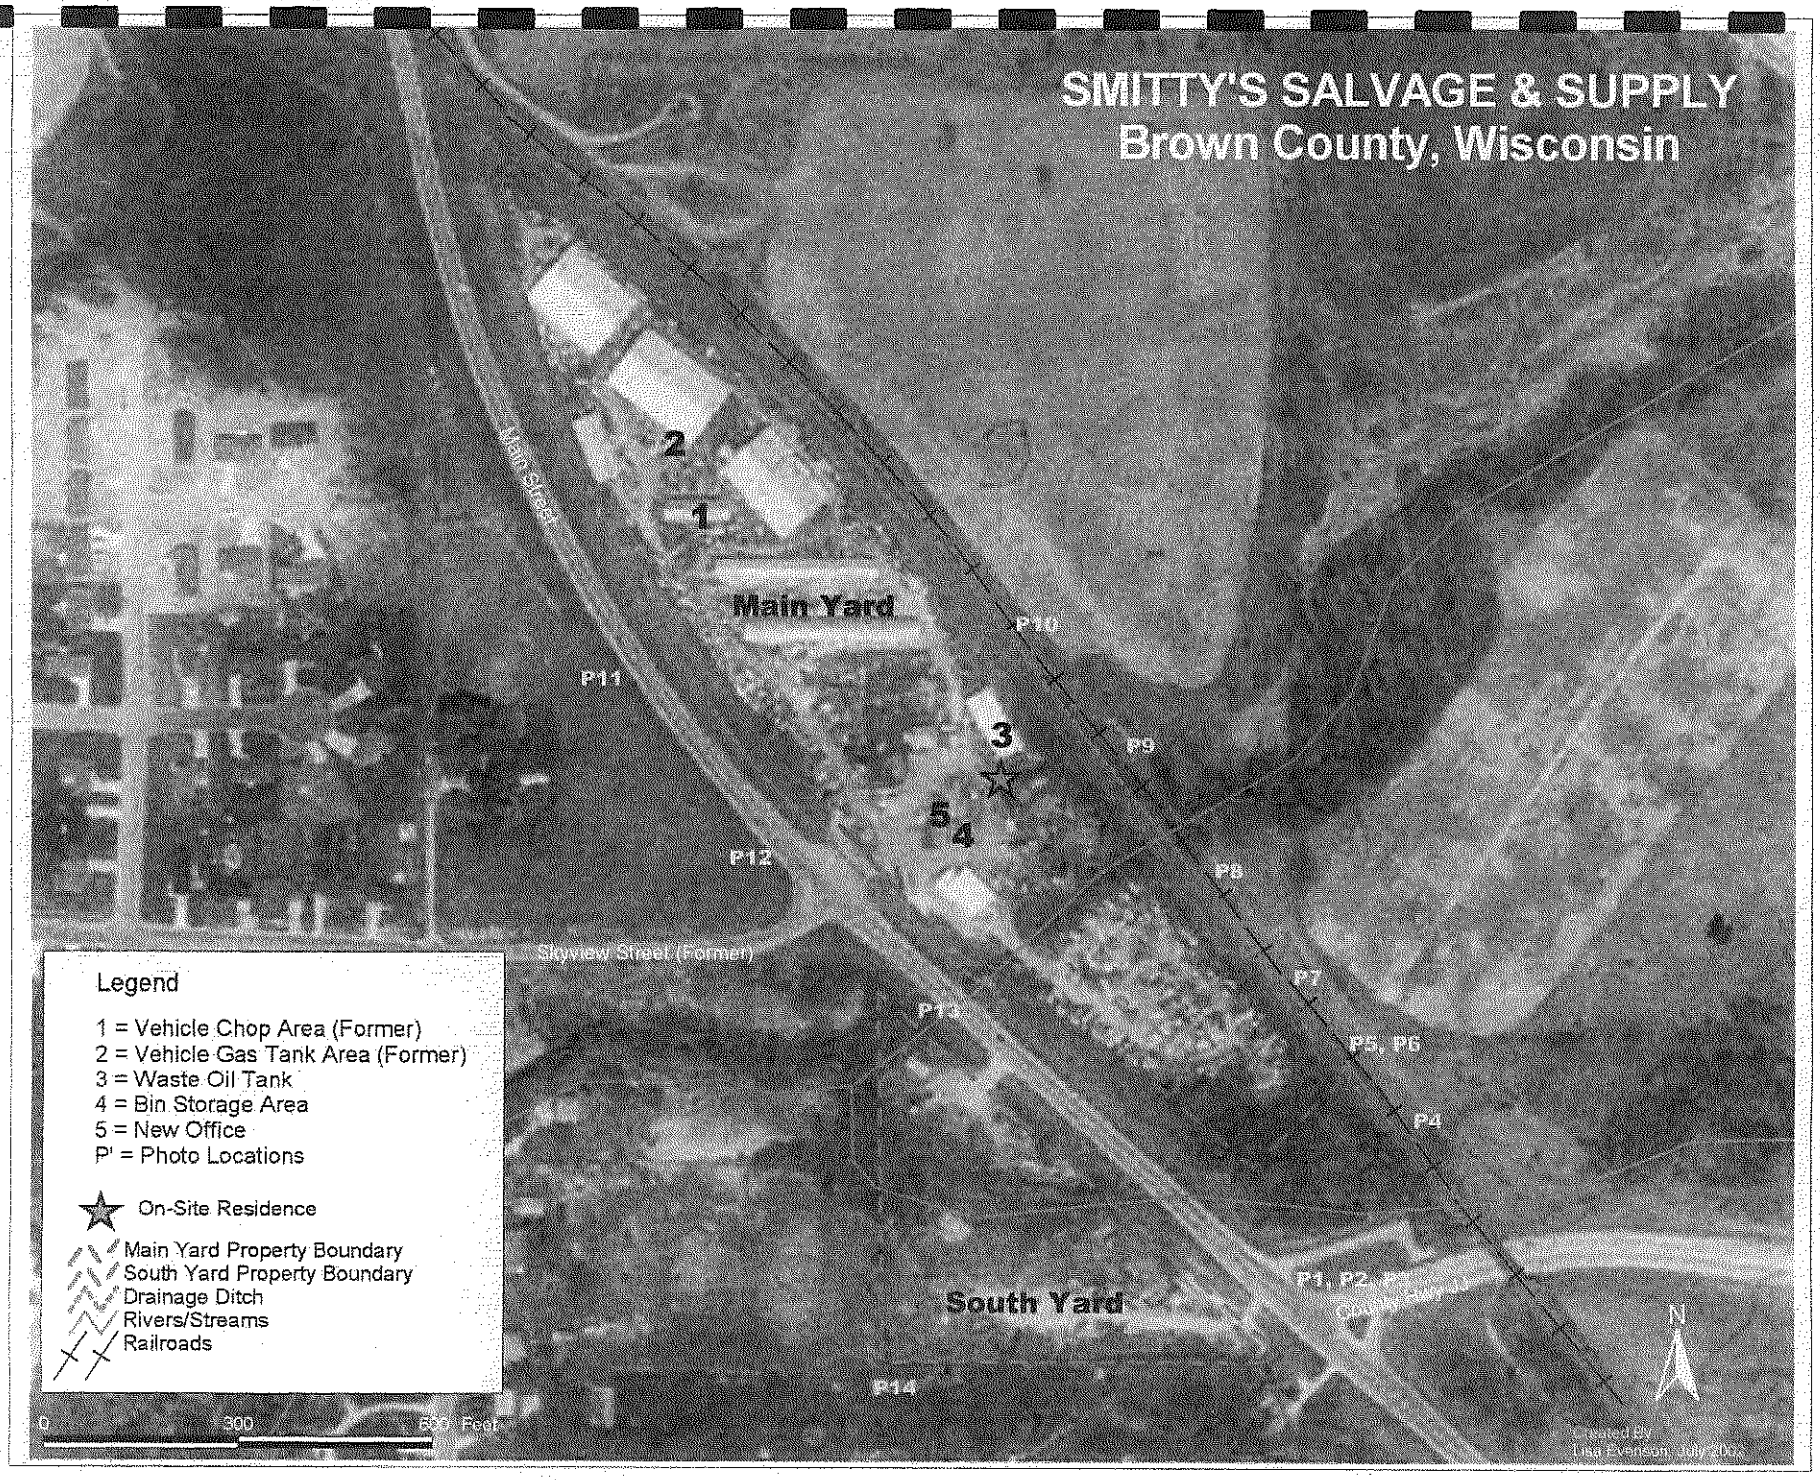
Figure 2

Bernard and Mary Smits to define the degree and extent of petroleum contamination on the Main Yard in the bin storage, old chop and vehicle gas tank pile (former) areas (Figure 2).

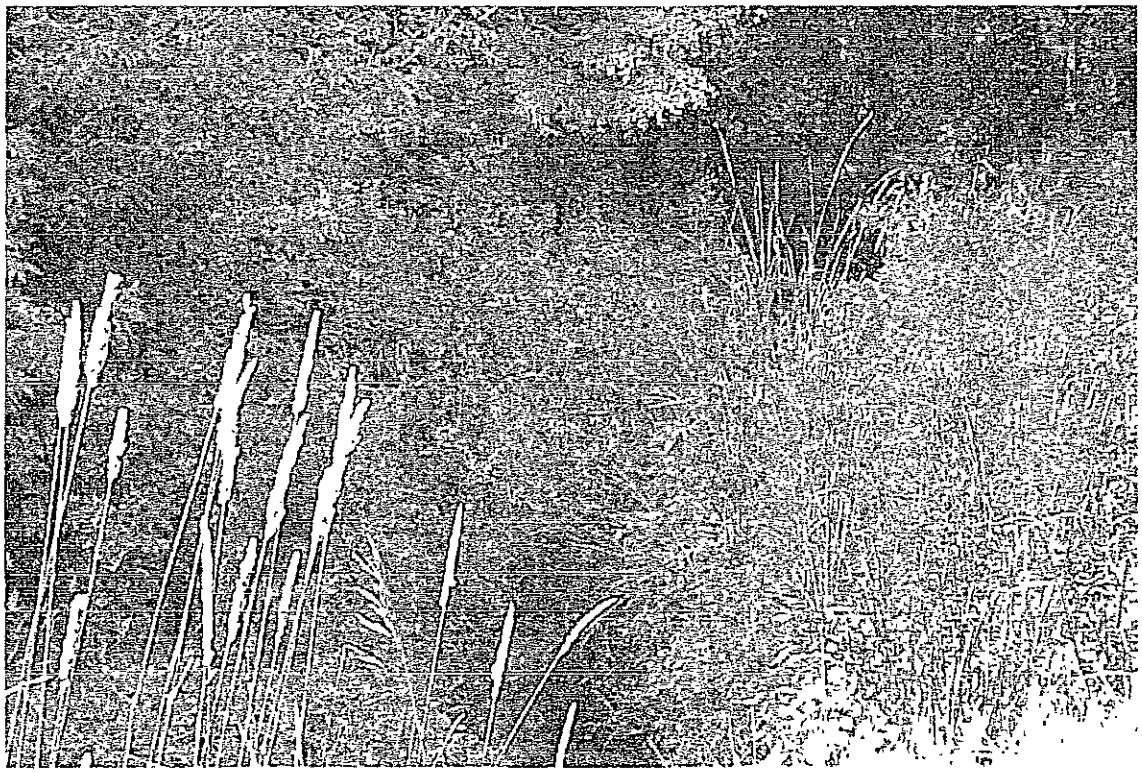
Photograph 13 East side of South Yard looking toward the southwest

One branch of the creek was observed along the east property boundary of the South Yard (photograph 13) Thick vegetation was observed on both sides of the creek There was water in the creek bed but no significant level of flow was observed The South Yard is not restricted to public access by any type of fence Thick vegetation consisting of grasses and trees cover the South Yard and can be observed in photograph 14 A single residential home was observed approximately 100 feet east of the South Yard on the southeast corner of the intersection of Main Street and County JJ Two small office buildings were also observed to the south of the South Yard
