MEMORANDUM

Subject: Meeting with Dave Murray of Reitz & Jens, Inc. concerning proposed revisions of the previously approved Westlake Landfill plans and specifications

REPORT OF SAMPLE ANALYSIS
LANDFILL MONITORING PROJECT

Landfill Monitoring Report
West Lake Landfill
January 5, 1981

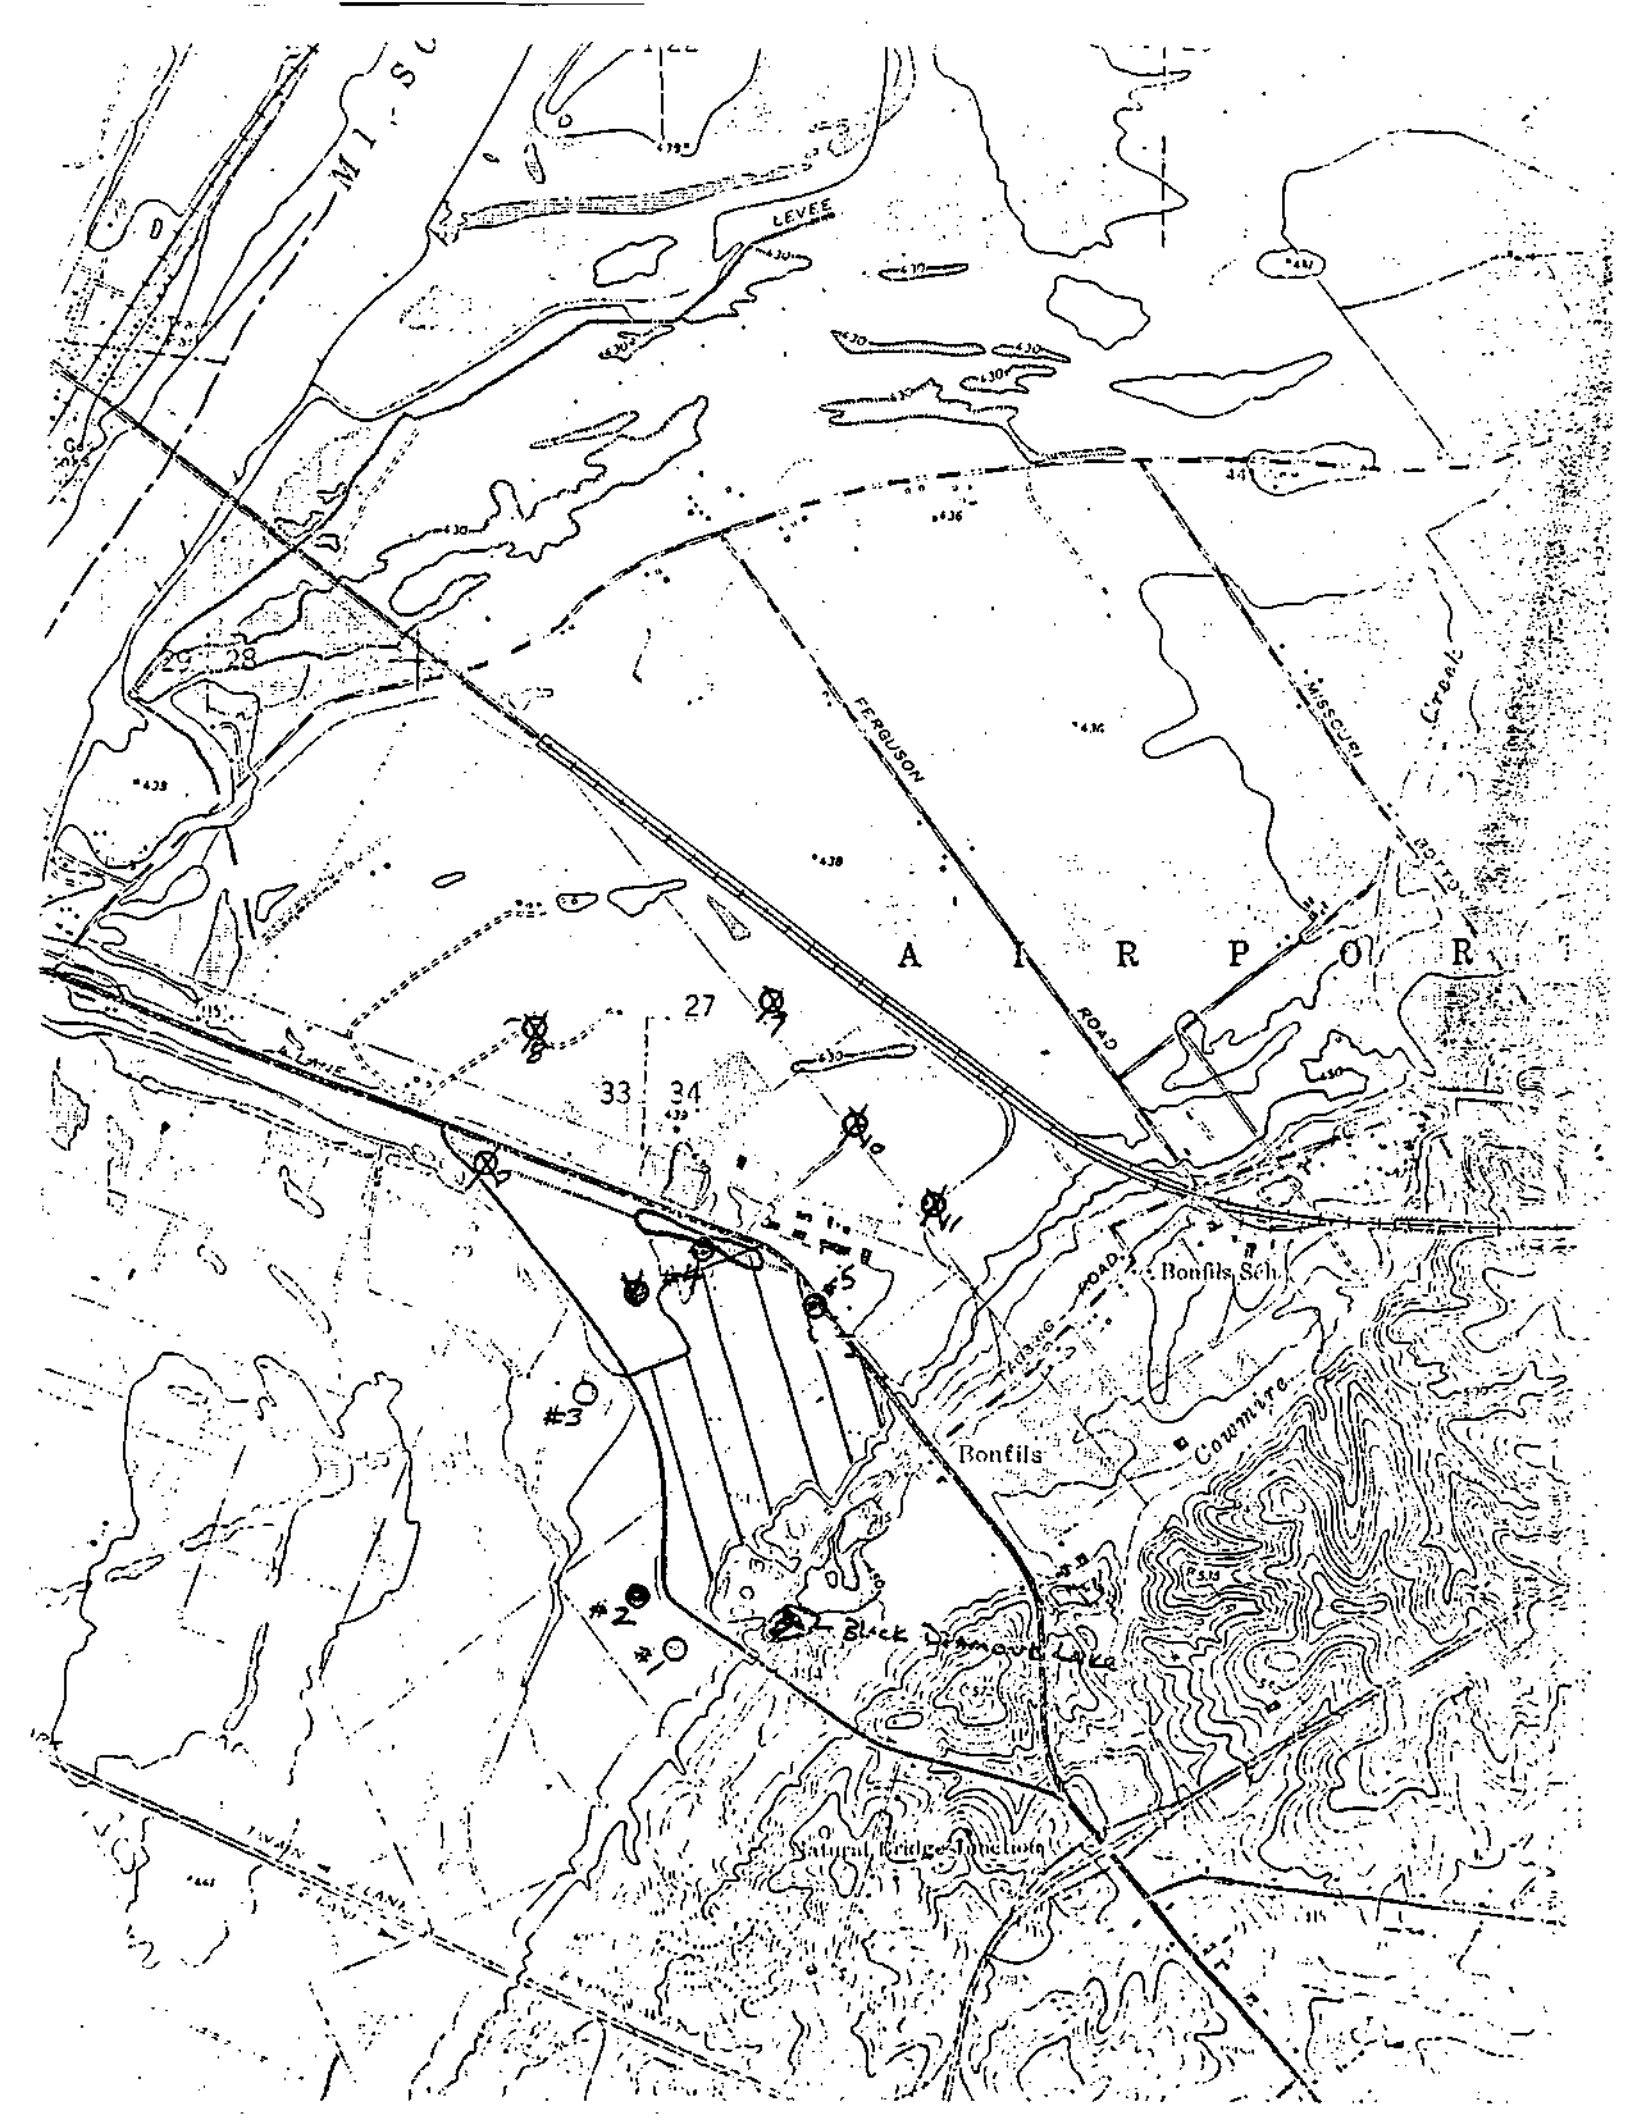
Because the drilling process and sample collection took more time than anticipated only five (5) of the originally scheduled eleven (11) borings were completed. Attached is a map of the West Lake Site showing the locations of those borings in which samples were collected.

Boring #1 was drilled on the south side of the landfill approximately 150 yds. south of monitoring Well #37. We first attempted to collect a sample from the boring after the auger had been removed. When the boring caved in the decision was made to leave the auger in place and lower the bailer (sampling device) through the augers hollow core.

Boring #2 was located on the south side of the landfill about 50 yds. south of monitoring Well #37A and 150 yds. west of boring #1.

Boring #3 was drilled on the southwest corner of the landfill approximately 50 yds. southwest of monitoring Well #41. Although we did not collect water at this site for radiological testing, we did split the sample with consultants for the Nuclear Regulatory Commission who did plan on conducting radiological analyses.

Boring #4 was located on the northwest side of the landfill immediately south of the slough. Samples collected here were split with the consultants from the Nuclear Regulatory Commission.

Boring #5 was drilled on the north side of the landfill along St. Charles Rock Road. Samples from this site were also split with the Nuclear Regulatory Commission Consultants.
