Bangor, MI Cemetery Road Fire
101 Cemetary Road

Location BANGOR, MICHIGAN Date 8-26-11

Project / Client CEMETARY RD FIRE / U.S. EPA

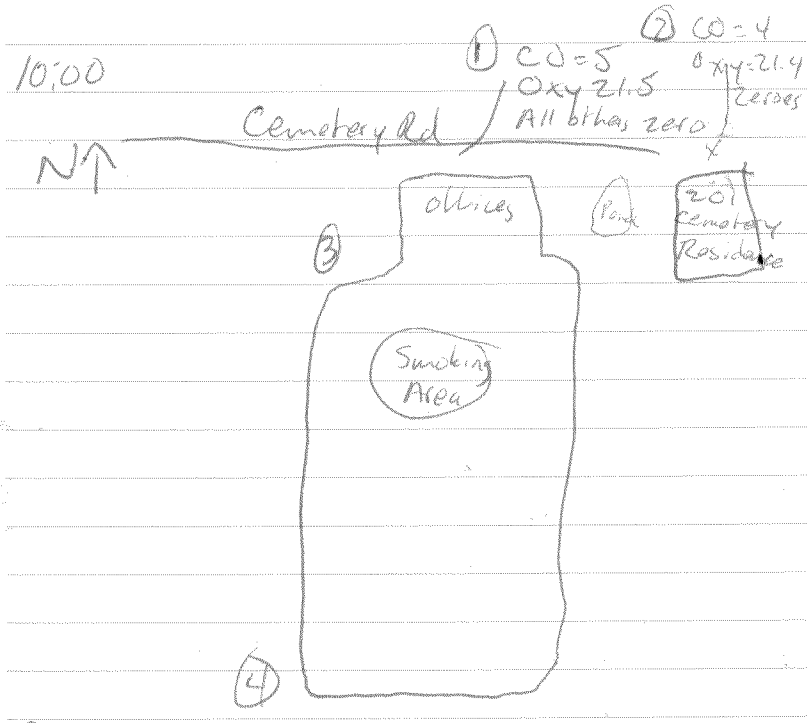
MultiRAE monitoring map on next page

③ - CO = 4 Oxy: 21.3 – zeroes
④ CO = 2 Oxy 21.1 – zeroes

- Initial monitoring yields no detections except for CO ranging from 1-5 ppm. NIOSH = 35ppm 8 hr average.
