Re: Operations & Maintenance Summary Monthly Report – June 2007
UniFirst Corporation, Wells G&H Site, Woburn, MA

Source Area & Operable Unit 1
Operations & Maintenance
Summary Monthly Report
UniFirst Corporation

June 1 – June 30, 2007

Wells G & H Site
Woburn, Massachusetts

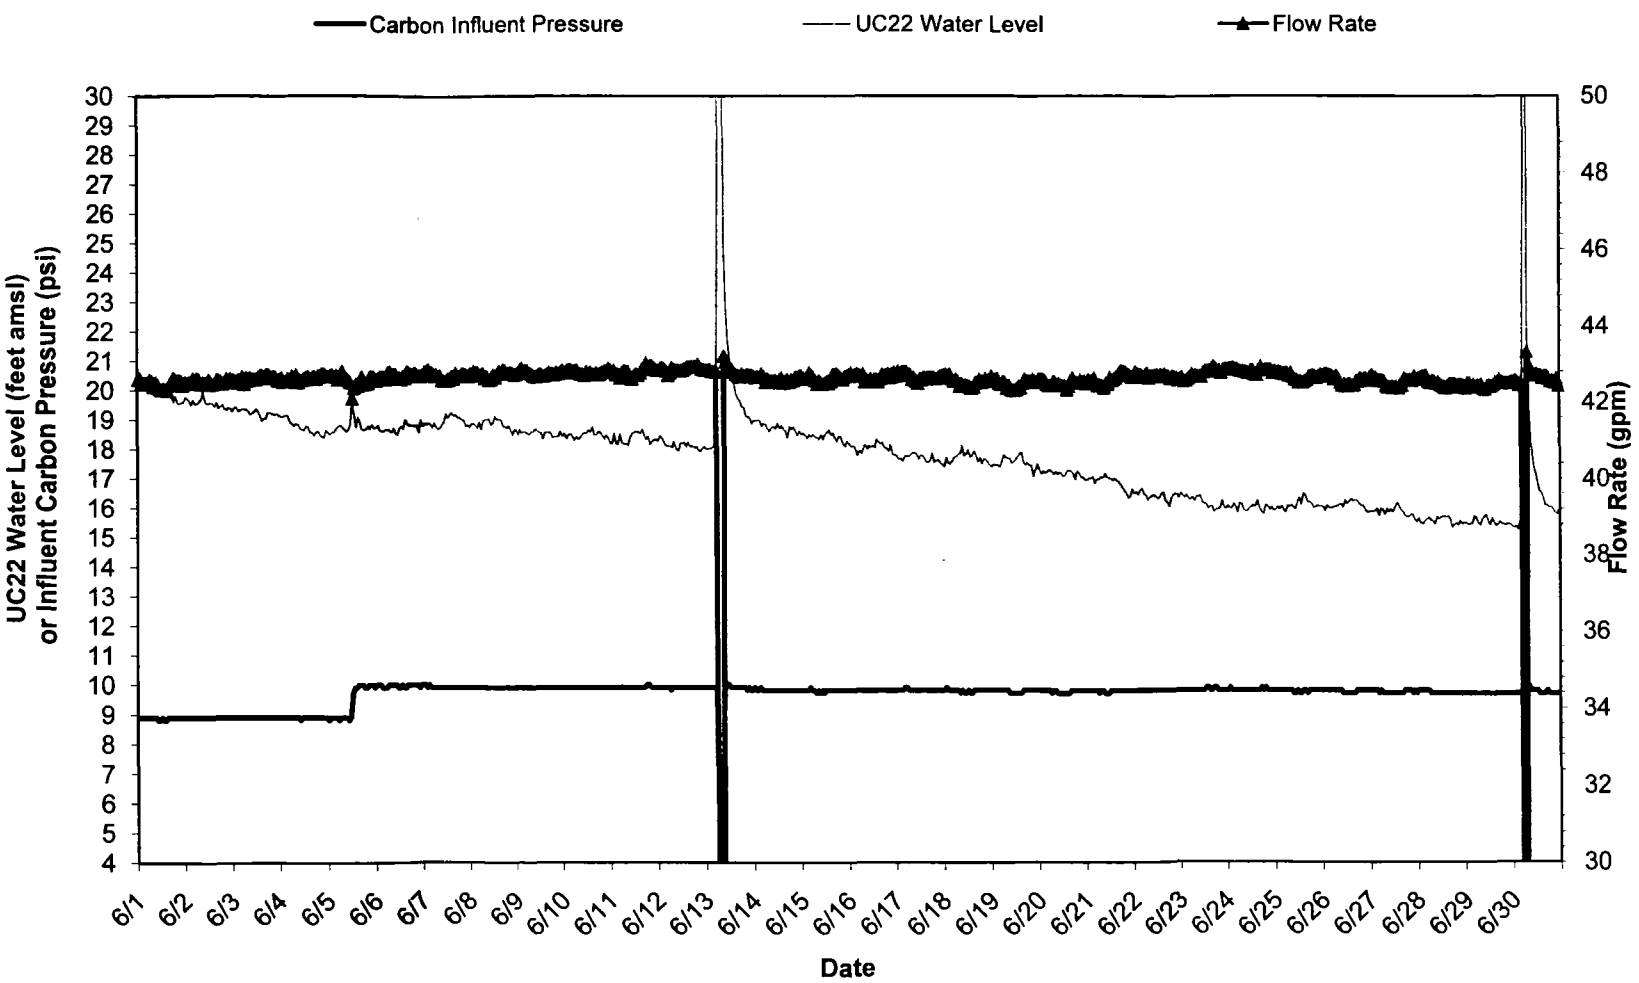
Figure 1: June 2007 Operations Data

The total monthly flow through the System for the reporting period was 1.83 million gallons. The average flow during this period was approximately 42.4 gallons per minute. The average hourly flow rate in gallons per minute is depicted in Figure 1.

The average hourly carbon pressure at the influent to the primary tank during the month was 9.6 psi. The trend of the carbon system pressure is illustrated in Figure 1. The process flow through the carbon vessels was Tank 1 to Tank 2 to Tank 3.

During the reporting period, the average hourly pumping water level elevation in well UC22 was approximately 17.9 feet. The water level elevations for the month are shown on Figure 1.
