FOCUSED SITE INSPECTION PRIORITIZATION
SITE EVALUATION REPORT

JACKSON COUNTY LANDFILL
1841 SMITH BRIDGE ROAD
JACKSON, OHIO

EPA ID NO. OHD 980 993 554

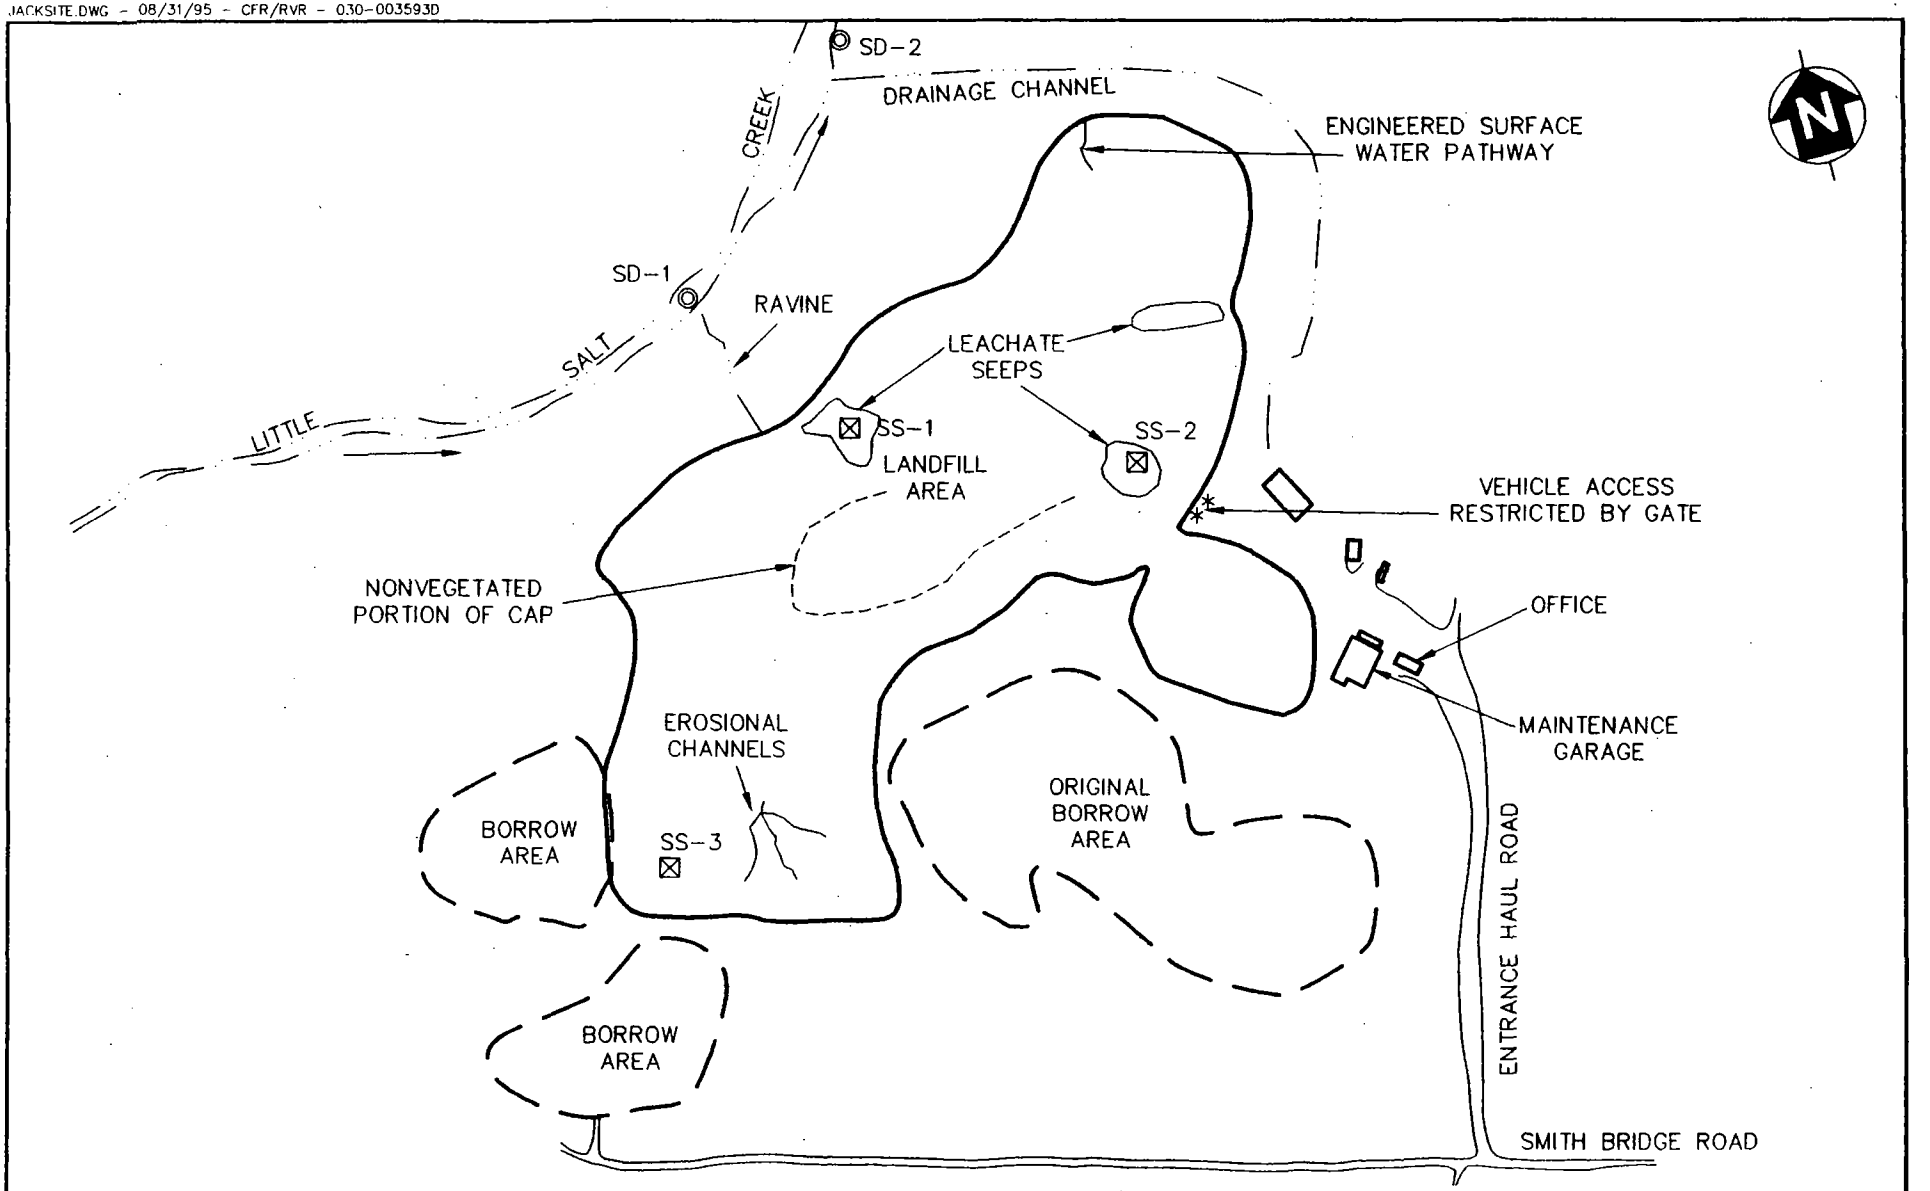
SD-2
DRAINAGE CHANNEL
CREEK
ENGINEERED SURFACE WATER PATHWAY
N
SD-1
RAVINE
SALT
LITTLE
LEACHATE SEEPS
SS-1
LANDFILL AREA
SS-2
VEHICLE ACCESS RESTRICTED BY GATE
NONVEGETATED PORTION OF CAP
OFFICE
MAINTENANCE GARAGE
EROSIONAL CHANNELS
BORROW AREA
SS-3
ORIGINAL BORROW AREA
ENTRANCE HAUL ROAD
BORROW AREA
SMITH BRIDGE ROAD
LEGEND
SOIL SAMPLING LOCATION
SEDIMENT SAMPLING LOCATION
175' 0 175' 350'
SCALE: 1" = 350'
SOURCE: MODIFIED FROM BURGESS & NIPLE, LTD. 1987 AS REVISED BY SBA, 1991
JACKSON COUNTY LANDFILL
JACKSON COUNTY, OHIO
FIGURE 3
ON-SITE SAMPLING LOCATIONS
PRC ENVIRONMENTAL MANAGEMENT, INC.

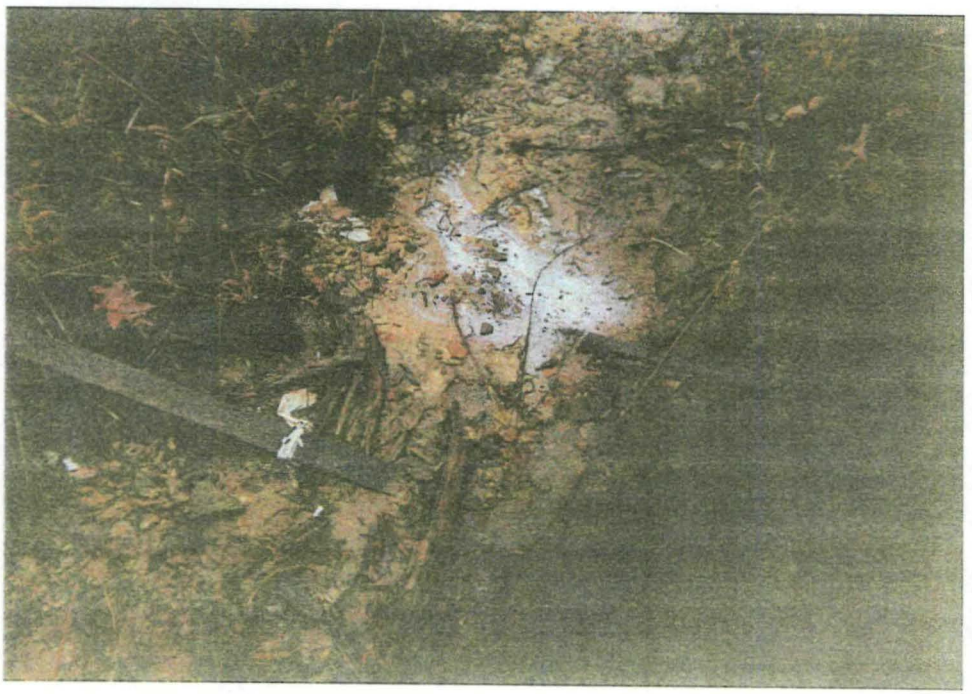
Photograph No. 1 Location: Jackson County Landfill (JCL)
Orientation: West Date: 01/19/95
Description: This photograph shows a leachate seep on the east slope of the landfill. Note the dead vegetation in the seep area.

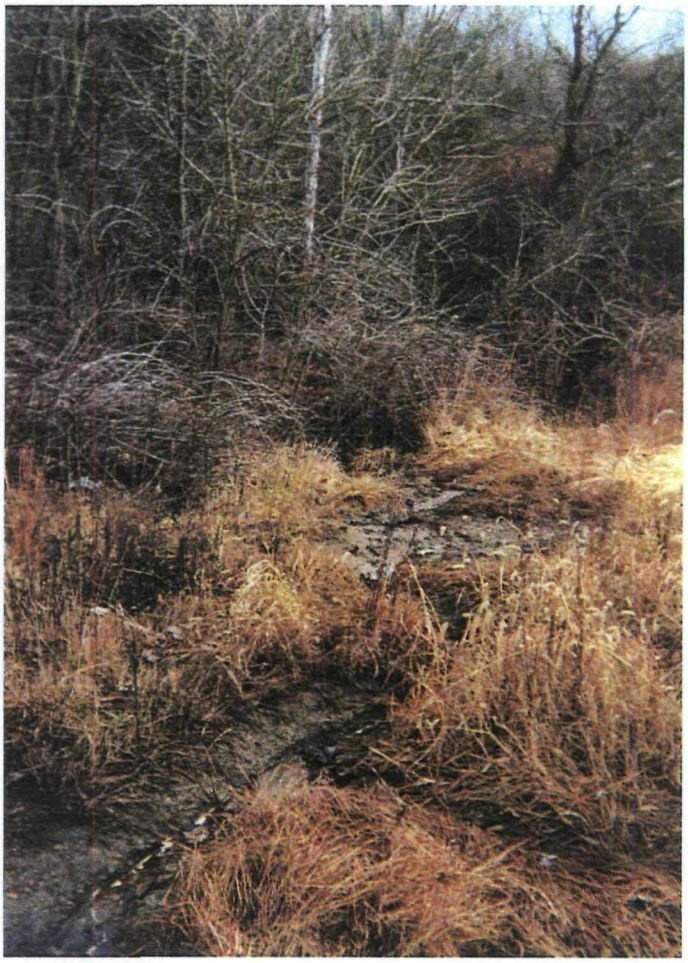
Photograph No. 3 Location: JCL
Orientation: Downward Date: 01/19/95
Description: This photograph shows an oily sheen produced by a leachate seep.

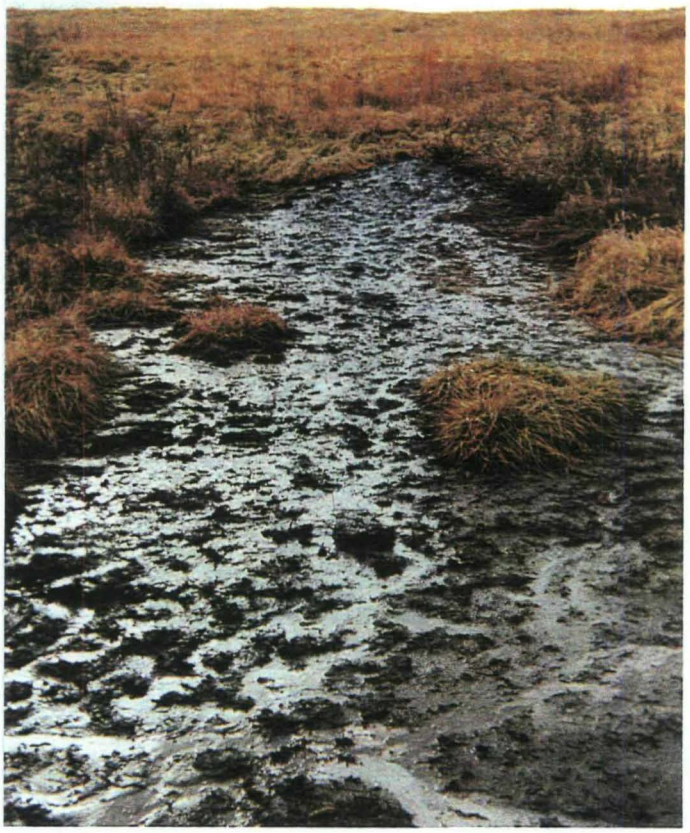
Photograph No. 4 Location: JCL
Orientation: North Date: 01/19/95
Description: This photograph shows an erosional channel created by a leachate seep on the north slope of the landfill.

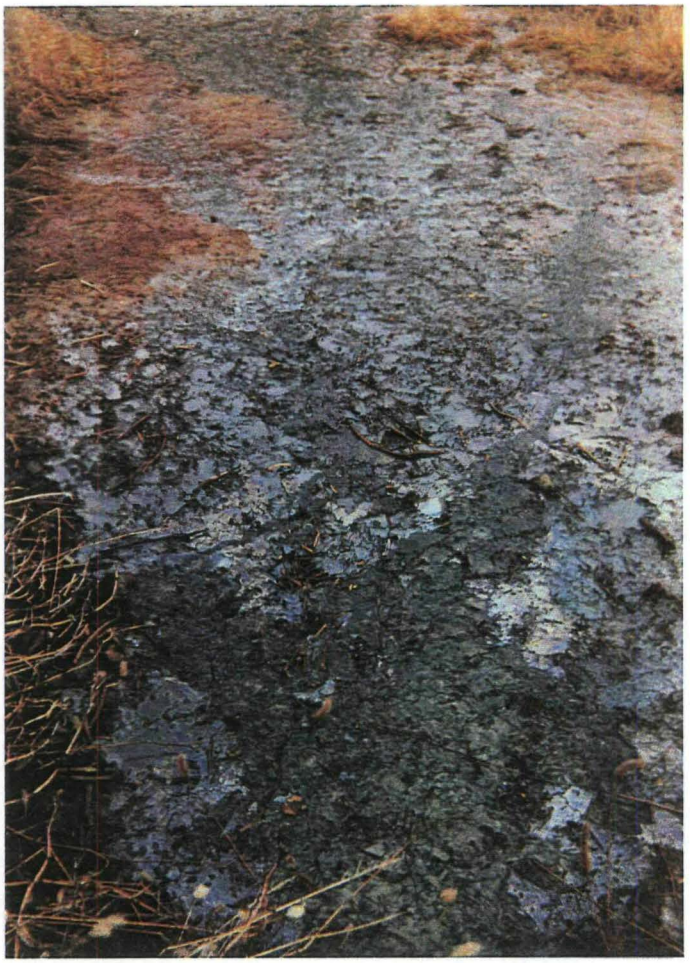
Photograph No. 5 Location: JCL
Orientation: Southeast Date: 01/19/95
Description: Test pitting activities caused this large leachate seep to form on the northwest slope of the landfill.

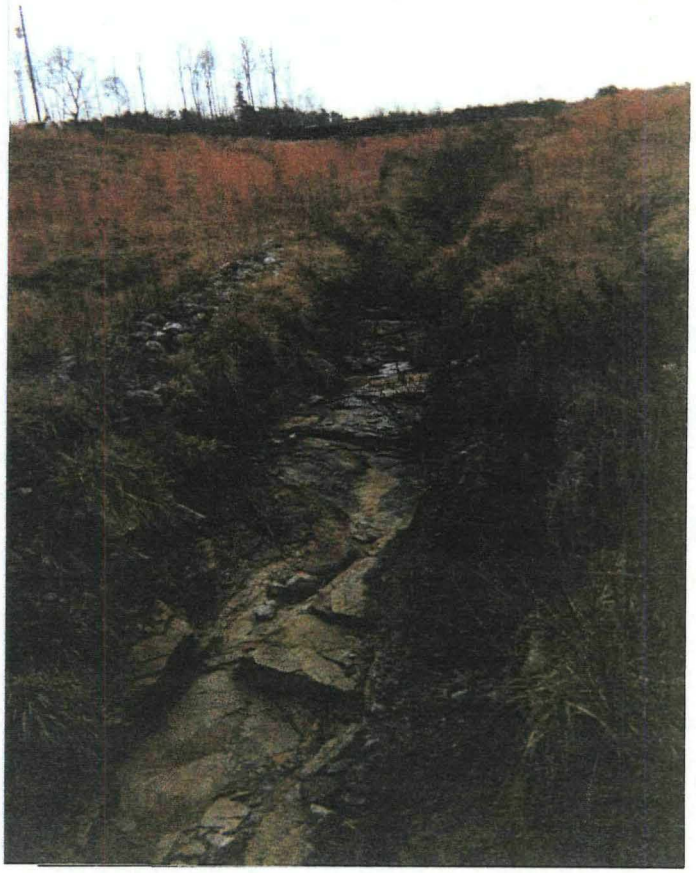
Photograph No. 7 Location: JCL
Orientation: North Date: 01/19/95
Description: This photograph shows the drainage channel on the east slope of the landfill.

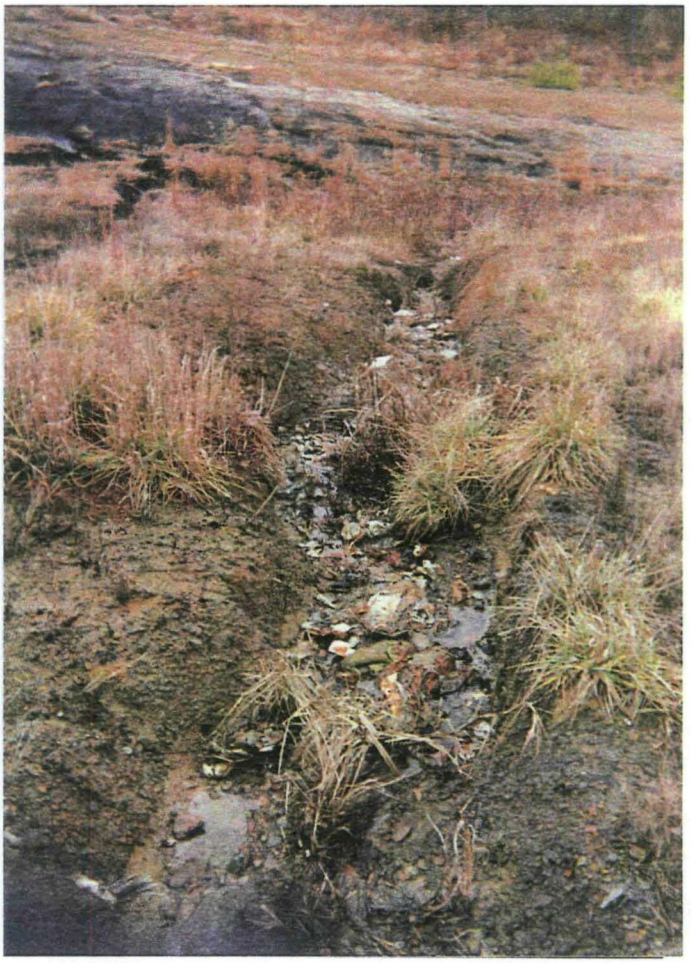
Photograph No. 10 Location: JCL
Orientation: East Date: 01/19/95
Description: Erosional channels dissect the landfill's north slope.

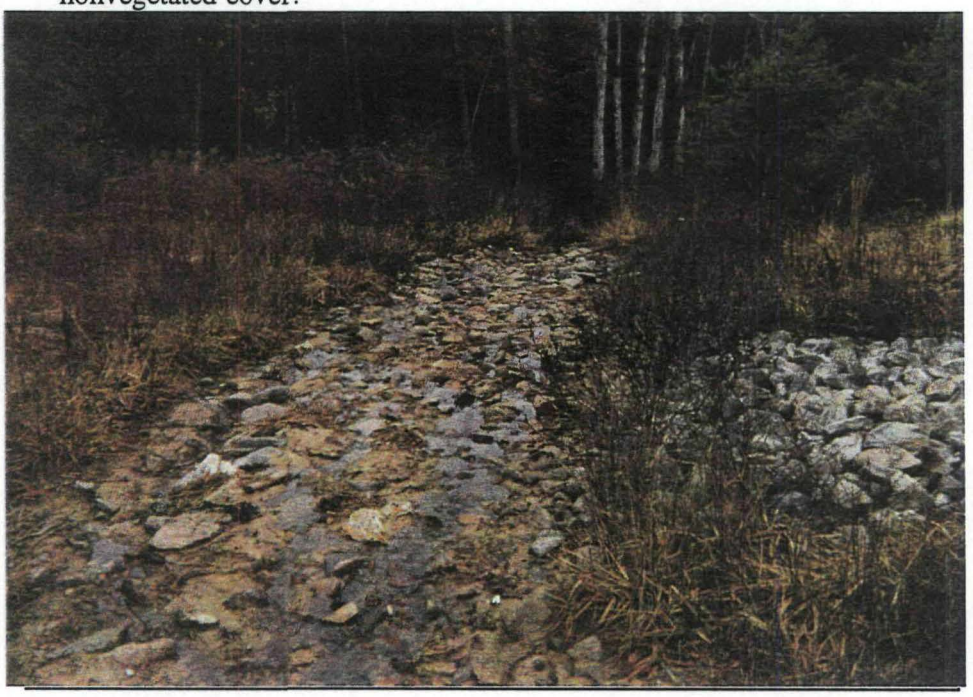
Photograph No. 17 Location: JCL
Orientation: North Date: 01/19/95
Description: This photograph shows the south portion of the landfill cap. Note the shaly, nonvegetated cover.
