RE: **Amendment to Letter Dated July 7, 2008, Regarding Greenleaf Notice of Violation #5586E**

AMENDED MEMORANDUM

SUBJECT: Site Visit – Greenleaf, L.L.C.
Neosho, Newton County, Missouri

NOTICE OF VIOLATION #5586E

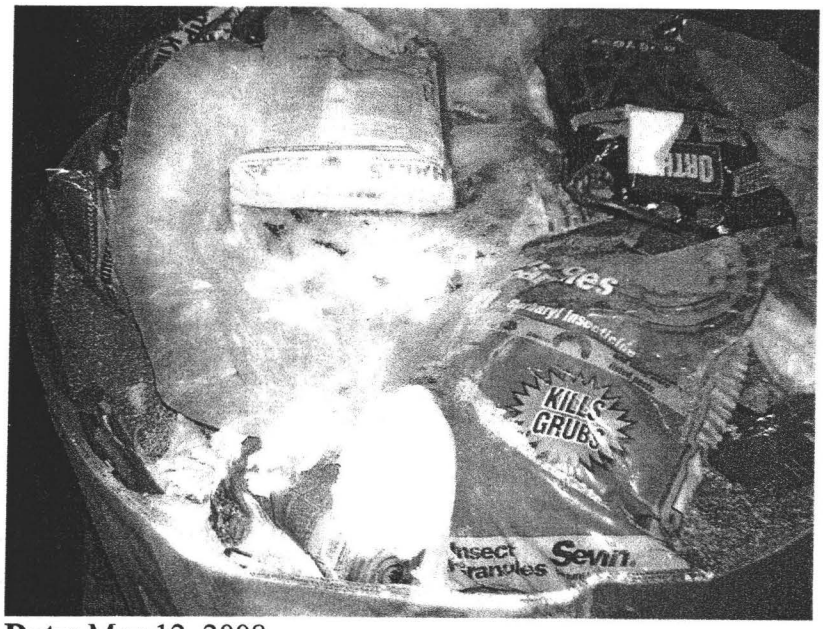
Date: May 12, 2008
Site: Greenleaf, L.L.C., Building 1
MOR000526152 and 042018
13960 Palm Road, Neosho, MO 64850
Photographer: Candace Bias
View of the pesticide Sevin, containing the active ingredient carbaryl. Carbaryl is a U279 listed hazardous waste. This hazardous waste is not properly managed.

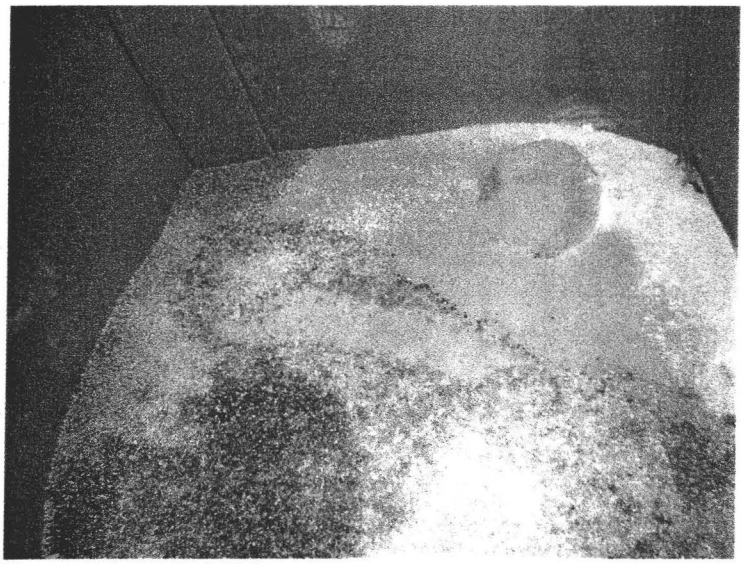
Date: May 12, 2008
Site: Greenleaf, L.L.C., Building 1
MOR000526152 and 042018
13960 Palm Road, Neosho, MO 64850
Photographer: Candace Bias
View of Stop Sale, Use or Removal pesticides in Building 1.

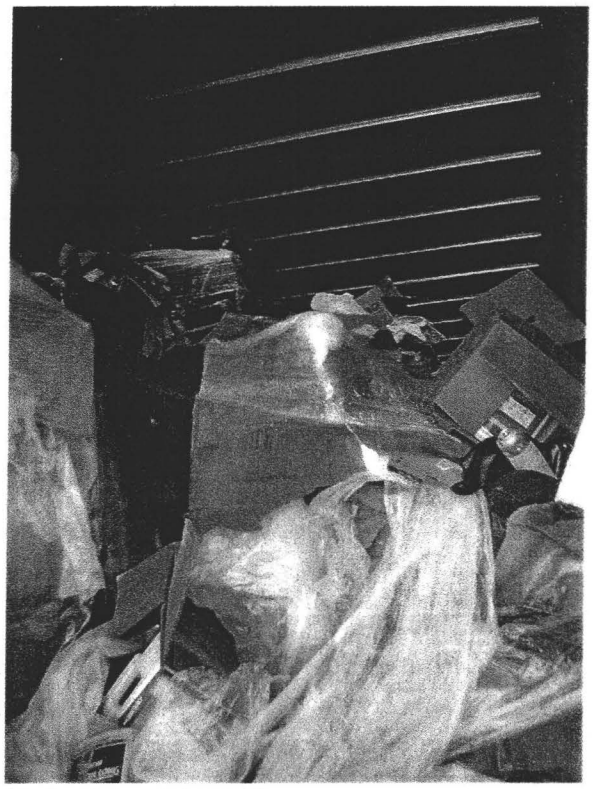
Date: May 12, 2008
Site: Greenleaf, L.L.C., Building 2
MOR000526152 and 042018
13960 Palm Road, Neosho, MO 64850
Photographer: Candace Bias
View of boxes labeled "Free Pest" on the west side of Building 2. Note the inadequate aisle space.

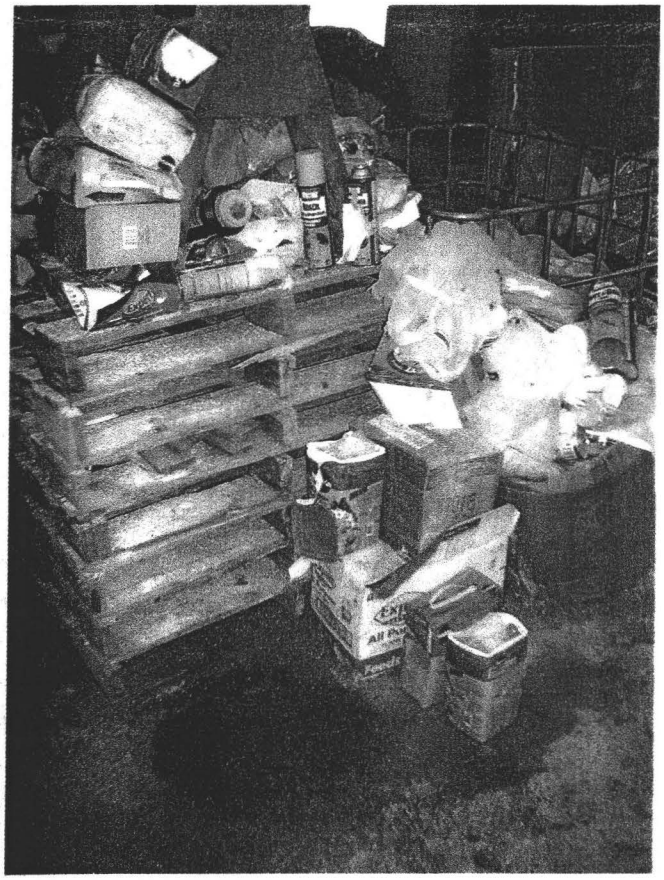
Date: May 12, 2008
Site: Greenleaf, L.L.C.
South Business Highway 71
Pineville, Missouri
Photographer: Candace Bias
View of Sweeney's Poison Peanuts Mole and Gopher Bait and Grant's Sure Stop Gopher Killer Pellets. Both pesticides contain the active ingredient zinc phosphide, a U249 listed hazardous waste at this concentration. This hazardous waste is not properly managed. Zinc phosphide can also produce gas that is dangerous to humans if it becomes wet.

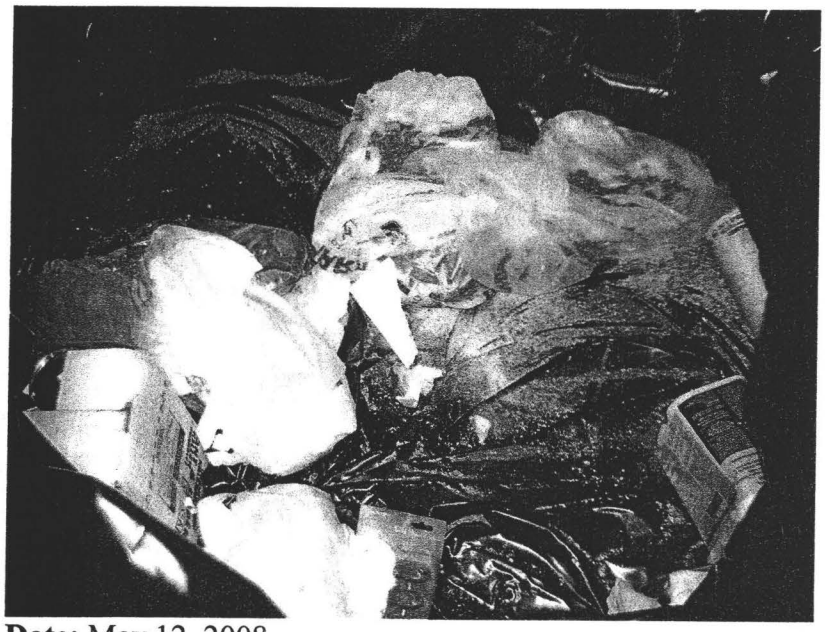
Date: May 12, 2008
Site: Greenleaf, L.L.C.
South Business Highway 71
Pineville, Missouri
Photographer: Candace Bias
View of spills.

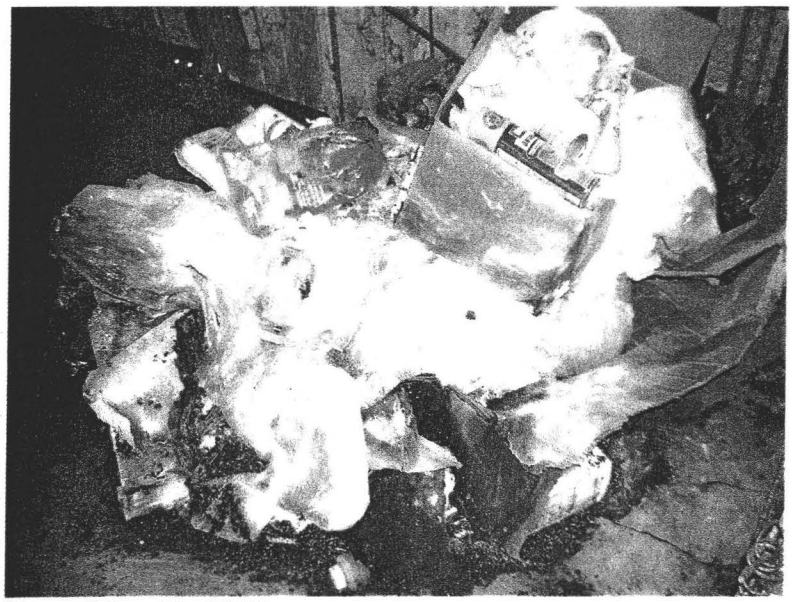
Date: May 12, 2008
Site: Greenleaf, L.L.C.
South Business Highway 71
Pineville, Missouri
Photographer: Candace Bias
View of spills and mixing of pesticides in boxes.
