Job Number FT 1305

SITE NAME: METRO DISPOSAL SYSTEM INC.
ADDRESS: ROUTE #3
FAIRMONT CITY, IL 61841
TDD: F05-8912-090
PAN: FIL041758
SSID: None
US EPA ID: ILD980607204

FIL04175B Wednesday, 5-8-91

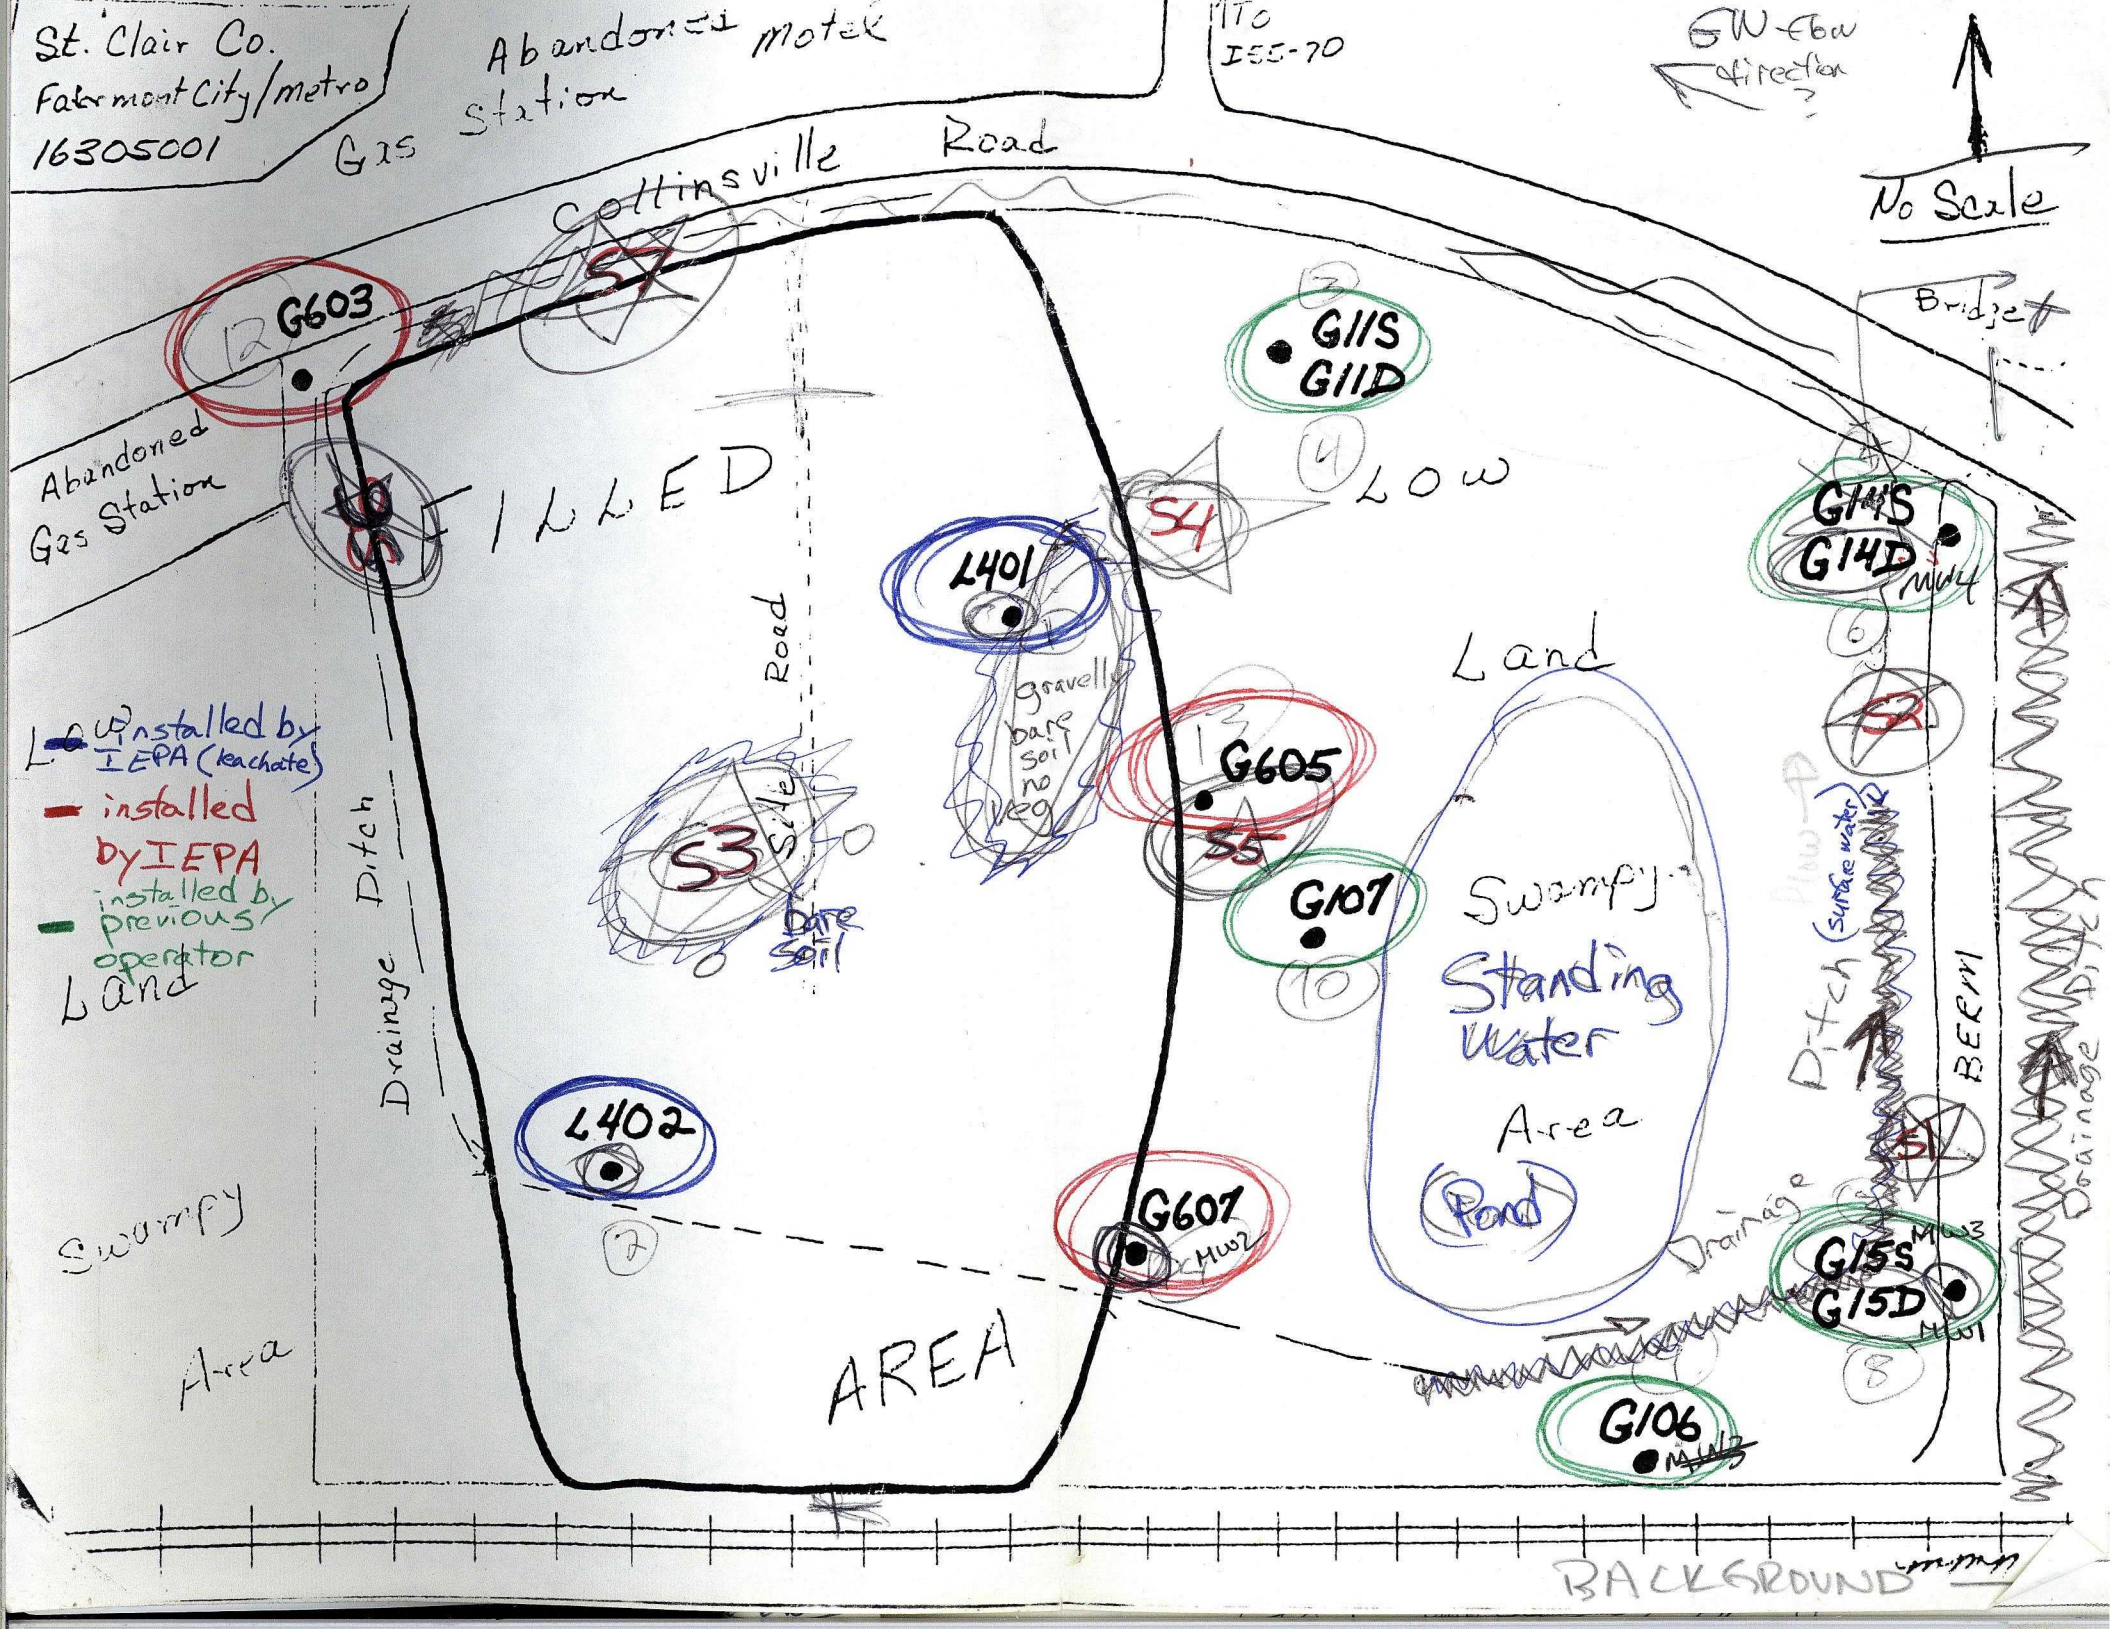
St. Clair Co.
Fairmont City/metro
16305001
Abandoned Gas Station
Abandoned Motel
Collinsville Road
To I55-70
GW-flow direction ?
No Scale
Bridge
G603
12
S7
G11S
G11D
3
4
LOW
S4
FILLED
Abandoned Gas Station
L401
gravelly bare soil no veg
Road
Land
G14S
G14D
MW4
6
S2
G605
13
S5
S3
Site
bare soil
G107
10
Swampy
Standing Water
Area
(Pond)
Ditch (surface water)
BERM
Drainage Ditch
Drainage Ditch
L402
2
G607
MW2
S1
Drainage
G15S
G15D
MW3
MW1
8
G106
MW3
AREA
Swampy
Area
Land
installed by IEPA (leachate)
installed by IEPA
installed by previous operator
BACKGROUND
