ANALYTICAL RESULTS REPORT OF AIR SAMPLING AT RICHARDSON FLAT PARK CITY, UTAH

TDD R8-8608-05

ANALYTICAL RESULTS REPORT
FOR RICHARDSON FLAT TAILINGS
PARK CITY, UTAH
TDD #R8-8608-05

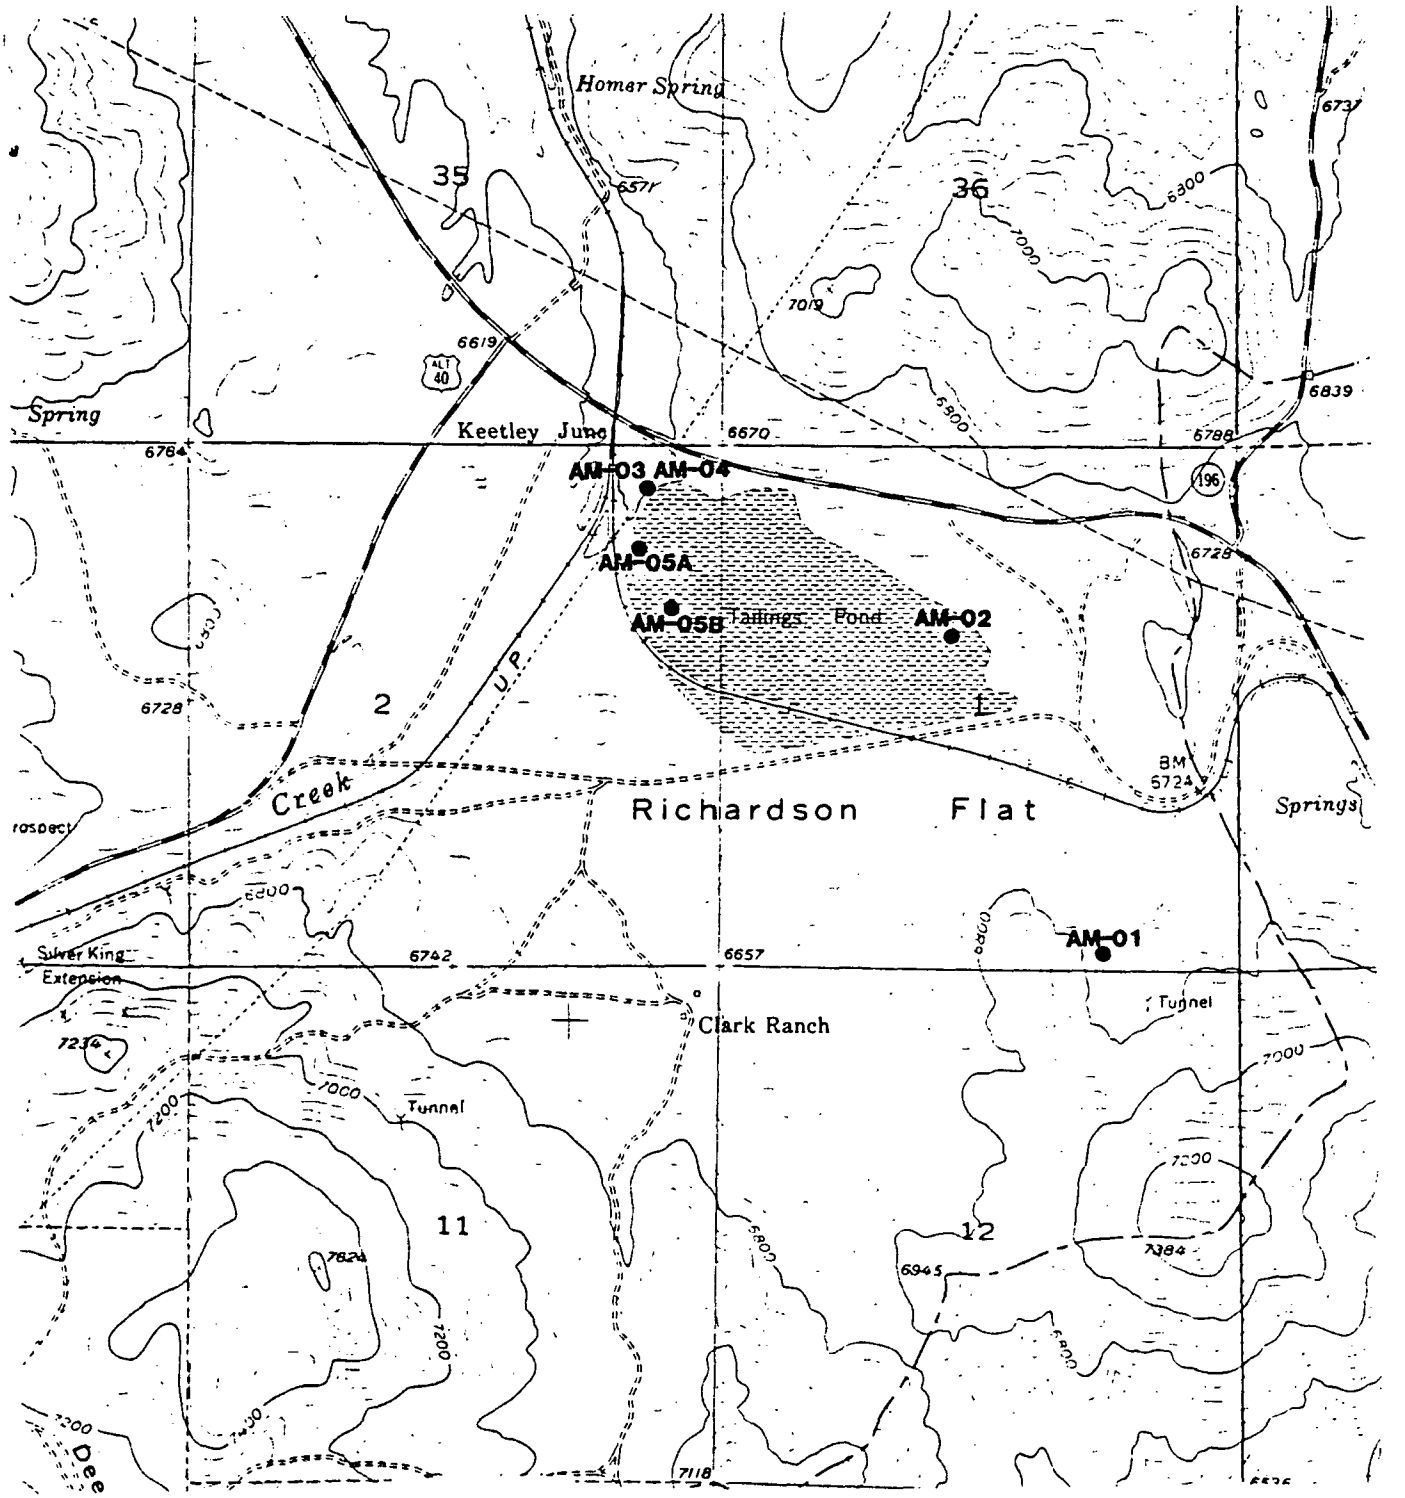
FIG.2

The results of the inorganic analyses are noted in Table 1. Sample locations are noted in Figure 2.

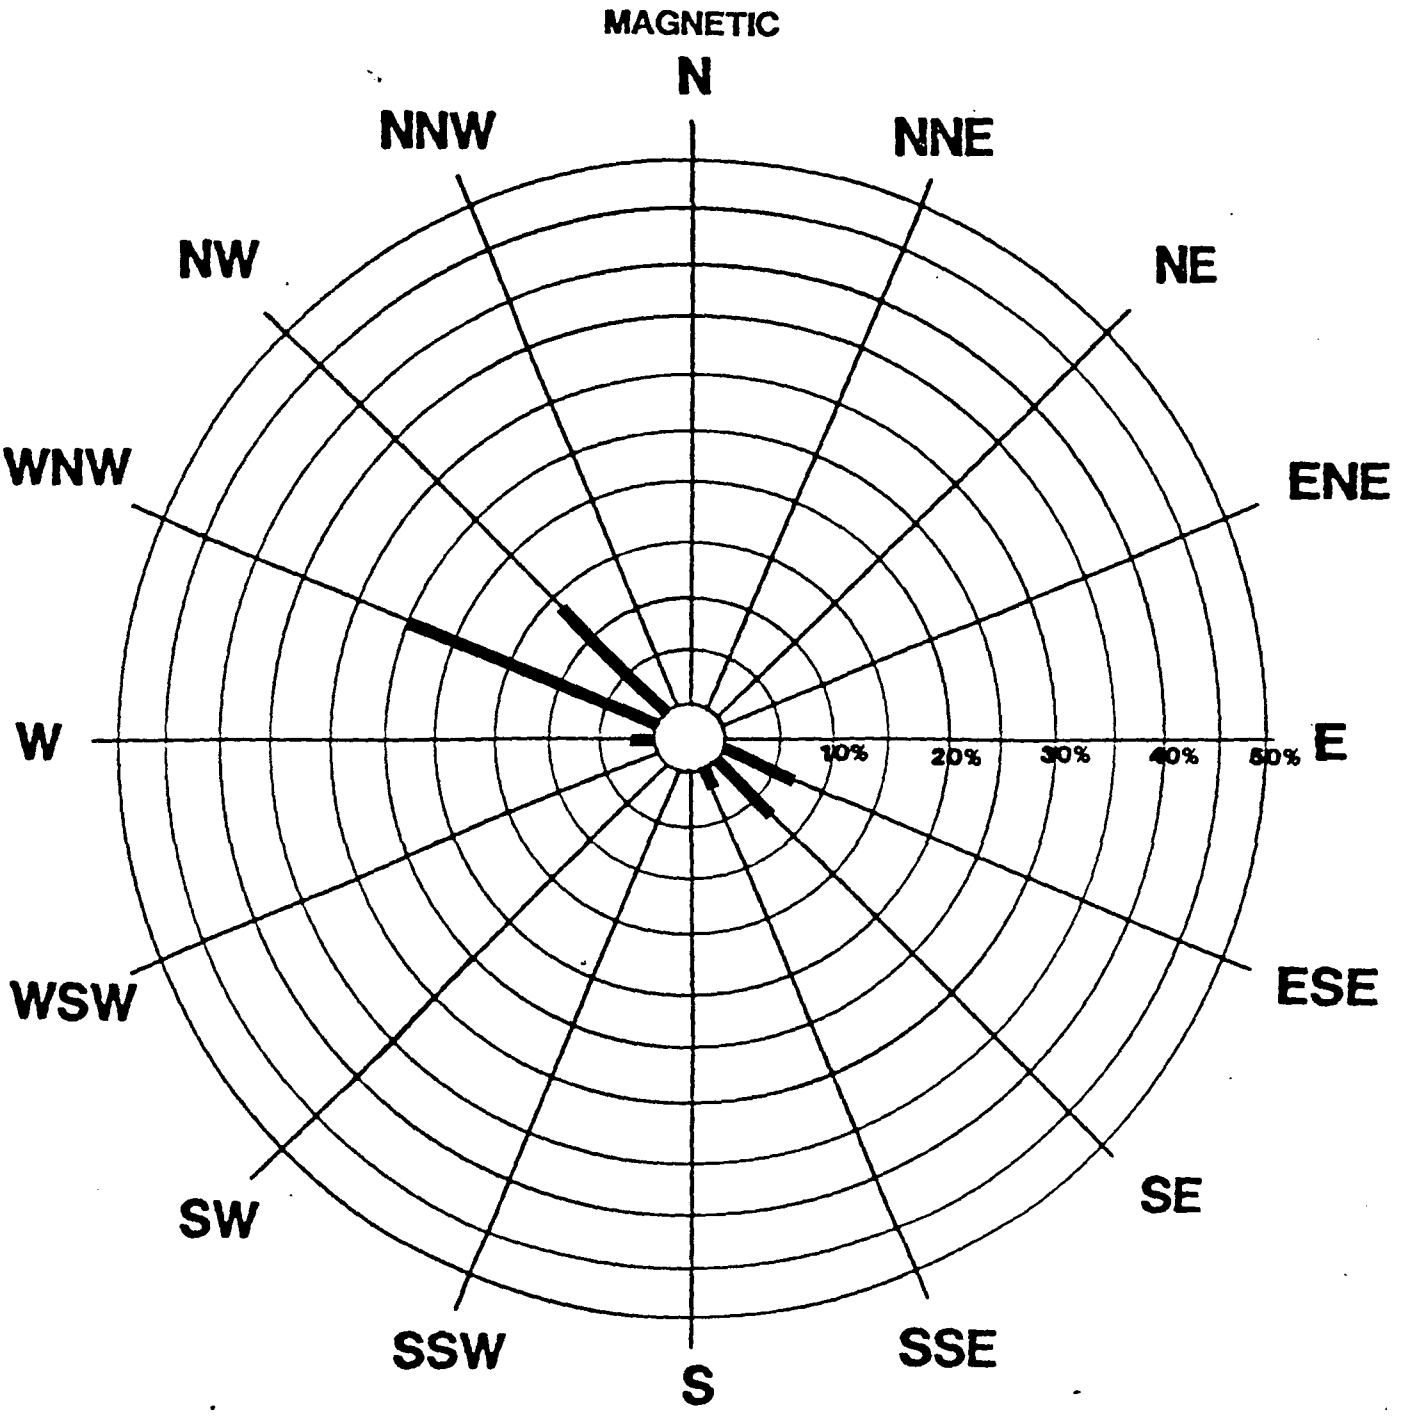
FIG.5

Sampling began at 1100 on July 9th and ended at 0300 on July 10th. The wind rose for this sample period is shown in Figure 5. The

predominant winds are from the WNW and NW with 25% and 18% of the wind respectively from those vectors. The sample period started with light and variable winds from 0-10 mph. At 1430, the wind increased to 10-20 mph and stabilized from the WNW. At 1800 hours the wind dropped back to 5-10 mph and at 2000 the wind went calm and continued that way until the sample period ended.

Based on the wind rose, the upwind sample location would be AM-04 and the downwind location would be AM-02. Comparing upwind versus downwind sample locations reveals an 11 fold increase in lead, a 5 fold increase in zinc, and 7 fold increase in arsenic.

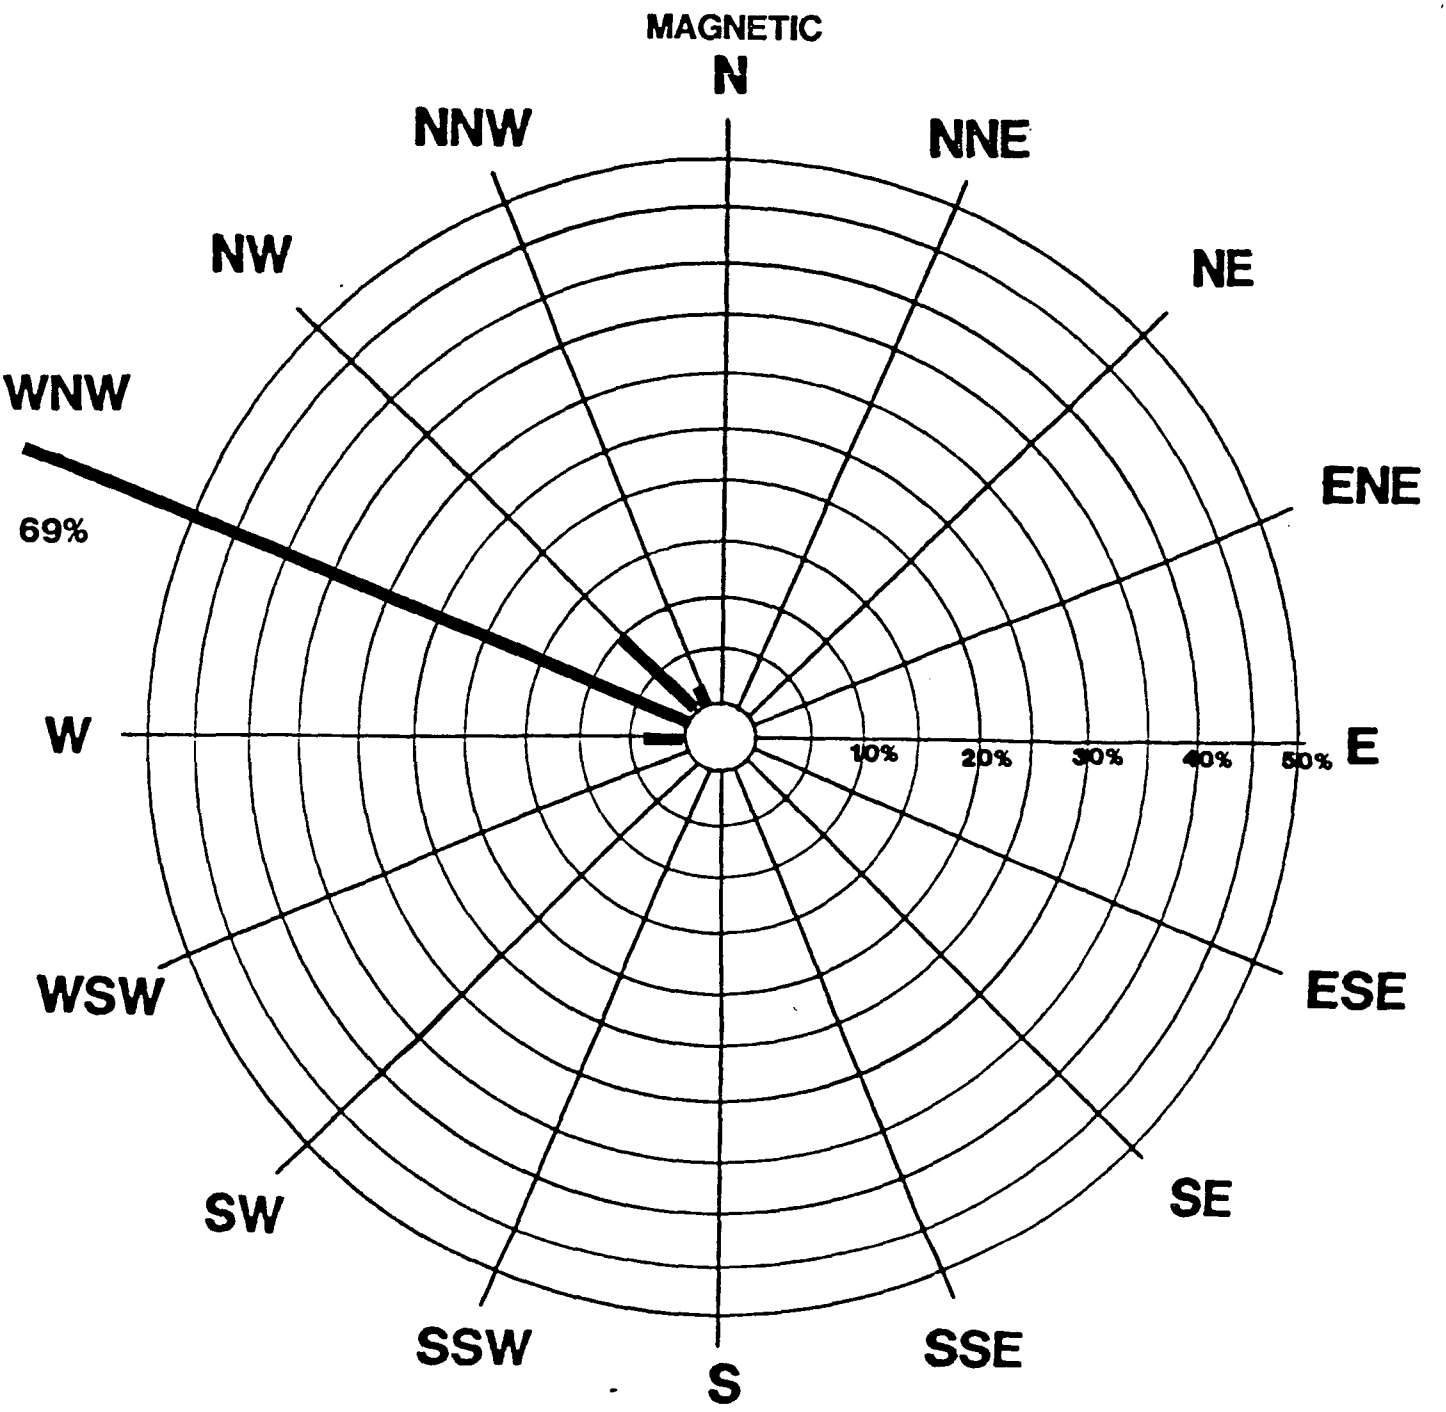
FIG.6

The sample period began at 1100 hours on July 10th and continued until 2300 hours. Figure 6 shows the wind rose for the site for this period of time. The predominant wind direction is WNW with 69% of the wind for this time period from that direction. Based on the wind rose and sampler locations, the upwind sampler would be AM-04 and the downwind location would be AM-02.

The wind at the start of the sampling period was from the NNW at 5-10 mph. At 1045, the wind picked up to 10-20 mph from the WNW and continued so until 1800 hours when the wind slowed to 5-10 and then went calm at 2000 hours.

Results from Table 4 show a 9 fold increase in lead, a three fold increase in zinc, a ten fold increase in arsenic and a two fold increase in cadmium when comparing upgradient versus downgradient.

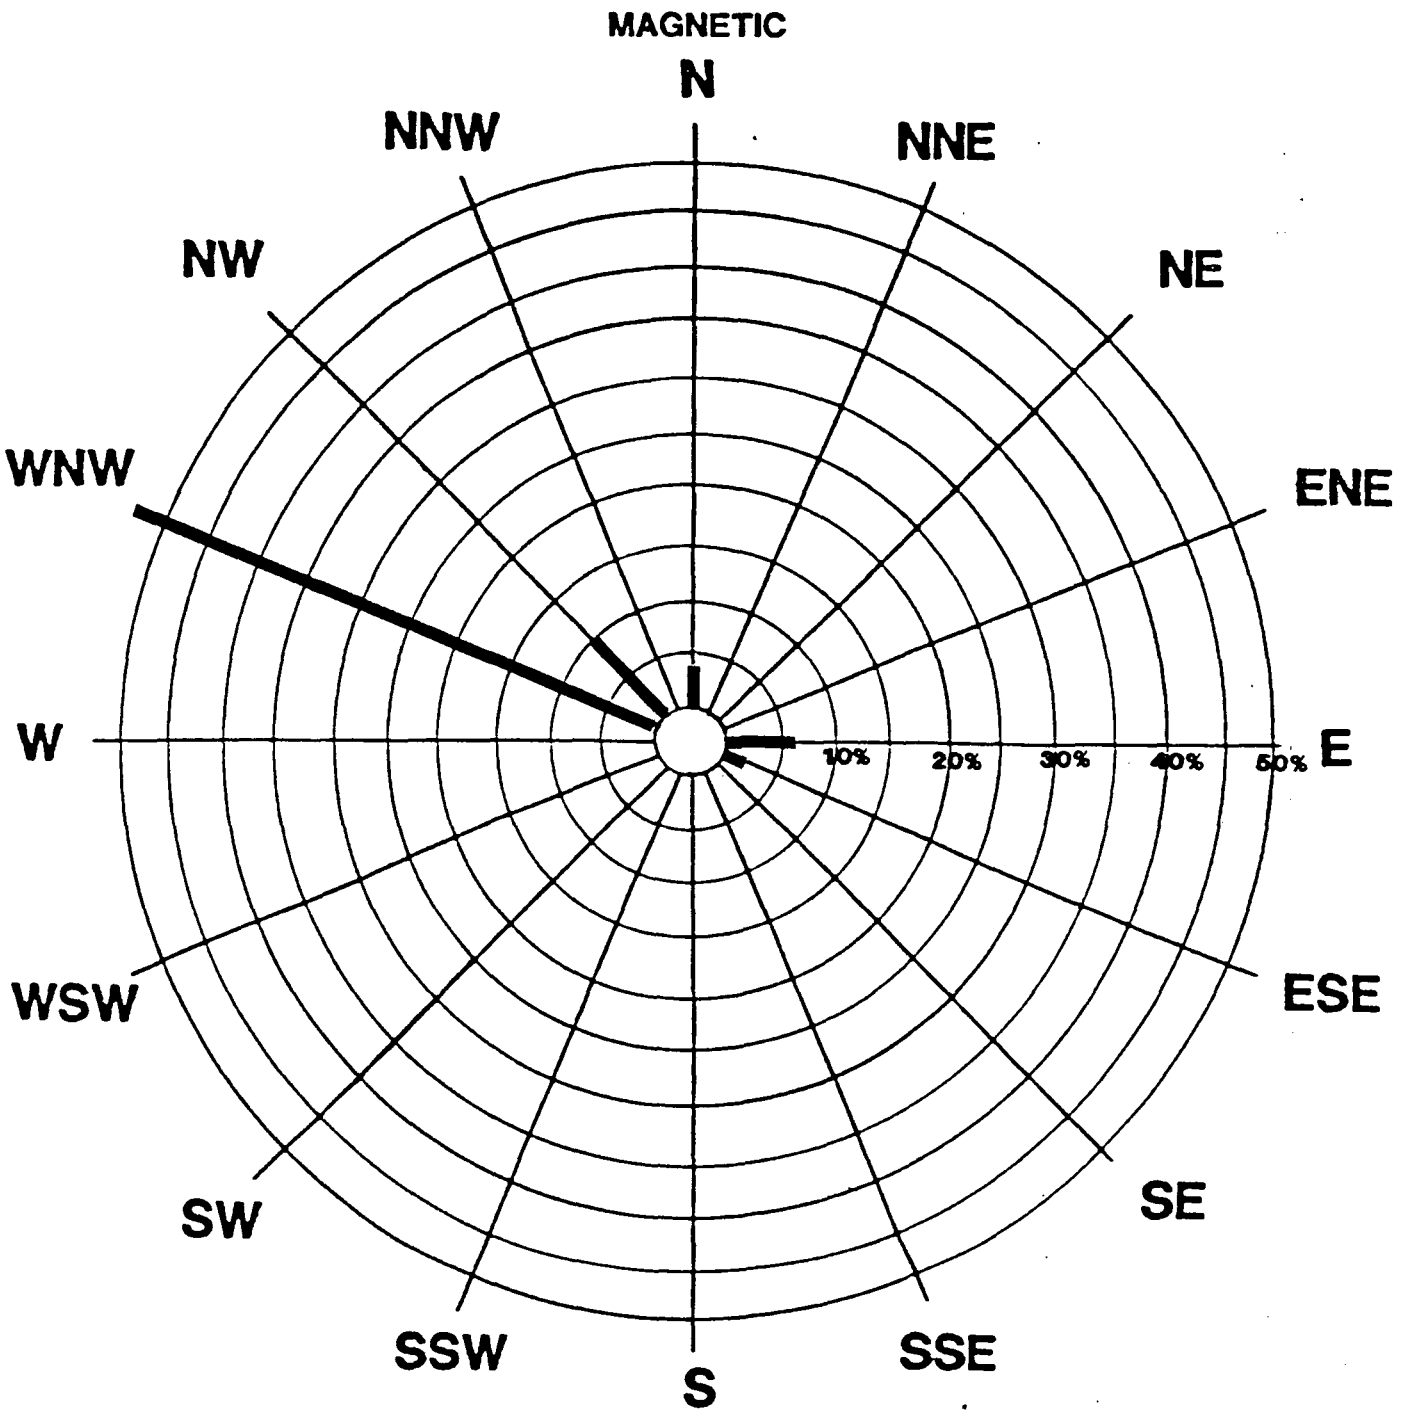
FIG. 7

Sampling was initiated at 1000 hours and continued until 2300 hours. Figure 7 shows the wind rose for this sampling period. The predominant wind direction is WNW with 55% of the sampling time followed by NW with 10%. Based on this information, the upgradient sample location is AM-04 and the downgradient is AM-02.

The sample period began with the wind blowing from the east at 5-10 mph. At 1100 hours, the wind became light at less than 5 mph and variable but at 1130 hours it stabilized with the wind coming from the WNW at 5-10 mph. The wind speed picked up to 10-20 mph at 1230 hours. It continued at this speed and direction through 1930 hours and also had a period of gusts to 30 mph around 1400 hours. The wind died off to 5-10 mph at 1930 hours and remained calm after 2000 hours.

Results from Table 4 show an increase in contaminant concentration of two fold for lead, three fold for zinc, seven fold for arsenic and 1.1 fold for cadmium for this sample period. Sampler AM-02 was the last sampler started so consequently when the winds went calm and remained that way for the last 3 1/2 - 4 hours of the sampling period there would be less particulate material becoming airborne to be collected by the sampler.

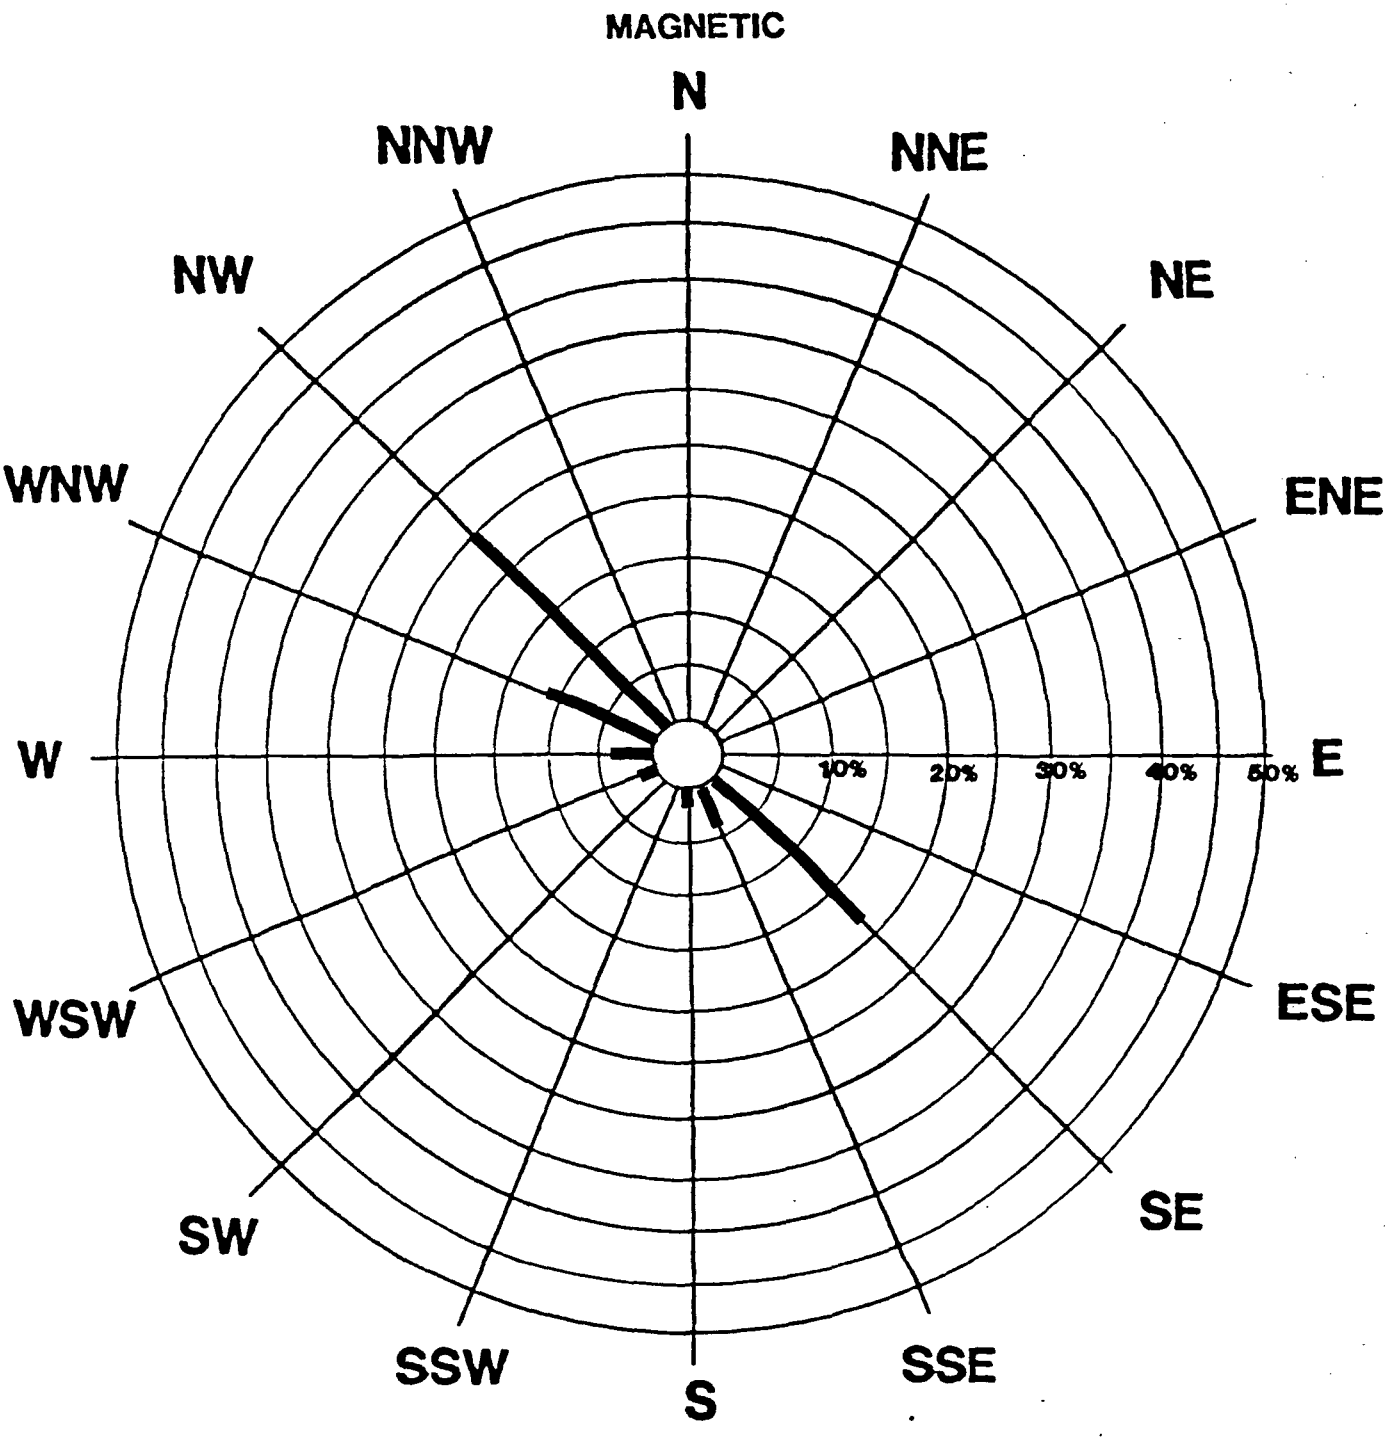
The sample period for the 5th day started at 1000 hours and stopped at 2400 hours. Figure 8 shows the wind rose for this sample period. The predominant wind direction was NW with 25% of the sample time but 18% of the time the wind was from the SE, the completely opposite direction. No reliable upgradient or downgradient sample locations can be derived from the information so the three sample locations next to the tailing were compared to the remote background at AM-01.

The wind was 0-5 mph and variable at the start of the sample period at 1000 hours. It increased to 5-10 at 1300 hours and was predominantly from the SE but shifted to the NW at 1400 hours. This remained the predominant wind direction until 1930 when the wind died and went calm until the end of the sample period.

In comparison to the remote background location at AM-01, the sampler at AM-02 shows a six-fold increase in lead, a two-fold increase in zinc and a 1.8 fold increase in arsenic. When comparing

AM-01 to AM-04 there is a 3.5 fold increase in lead, 1.3 fold increase in zinc, and a 1.5 fold increase in arsenic at sample location AM-04. Comparing AM-05 to AM-01 there is a 2.4 fold increase in lead, a 1.5 fold increase in zinc, a 1.2 fold increase in arsenic and a 1.25 fold increase in cadmium at sample location AM-05.
