Gamma Count Rate Survey in Pines, Indiana

Conducted October 10 – 15, 2009

PINES
(People in Need of Environmental Safety)

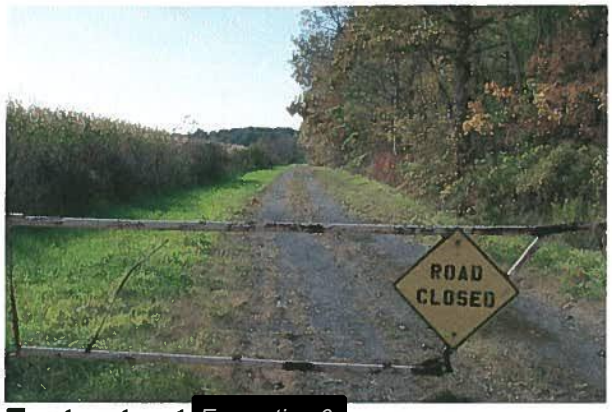
** West of gate near County Line Road
Glittering black material on surface
9500 – 10,000 counts per minute (cpm)

** [redacted]
2 minute count with probe tip on contact with the ground
21,387 counts/2 minutes = 10,694 cpm

East gate at [redacted]
