Gamma Count Rate Survey in Pines, Indiana

Conducted October 10 – 15, 2009

PINES
(People in Need of Environmental Safety)

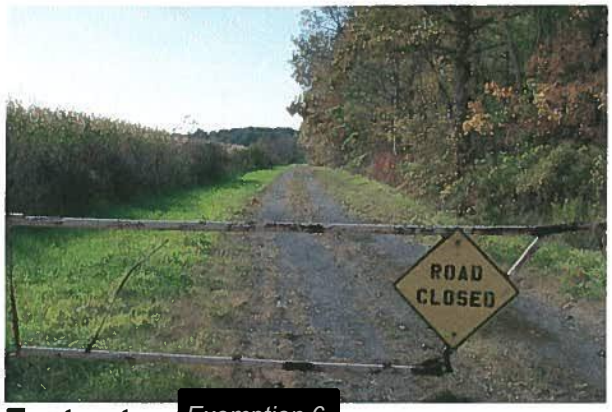
East gate at [redacted]

** West of gate near County Line Road
Glittering black material on surface
9500 – 10,000 counts per minute (cpm)

** [redacted]
2 minute count with probe tip on contact with the ground
21,387 counts/2 minutes = 10,694 cpm

East of gate on [redacted] between gate And Porter / LaPorte County Line Road, Looking northeast

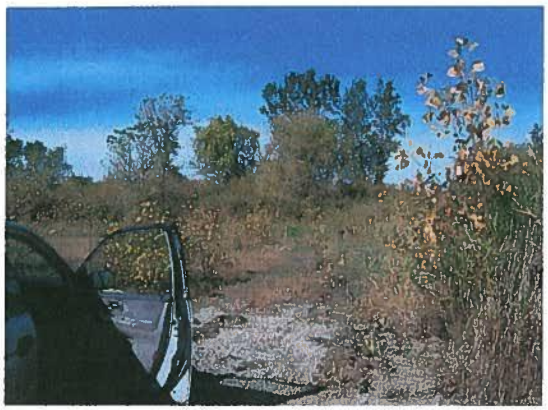
South of I-94, west of 500 E –
Stone pile / asphalt patch area

South of I-94, west of 500 E
Stone pile / asphalt patch area

** West of berm where materials have been removed
8000 – 8500 counts per minute (cpm)

** Area in front of barbed wire fence to west
N 41° 39.254' / W 086° 58.25'8'
4000 – 4500 cpm
