VAPOR INTRUSION
WORK PLAN IMPLEMENTATION REPORT

Former Solutia Queeny Plant

St. Louis, Missouri

March 27, 2018

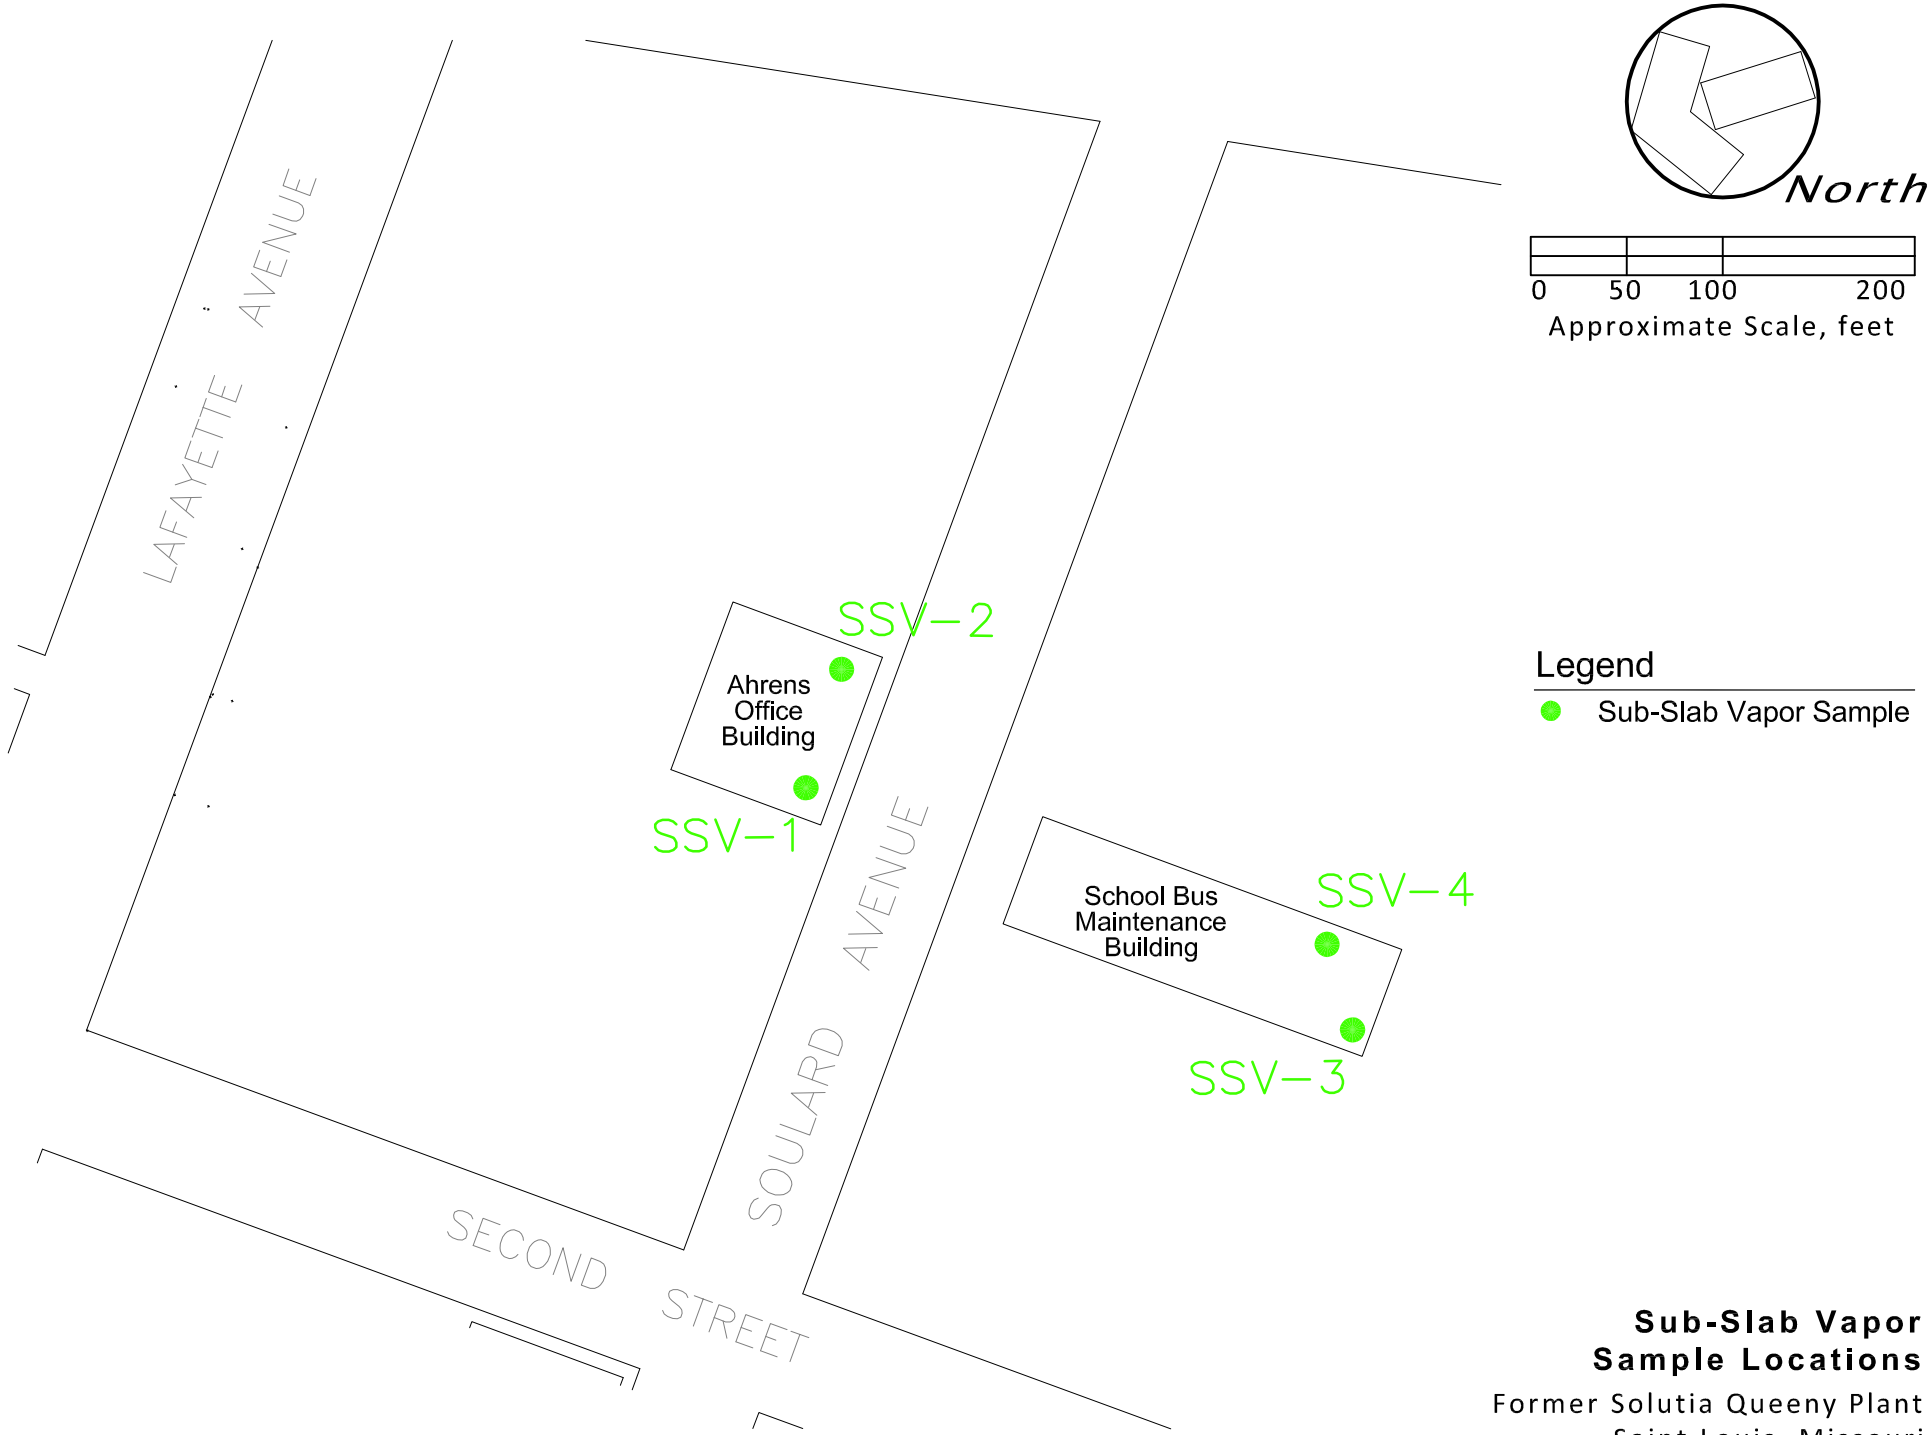
Sub-Slab Vapor Sample Locations

Tables 1 through 4 show the COPC concentrations and their respective cancer risk results and noncancer hazard indices (HIs; with the HI being a sum of the individual chemical's hazard quotients [HQs]). Only samples SSV-1 and SSV-2 demonstrated a cumulative cancer risk greater than 1E-05 as well as an exceedance of the noncancer HI criteria of 1.0. The chemicals which demonstrated the major contribution to the cumulative risks in sample SSV-1 are: Chloroform, PCE, and TCE. Each of the risk results for those chemicals demonstrated either a cancer risk greater than 1E-05 and/or an HQ greater than 1.0. For sample SSV-2, the following constituents exceeded at least one of those criteria: PCE, and TCE.

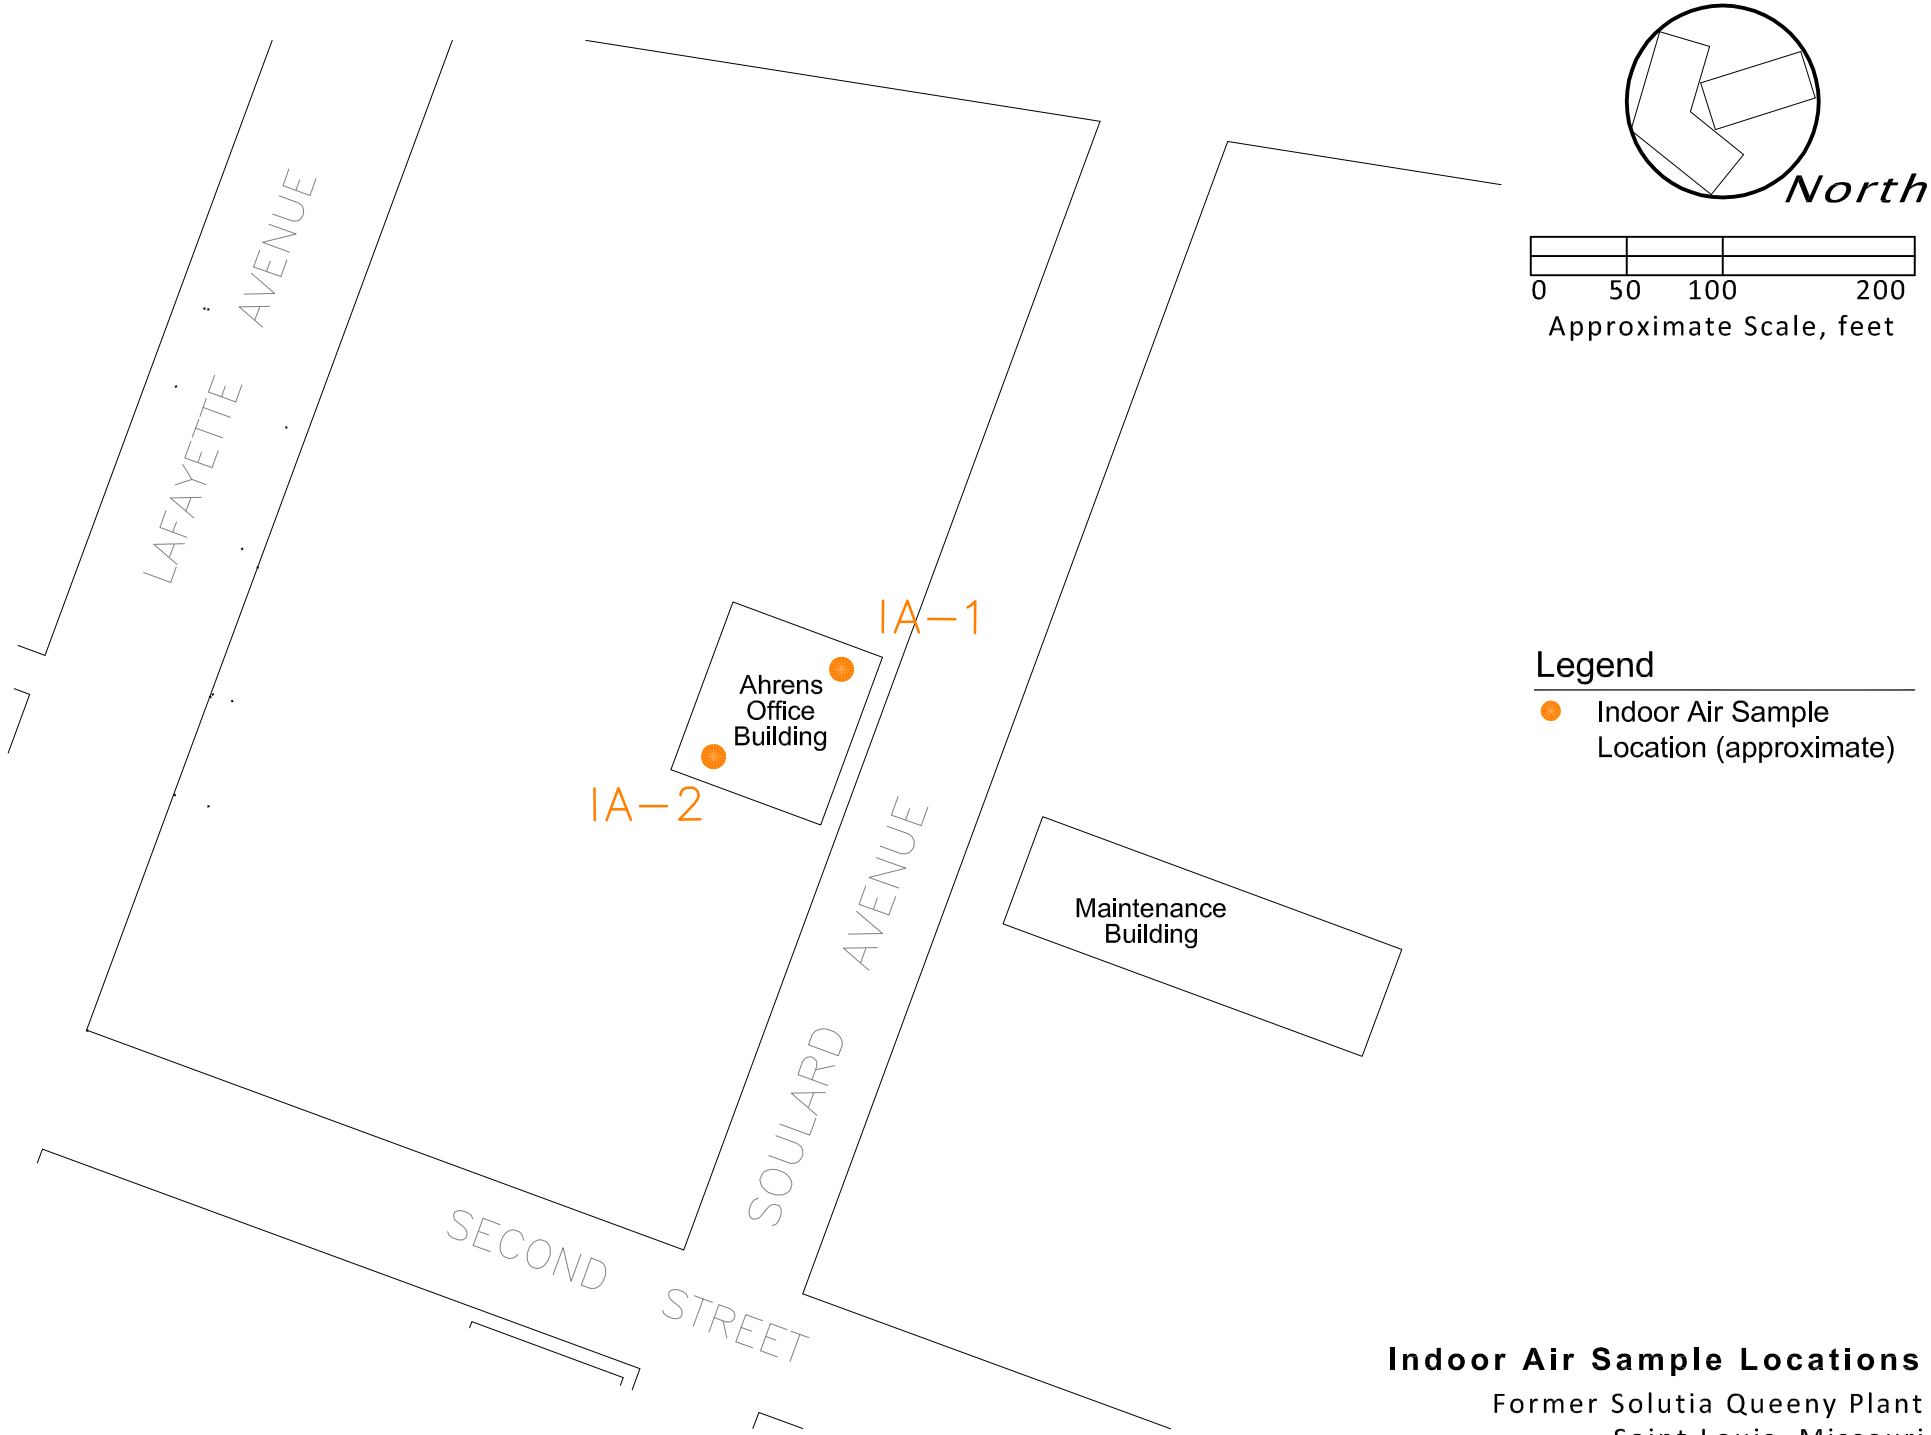
Indoor Air Sample Locations

Sample Date: January 24			
	IA-1		**IA-2**	
Chemical	**Cancer Risk**	**Hazard Quotient**	**Cancer Risk**	**Hazard Quotient**
Tetrachloroethene	1.6E-06	0.4	2.1E-06	0.54
Trichloroethene	7.7E-06	**1.8**	1.0E-05	**2.3**
Cumulative Risk	9.3E-06	**2.2**	**1.2E-05**	**2.8**

The data indicated that indoor air concentrations of the COPCs were present below action levels for both sampling events, and below screening levels for all the COPCs for the most recent round. Furthermore, the July event indicated that detected concentrations were all below its associated cancer risk, its HQ, and the EPA suggested action level for TCE noted above. Consequently, the data do not demonstrate the need for a mitigation system for the investigated building.
