SFUND RECORDS CTR
2385815

DATE: 11·14·85 NAME: Schmit #1
DESCRIPTION: GenDyn-Bldg 1
Ground floor substation w/ 3 retrofilled Westinghouse transformers, #3011134 → #3011136.

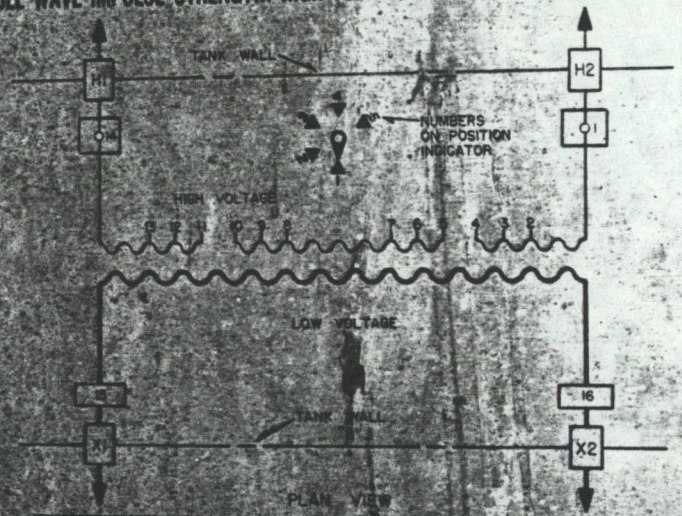
DATE: 11.14.85 NAME: Schmit #2
DESCRIPTION: GenPlan-Bldg.1
Westinghouse #301134.1 Nameplate.

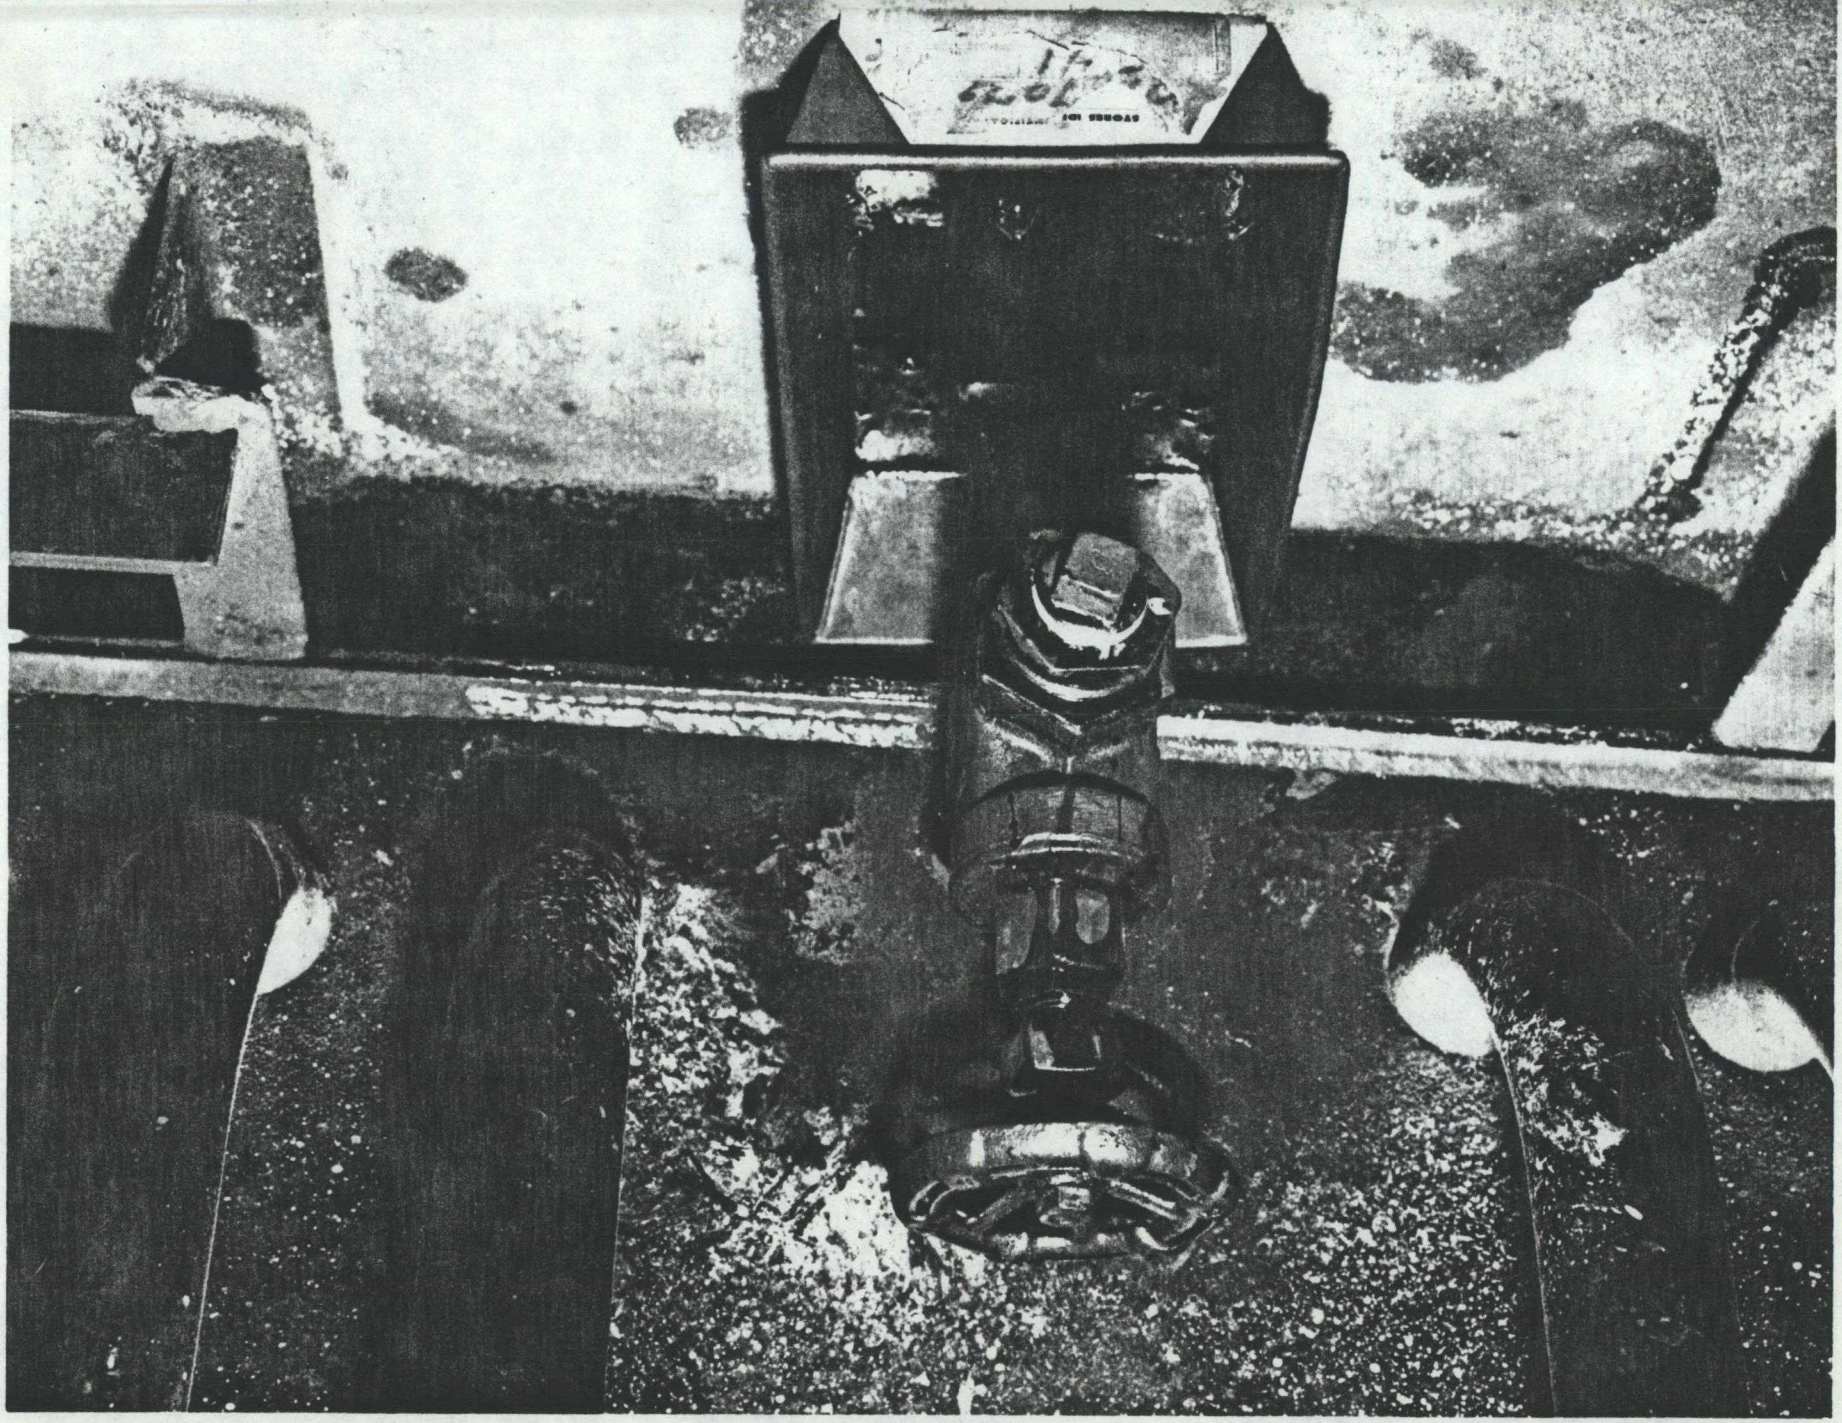
DATE: 11-19-85 NAME: Schmit #3

Fluid currently leaking from drain valve of

#3011134

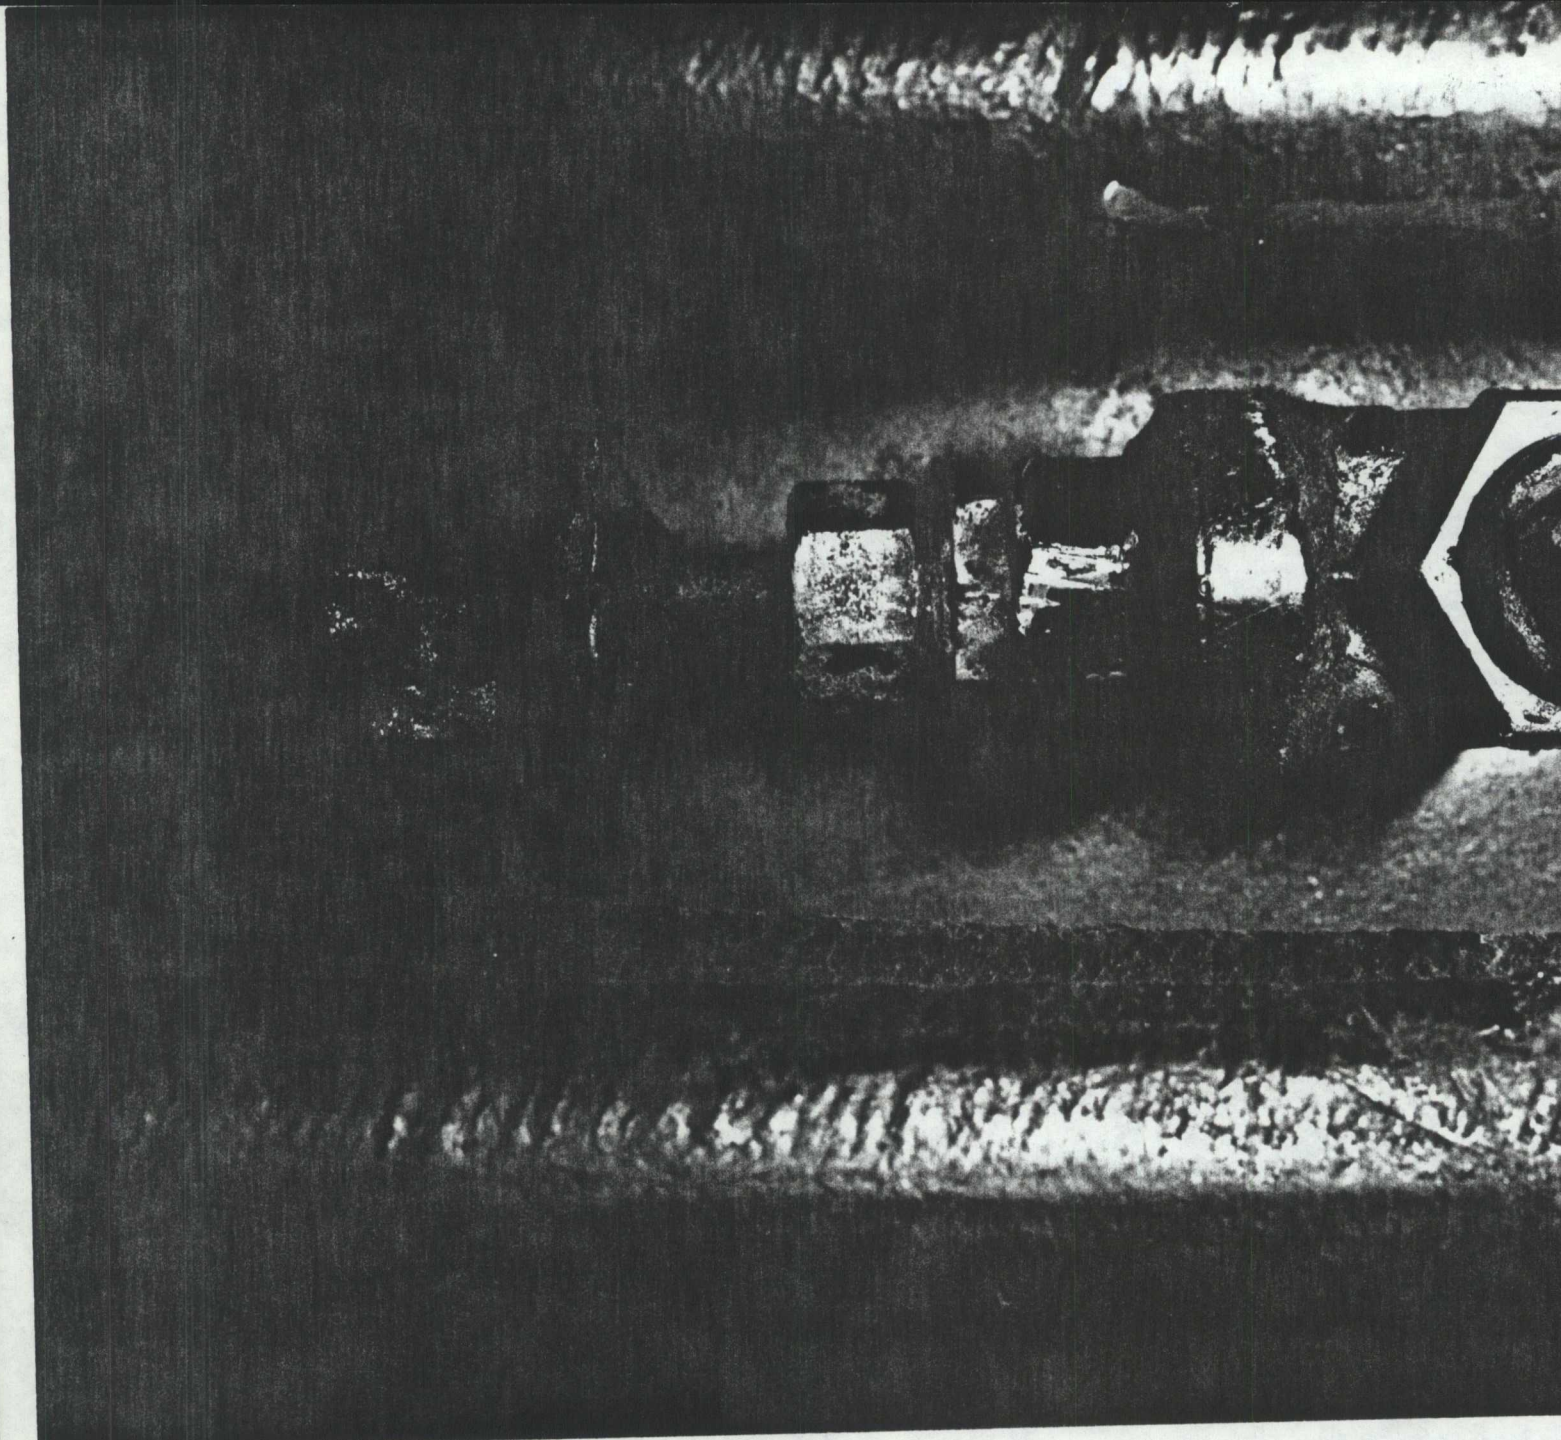
DATE: 11.14.85 NAME: Schmit #4

Material leaking around secondary drain valve of #301124.

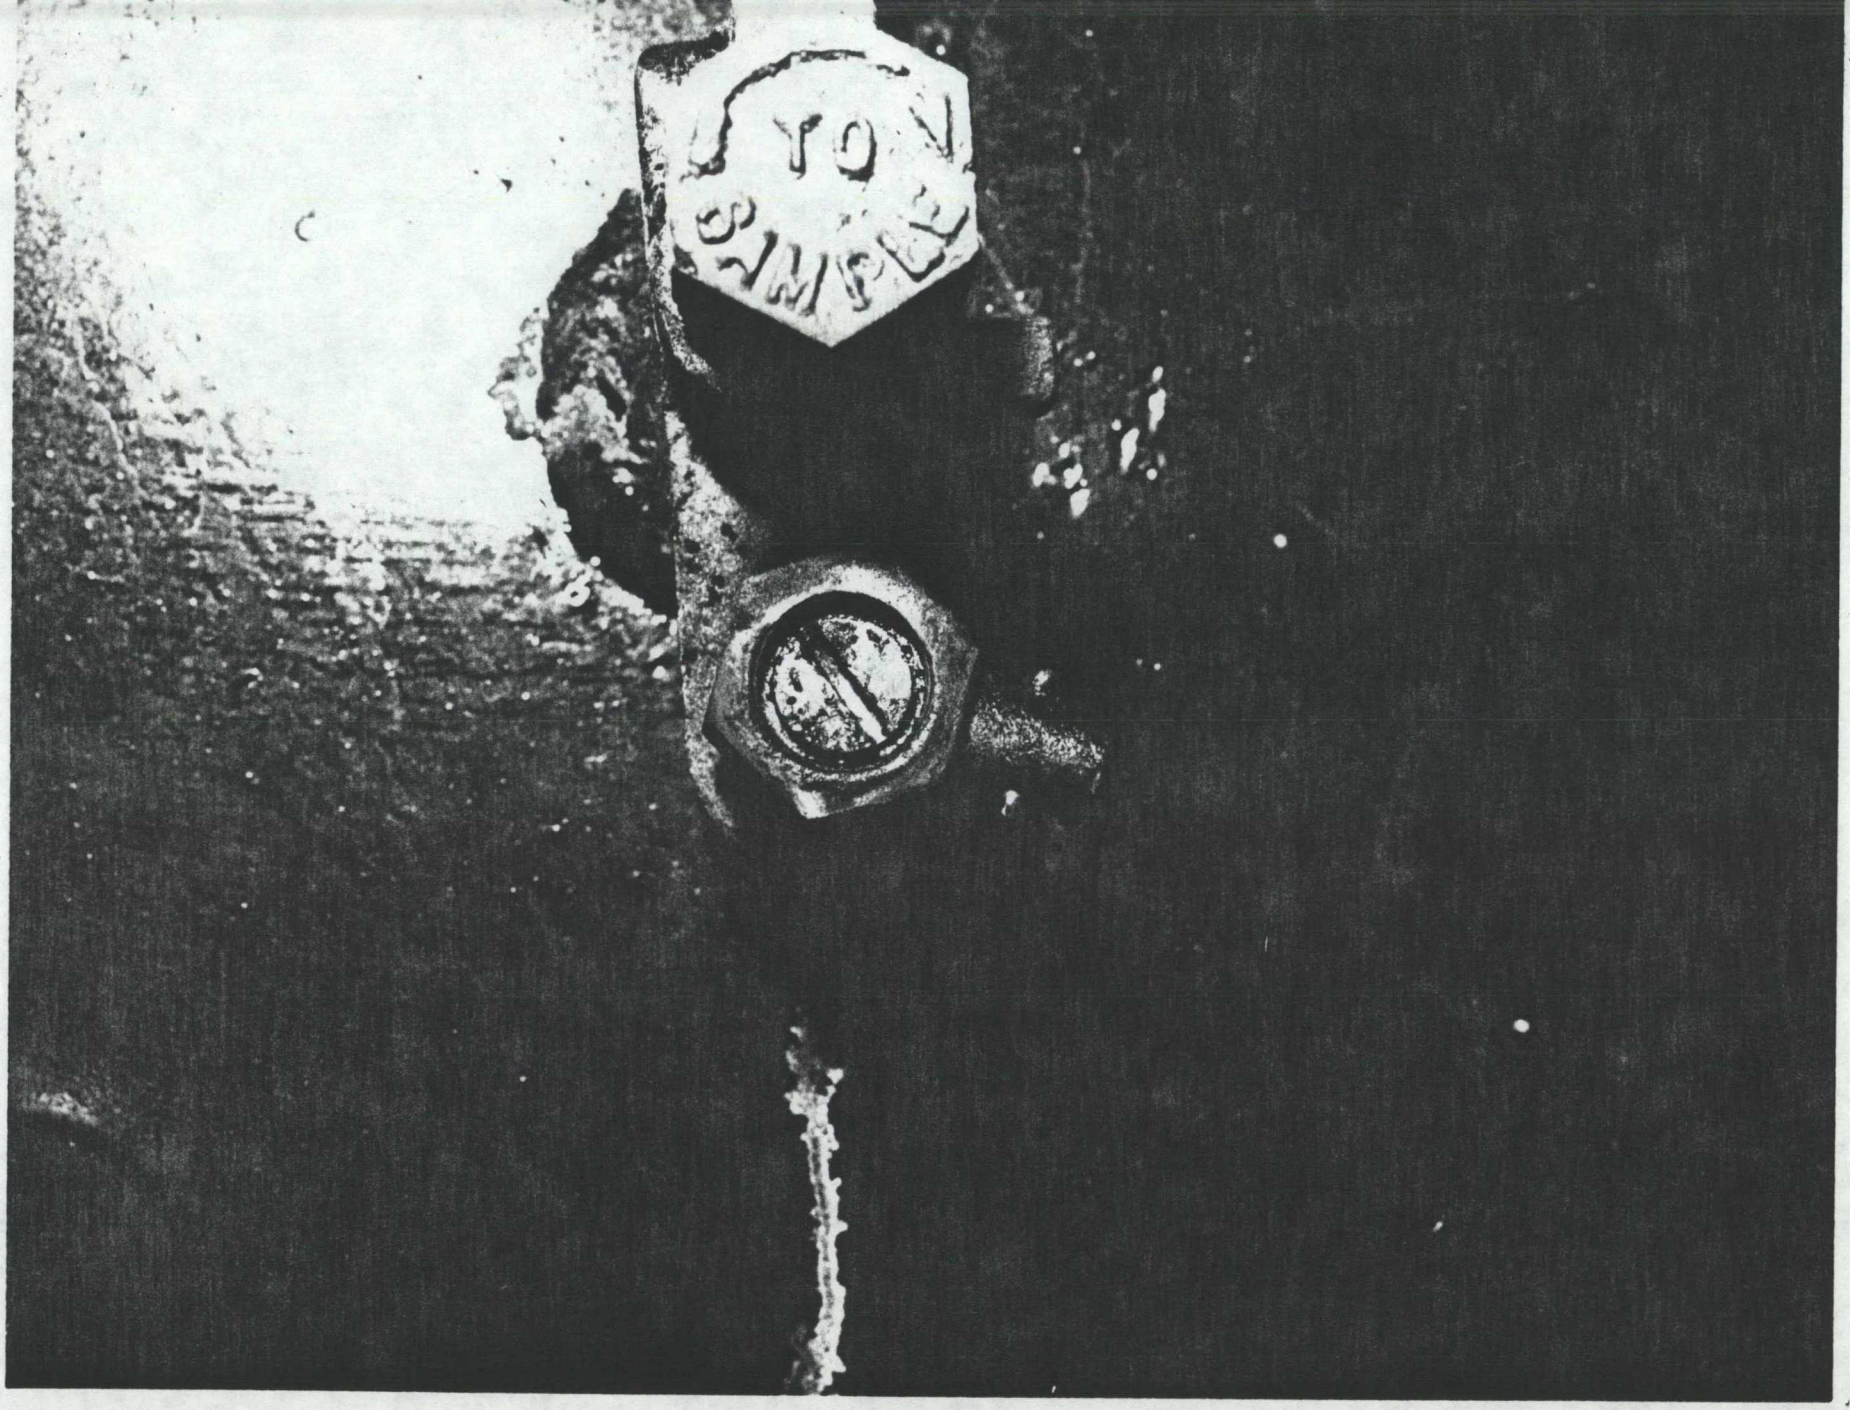
DATE: 11.14.85 NAME: Schmit #5
DESCRIPTION: GenPyn-Bldg 1
Drip from sample tap of #301 134

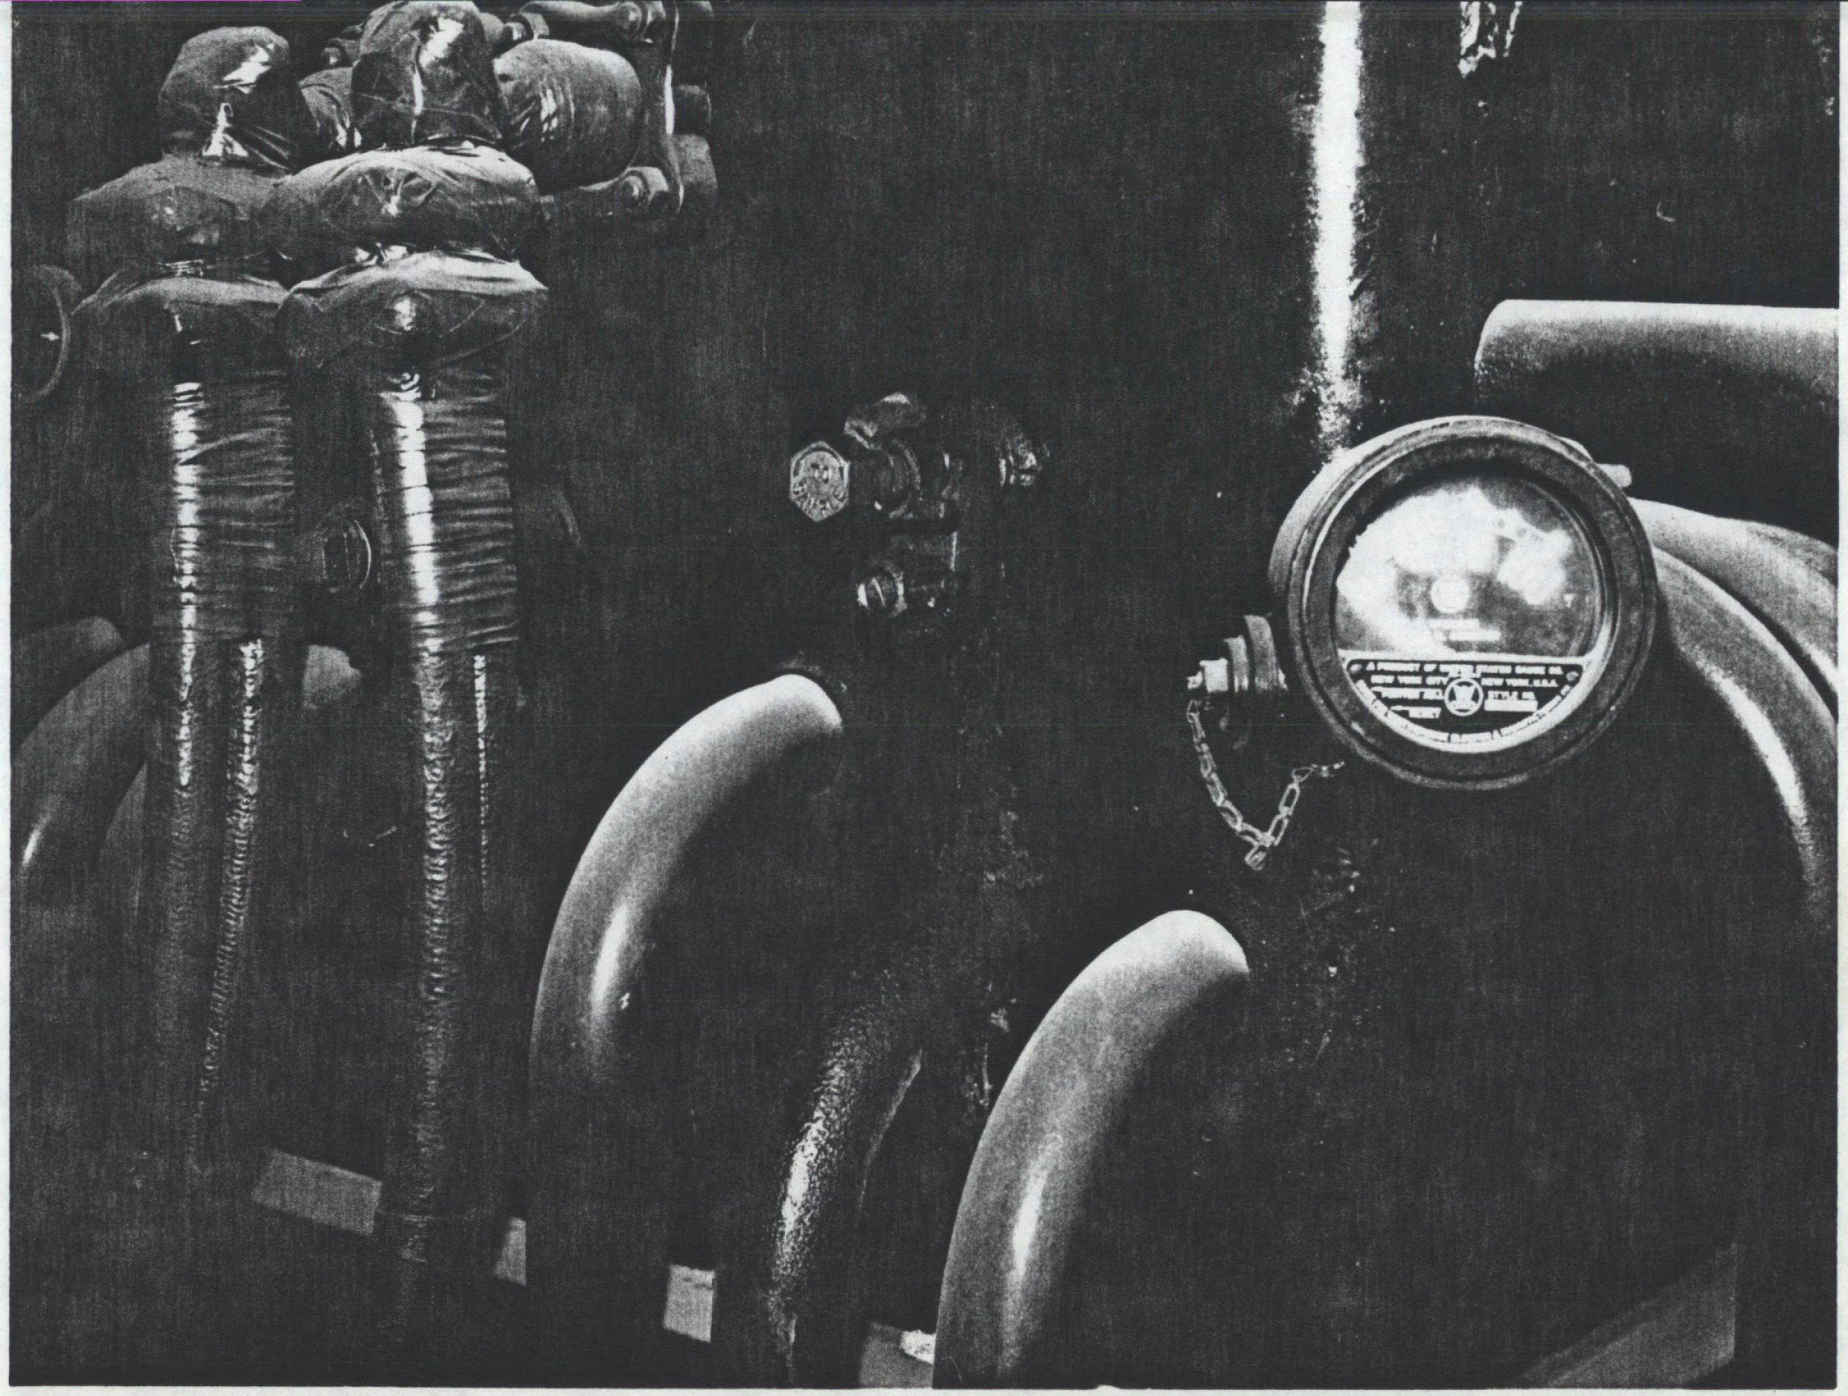
DATE: 11·14·85 NAME: Schmit #6
DESCRIPTION: GenDyn – Bldg 1
Middle transformer of 3. Note run from sample tap. (#3011434 → 36)

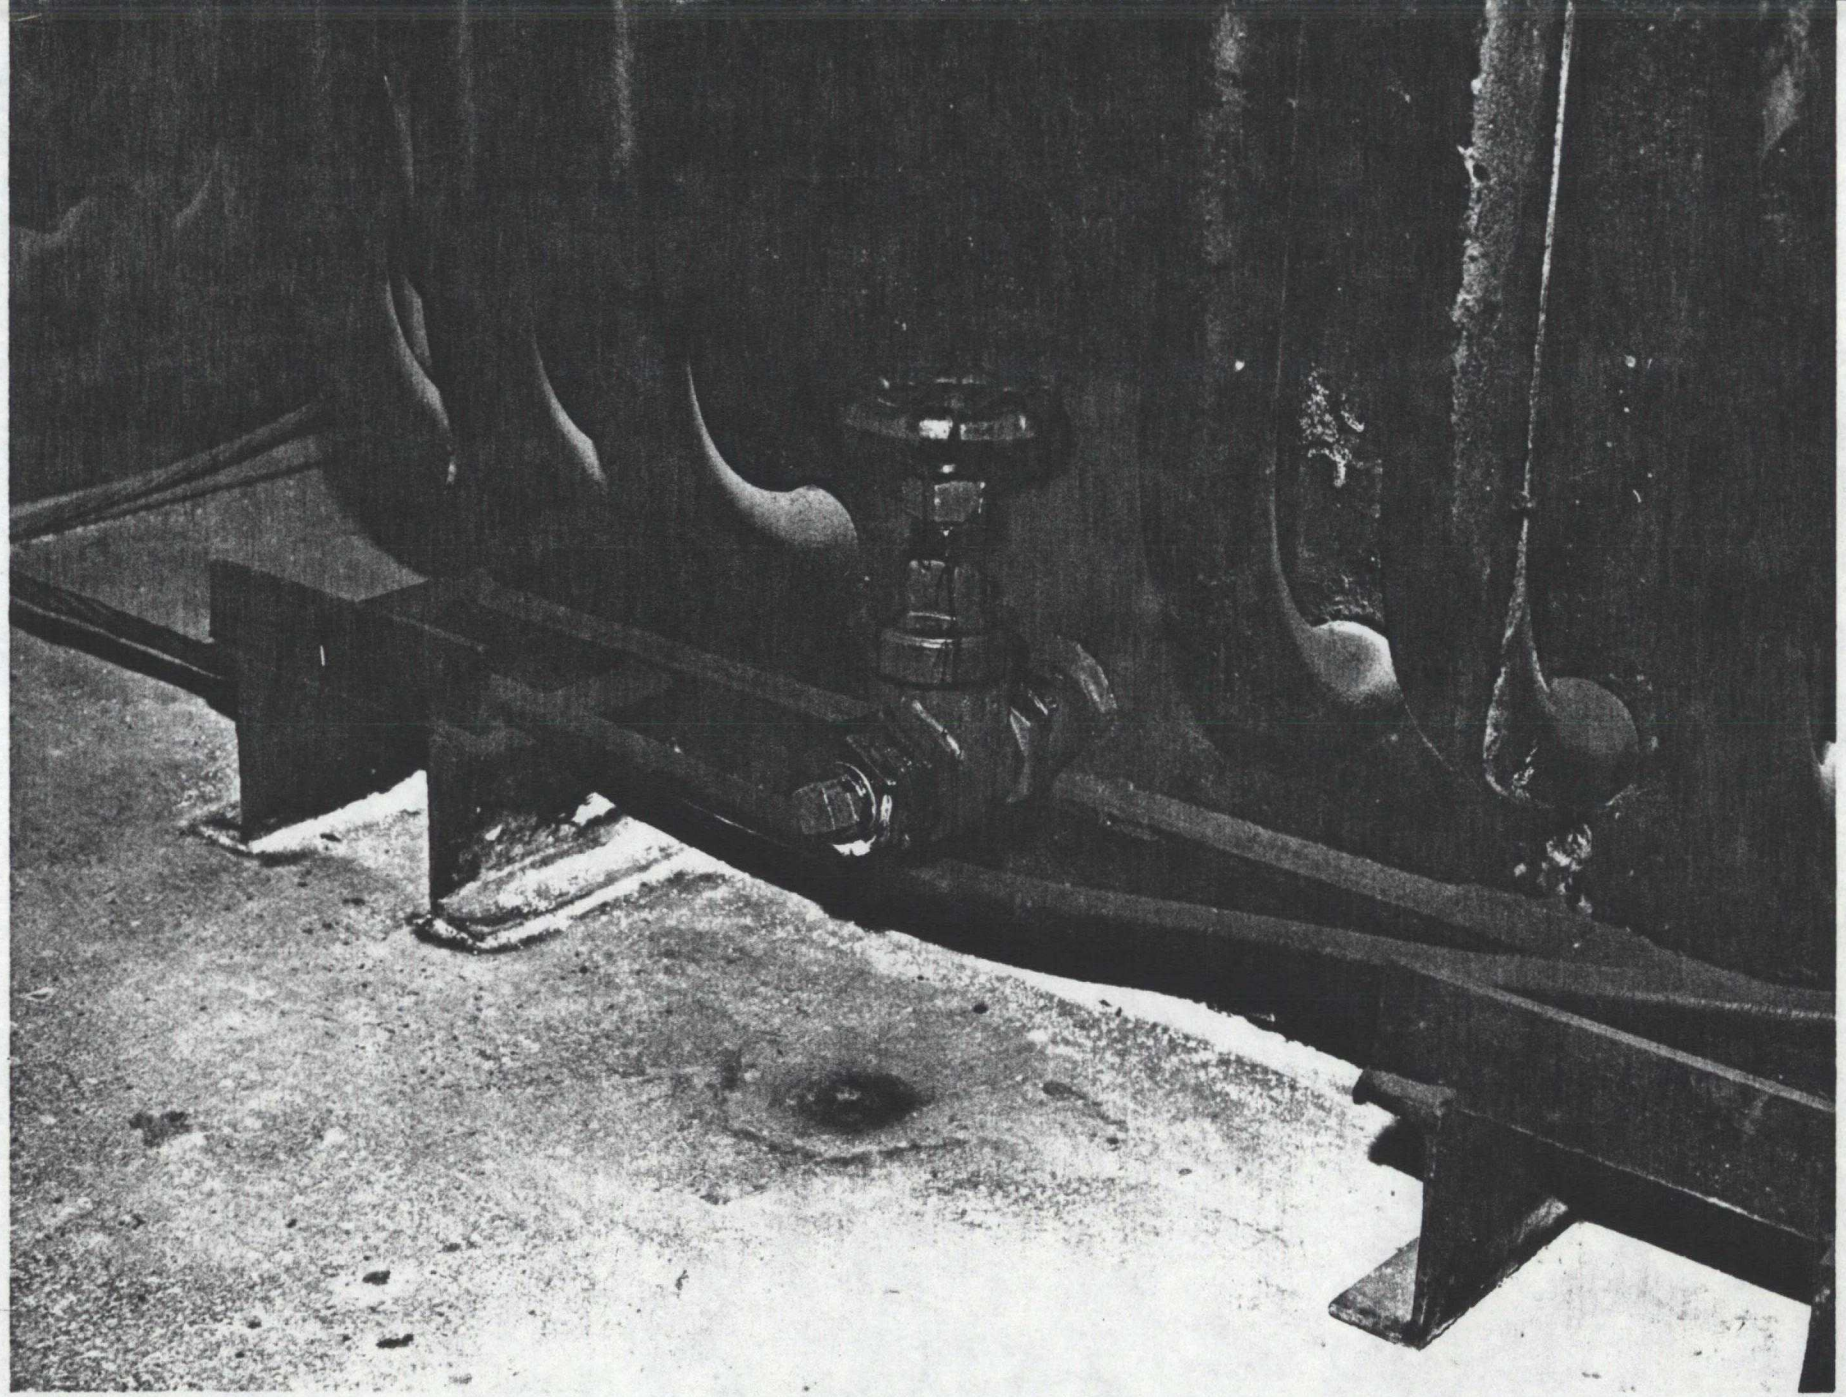
DATE: 11.14.85 NAME: Schmit #7

Middle transformer of 3. Note stain beneath valve & drip forming on underside of nut.

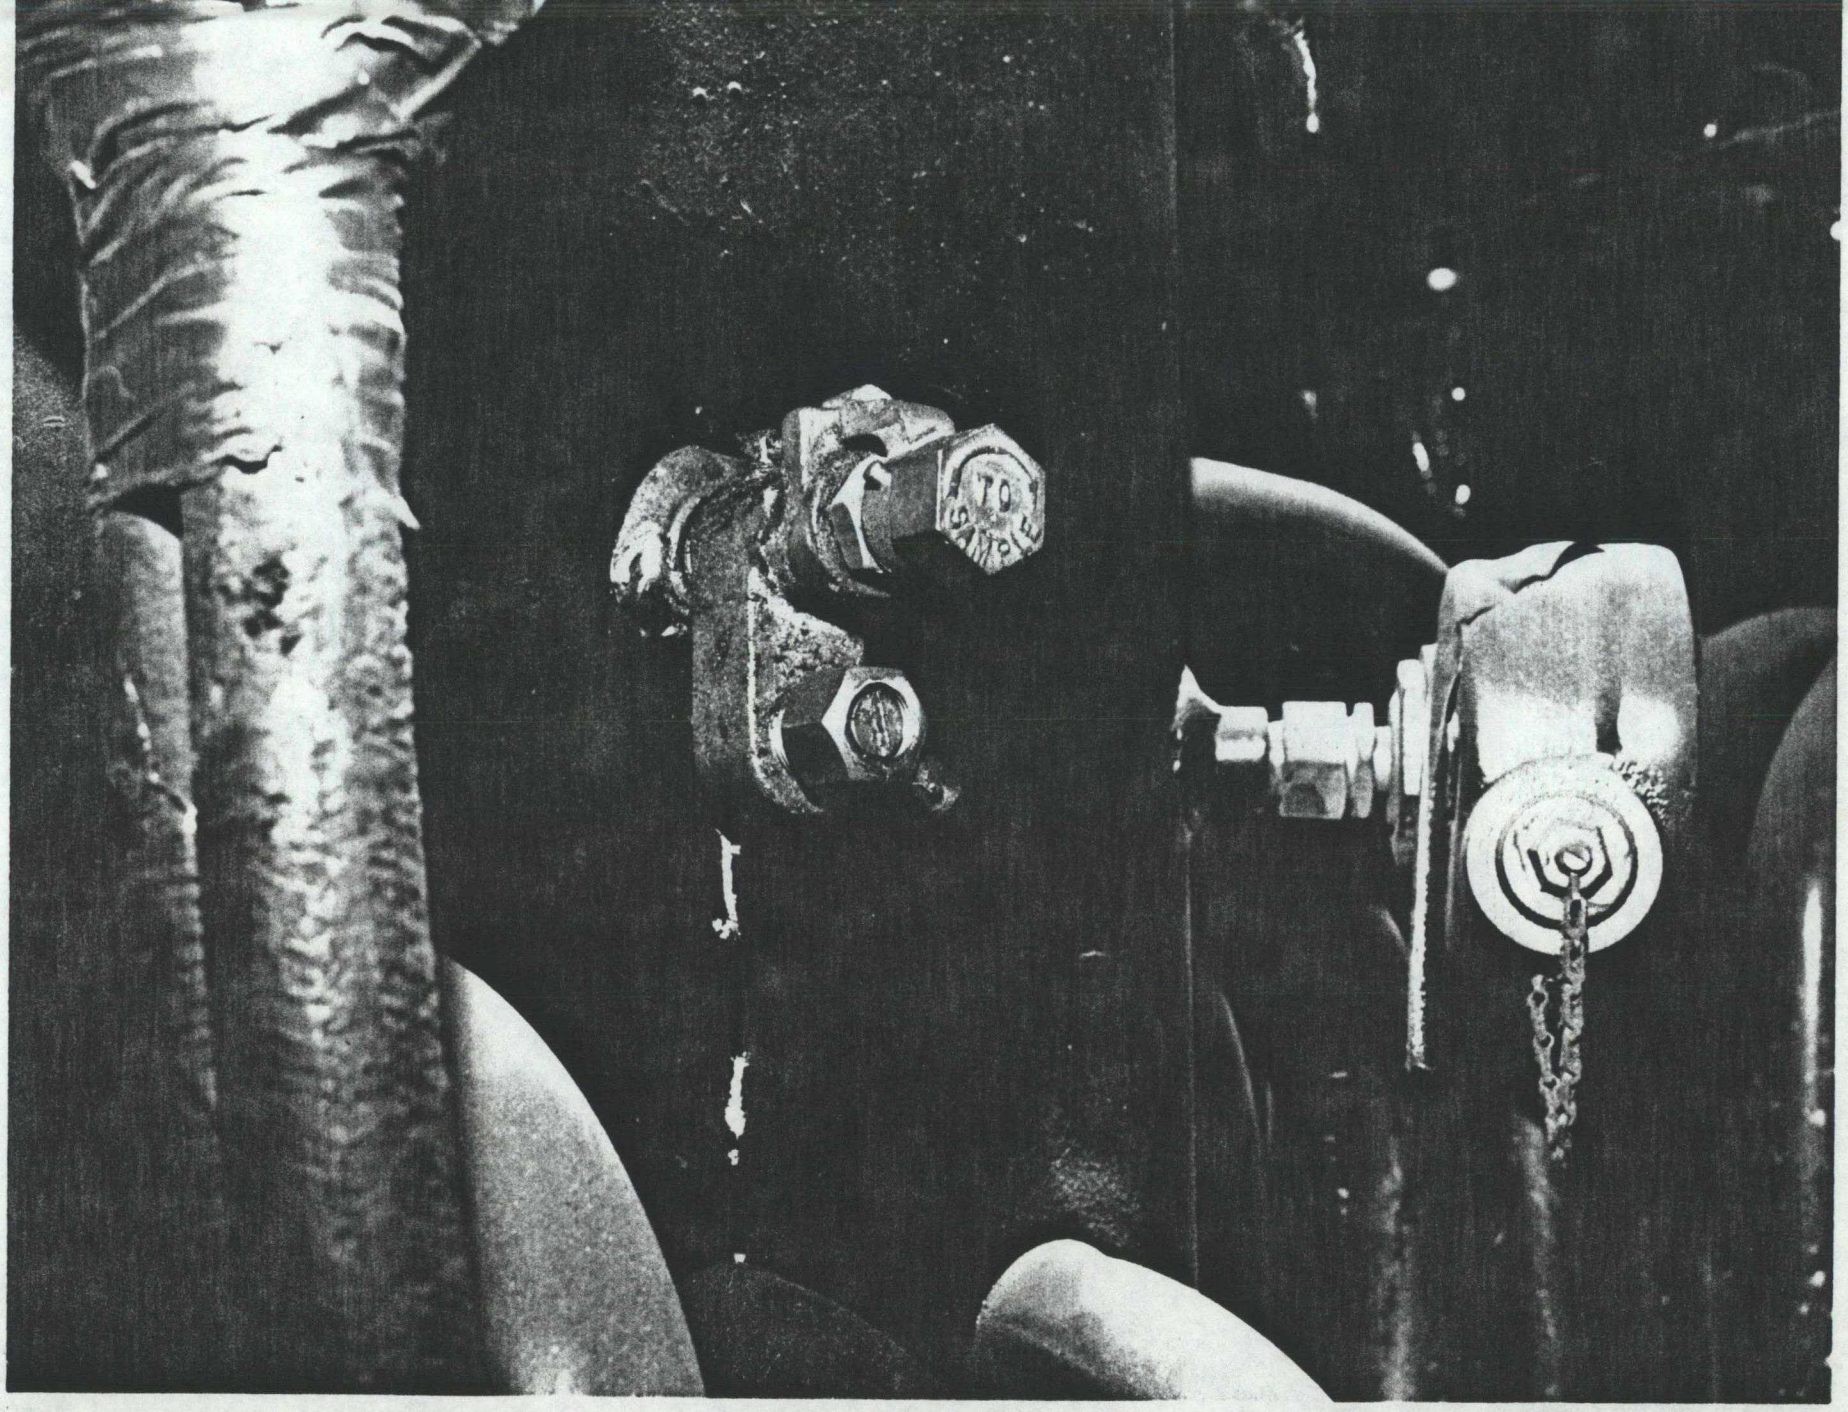
DATE: 11-14-85 NAME: Schmit #6

Left transformer of #301134 → 36 (facing nameplates). Nameplate was inaccessible. Note leaked material around sample tap and oil shadow surrounding sample tap.

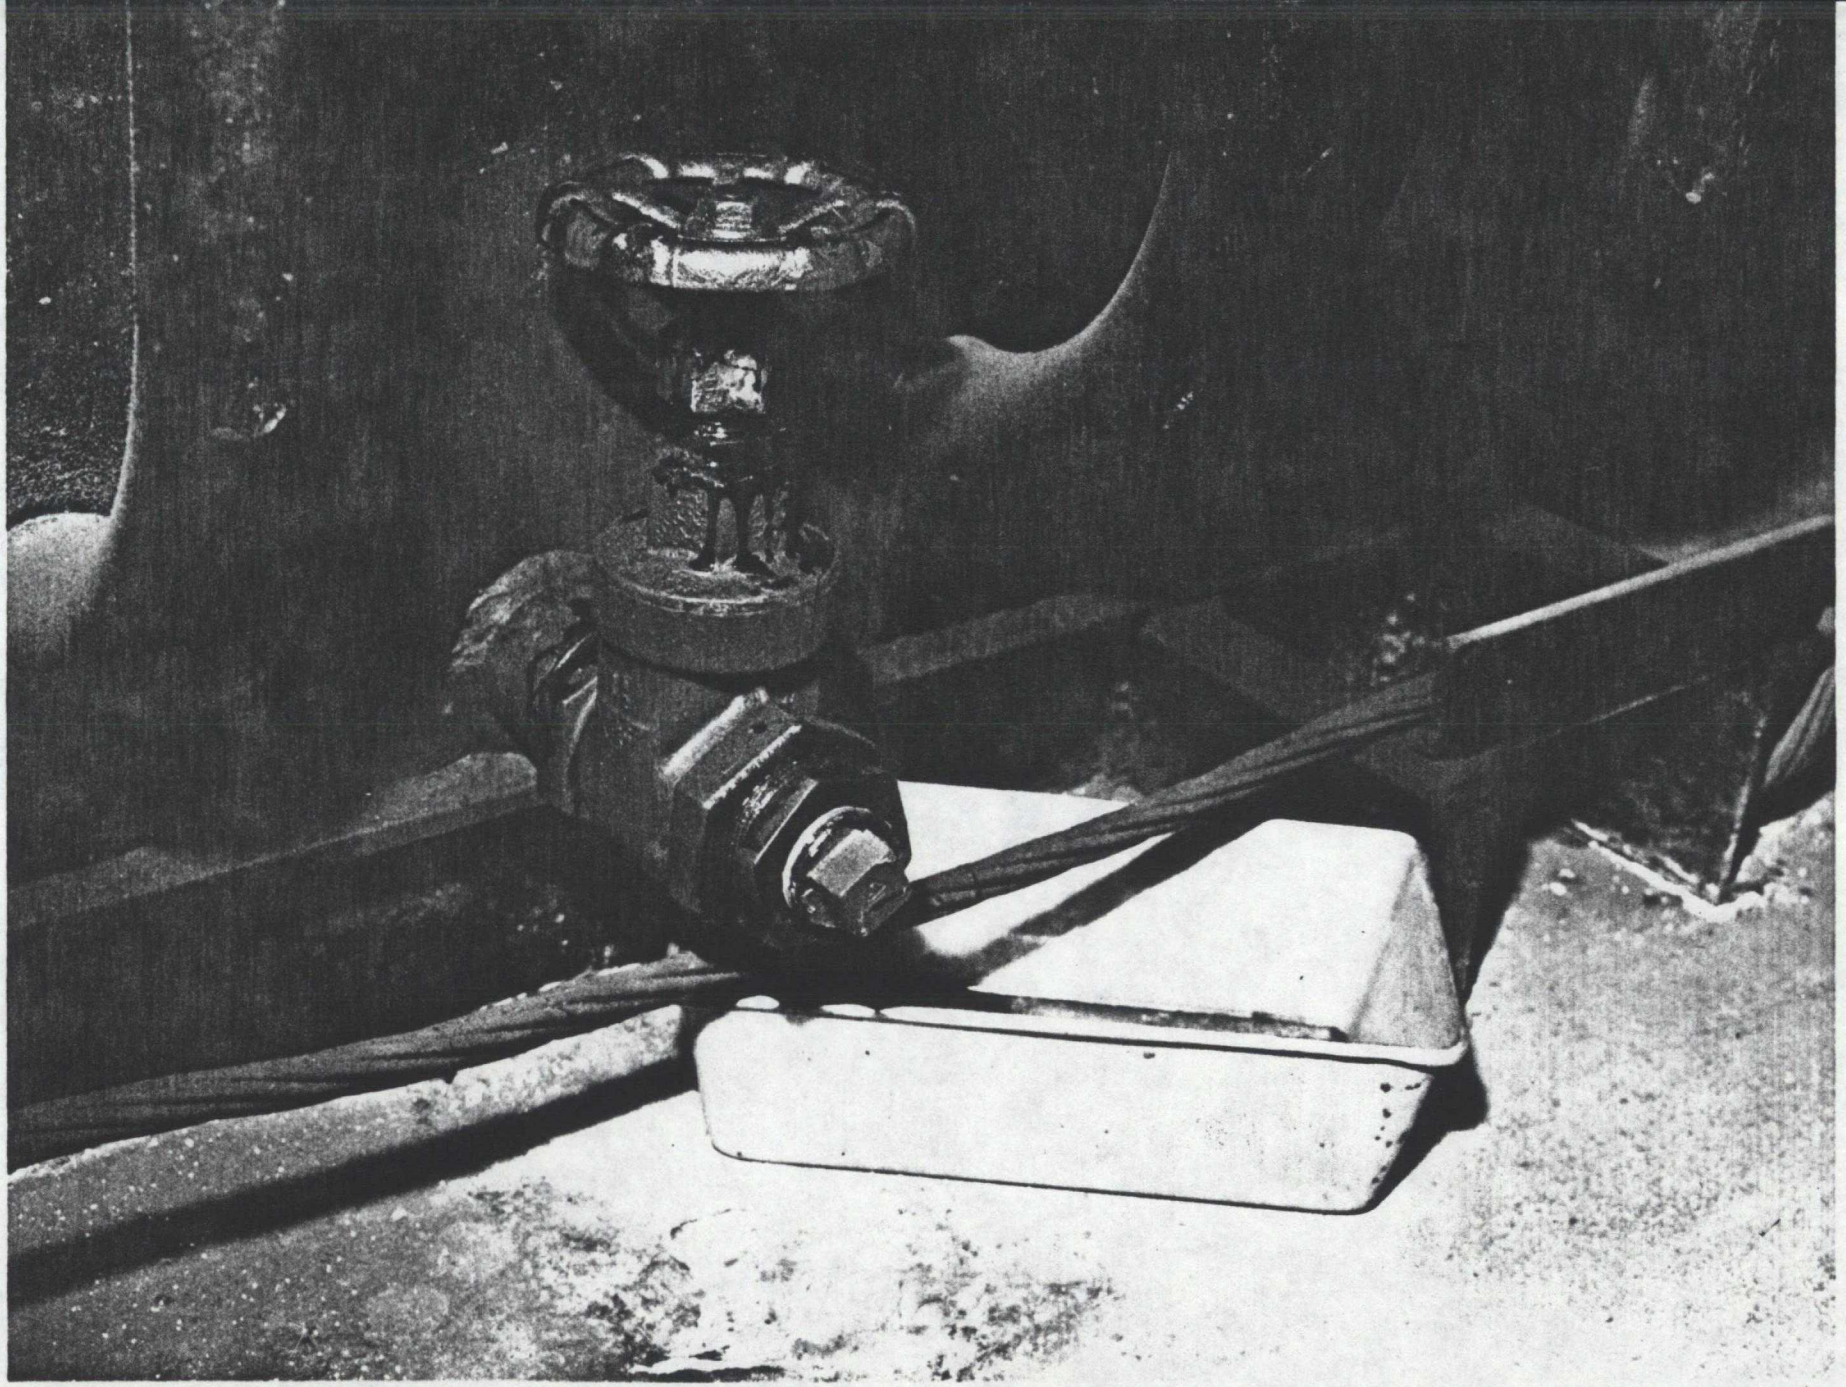
DATE: 11-14-85 NAME: Schmit #9

Left transformer of 3. Note leak from drain tap.
